Douglas County Courthouse  
Commission Chamber

Courthouse Background

Built in 1903, the historic Douglas County Courthouse was designed by John G. Haskell and Frederick C. Gunn in the Richardsonian Romanesque style, and it is a late example of the style. The commission chamber, formerly the courtroom, occupies the southeastern corner of the second story.

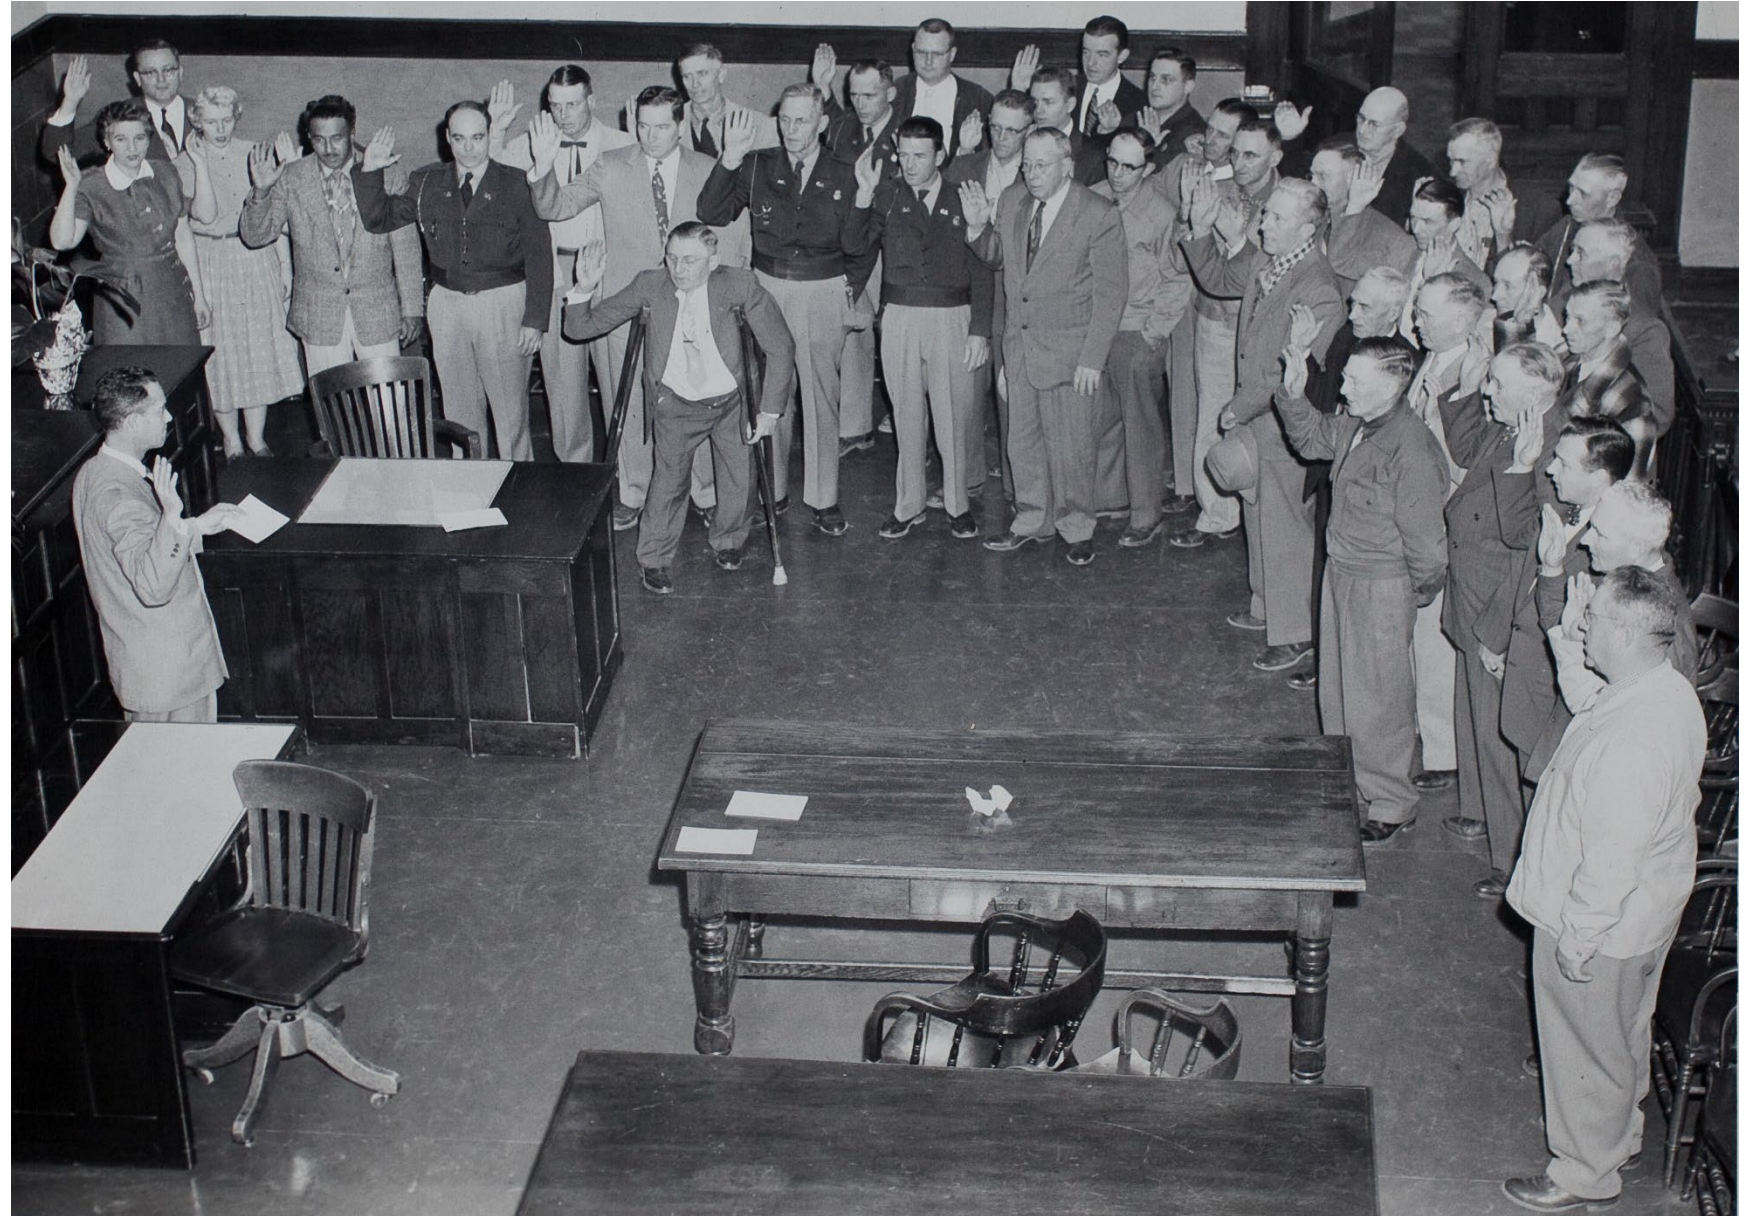
# 1955 Photo

This photo gives a good view of the court – or business side of the courtroom. At the lefthand side of the image, the dais is pressed against the west wall. The floor is covered with a material that appears to be a linoleum tile, instead of or installed over the historic hardwood floors.

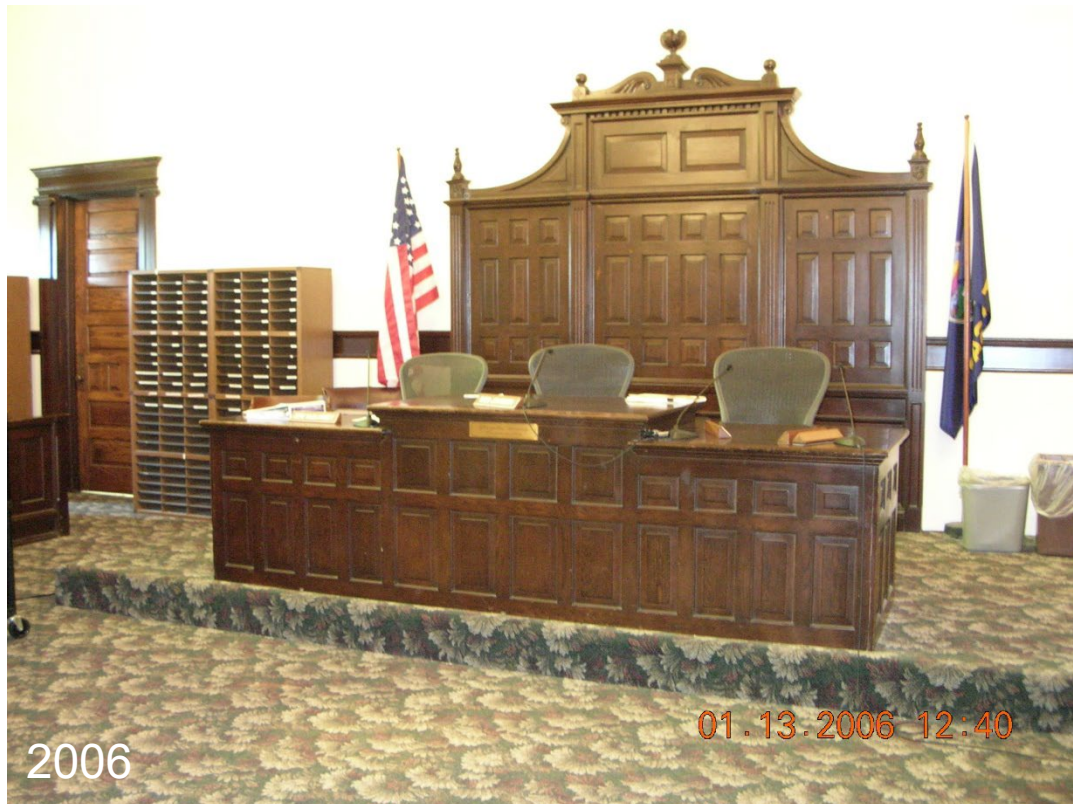
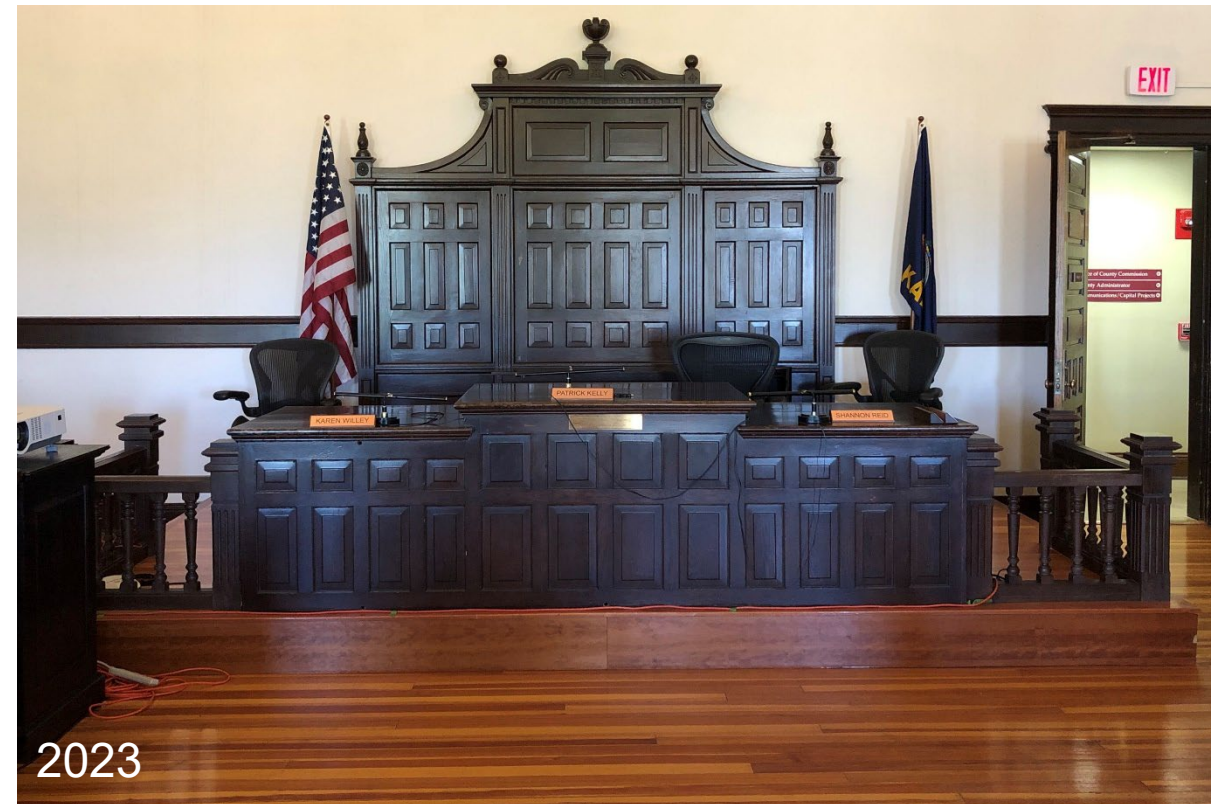
# 2006 Dais

Between 2006 and 2023, the dais was remodeled, with the carpet stripped off and a new set of railings attached to either end of the desk. Note that the carpet on the floor was removed during that time, exposing the hardwood floors.

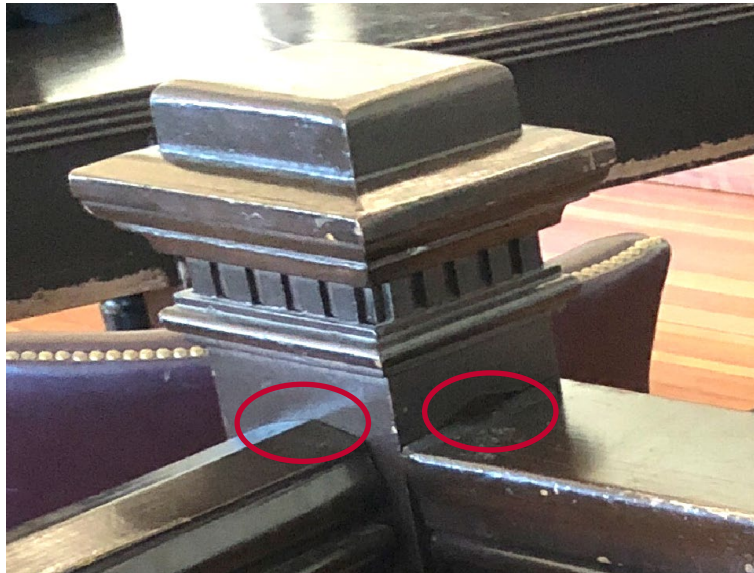
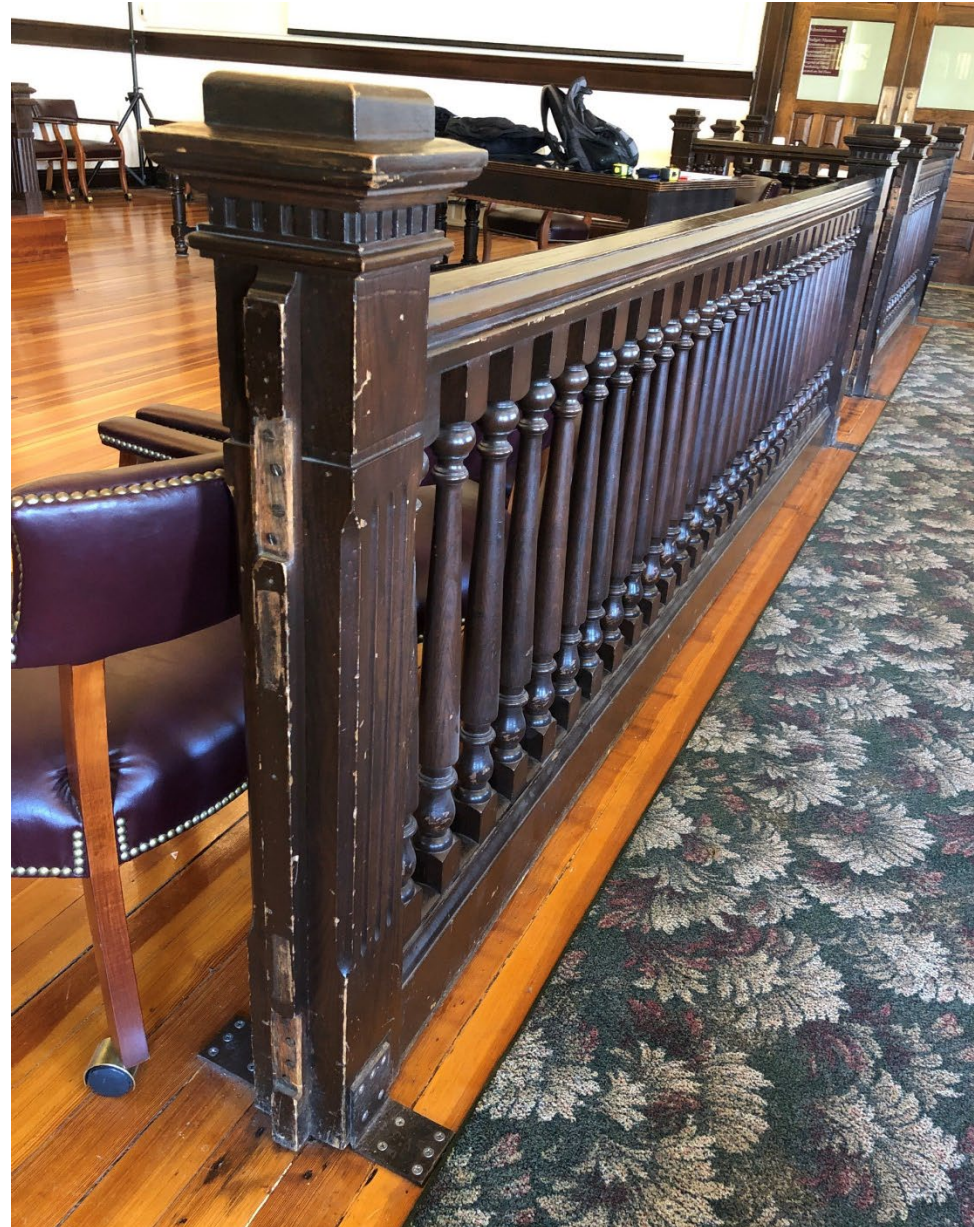
# Railing Characteristics

The dividing rail showed signs of its complicated history. Two of the gates were removed and stored in the attic. Scars from the hinges were visible on the insides of the posts. The jog the railing took around the north door was not original, and some damage could be seen on the posts around that location.

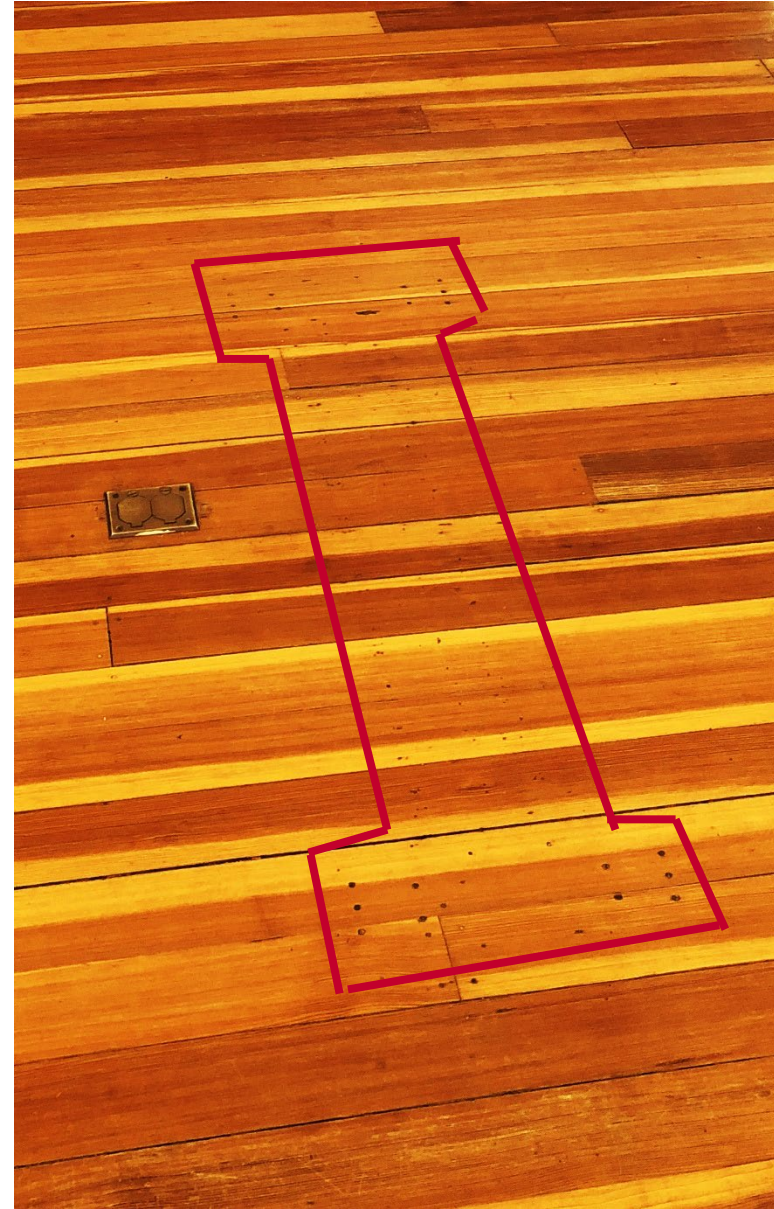
# Railing Position

A scar of the original railing location could be seen on the floor, approximately 19' – 11" from the north wall.

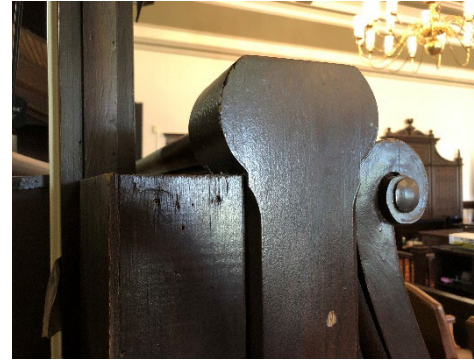
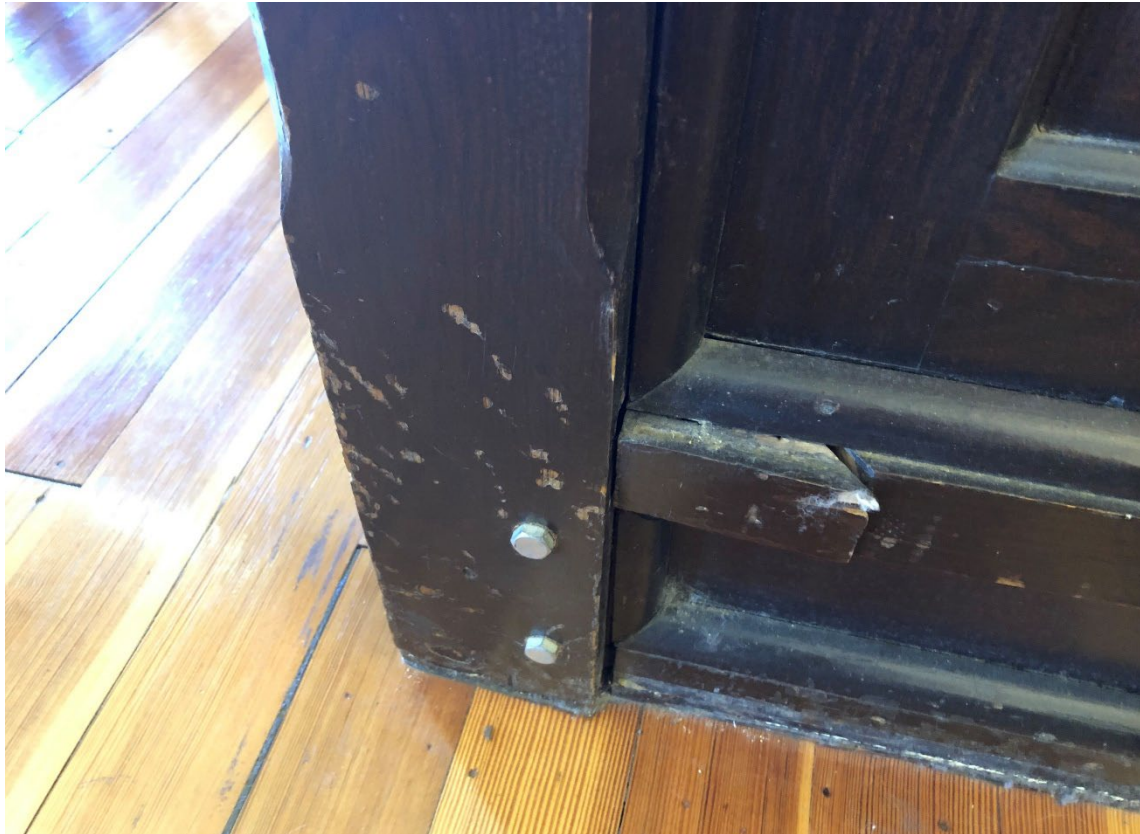
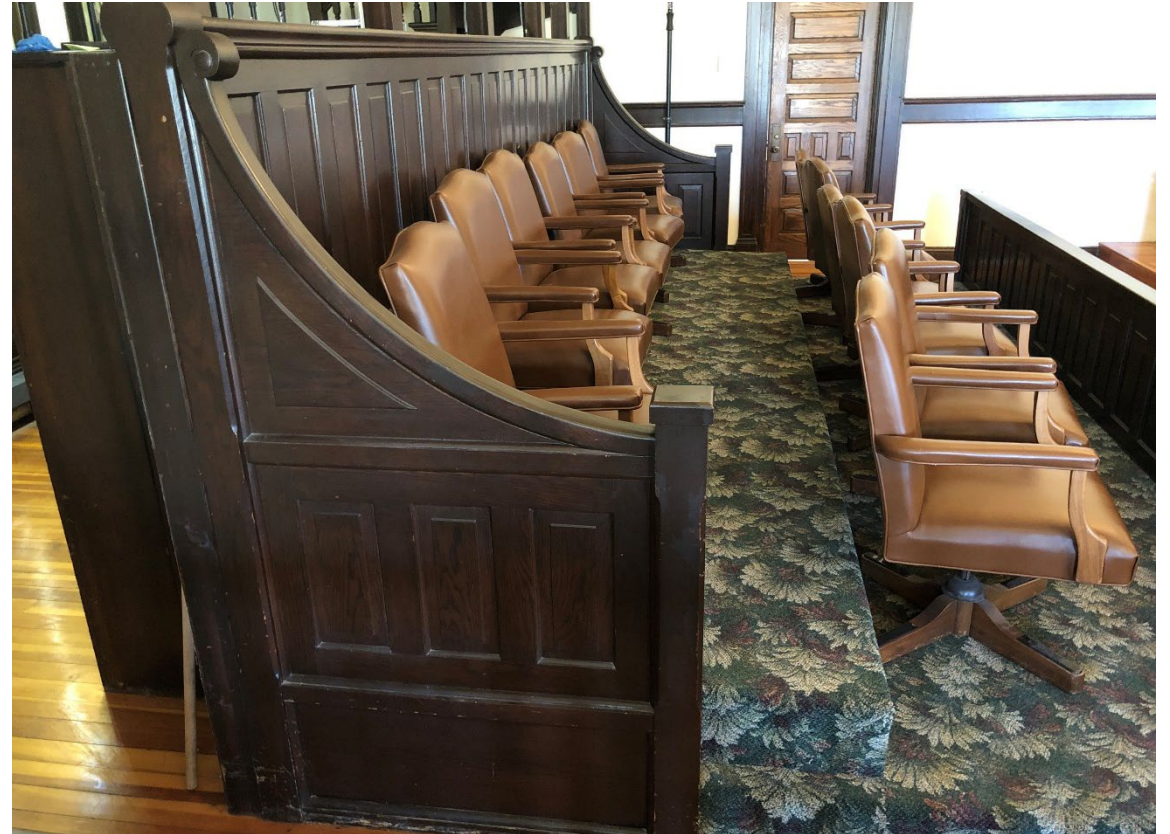
# Jury Bench

The Jury Bench showed signs of modification, such as non-original wood and anachronistic carpentry.

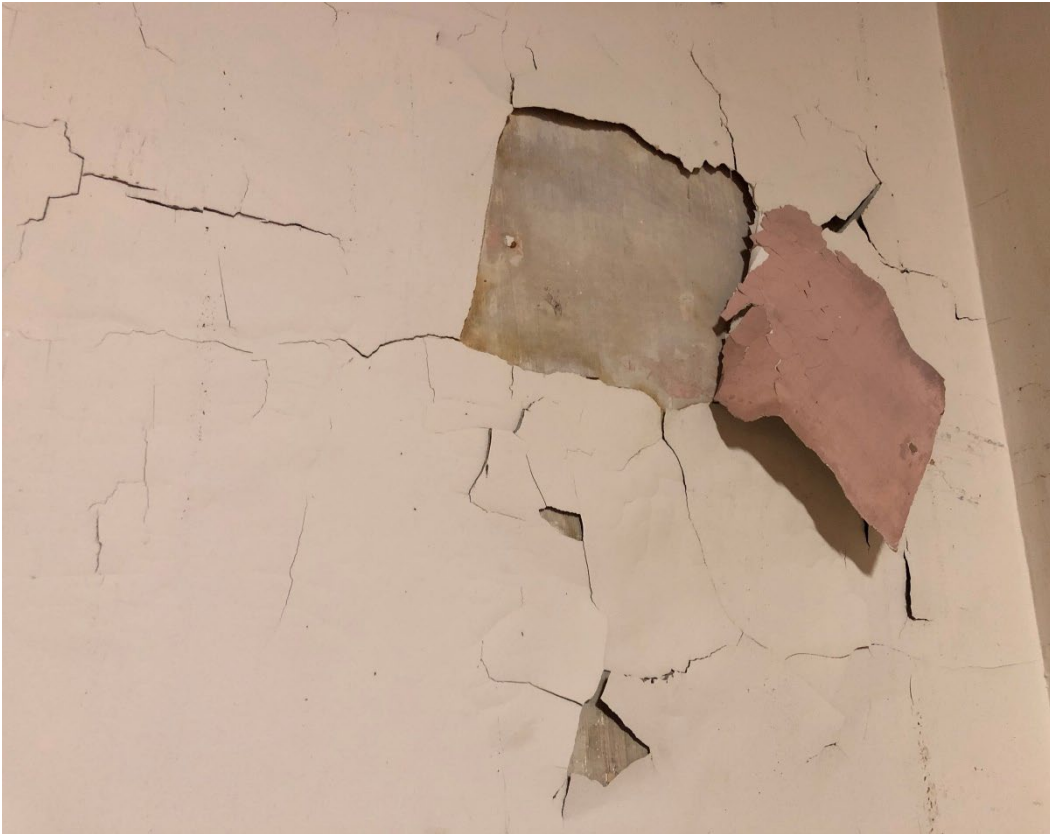
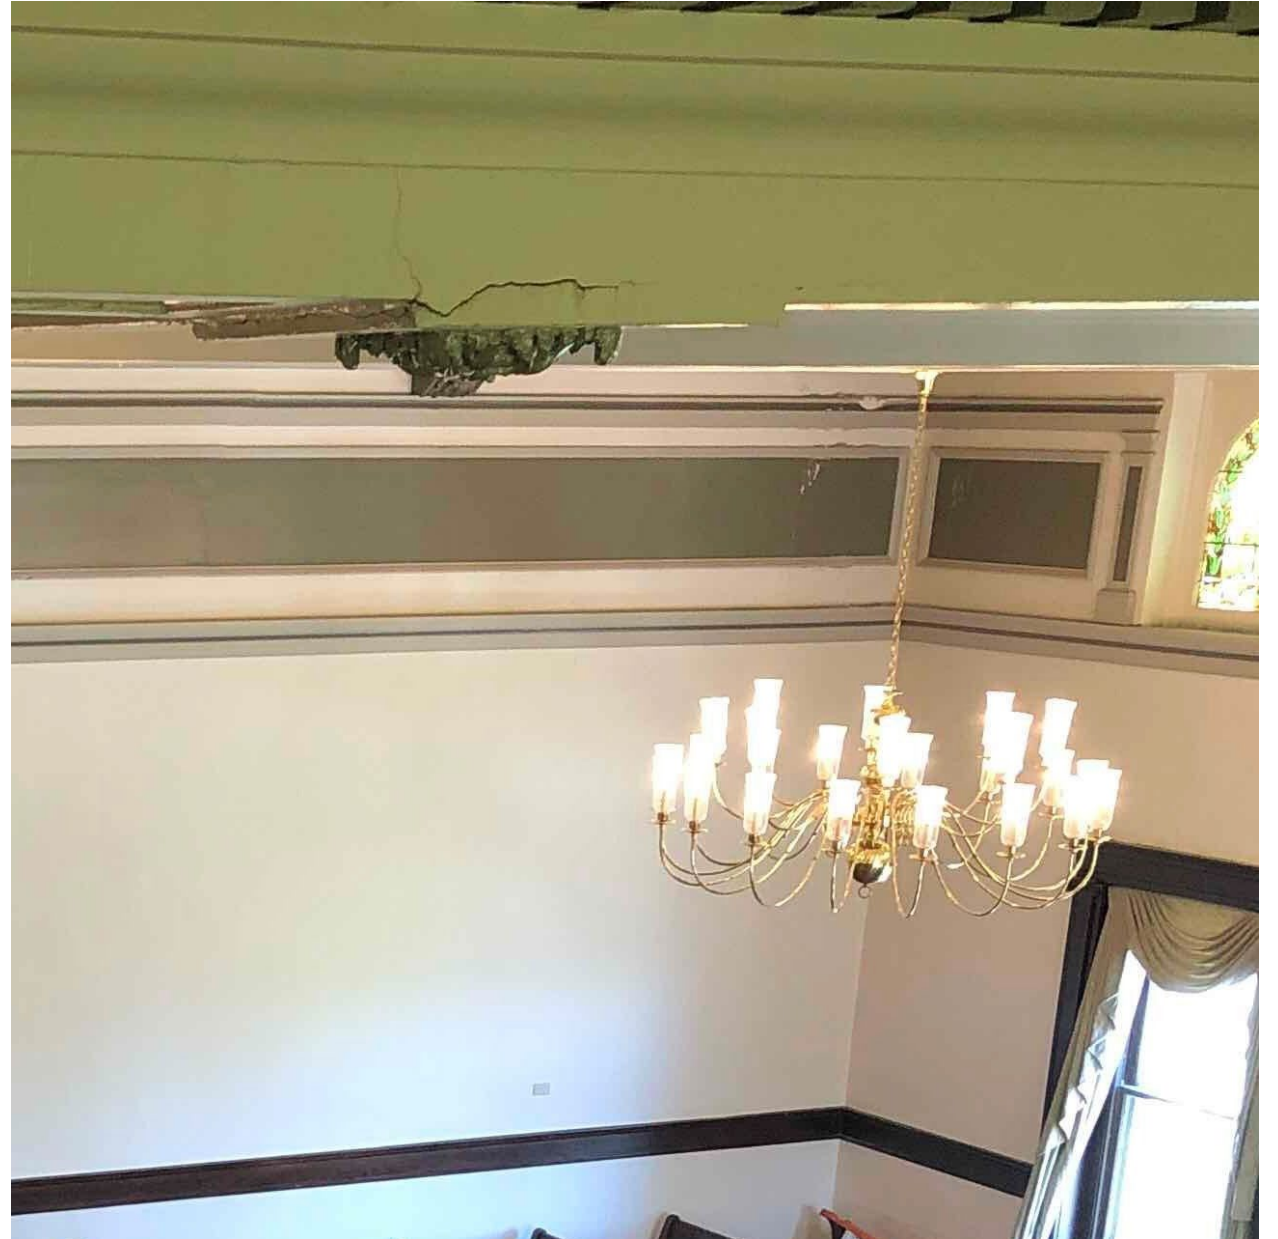
# Plaster Condition

The plaster was in fair condition, though serious damage was present in the northeast corner of the room.

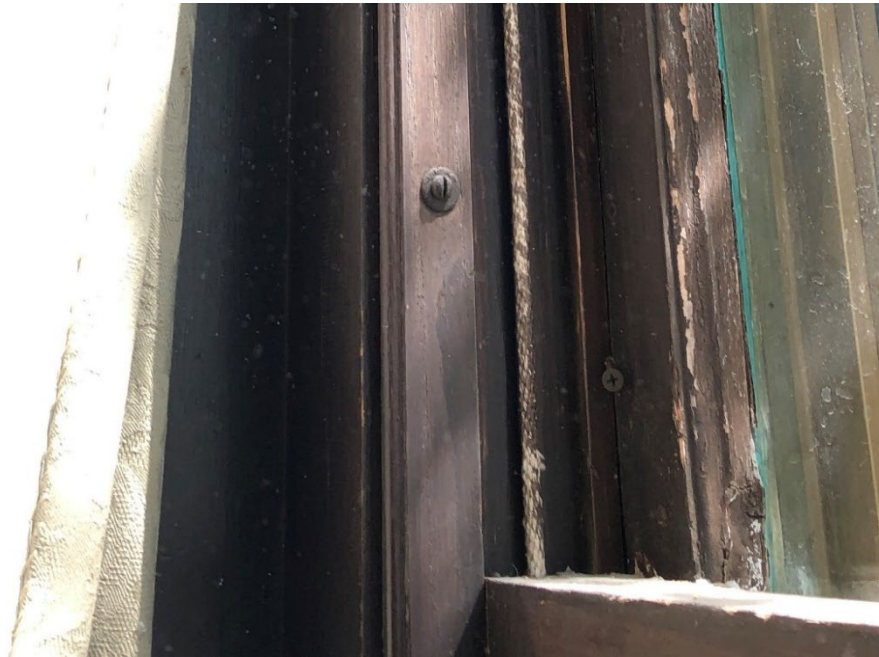
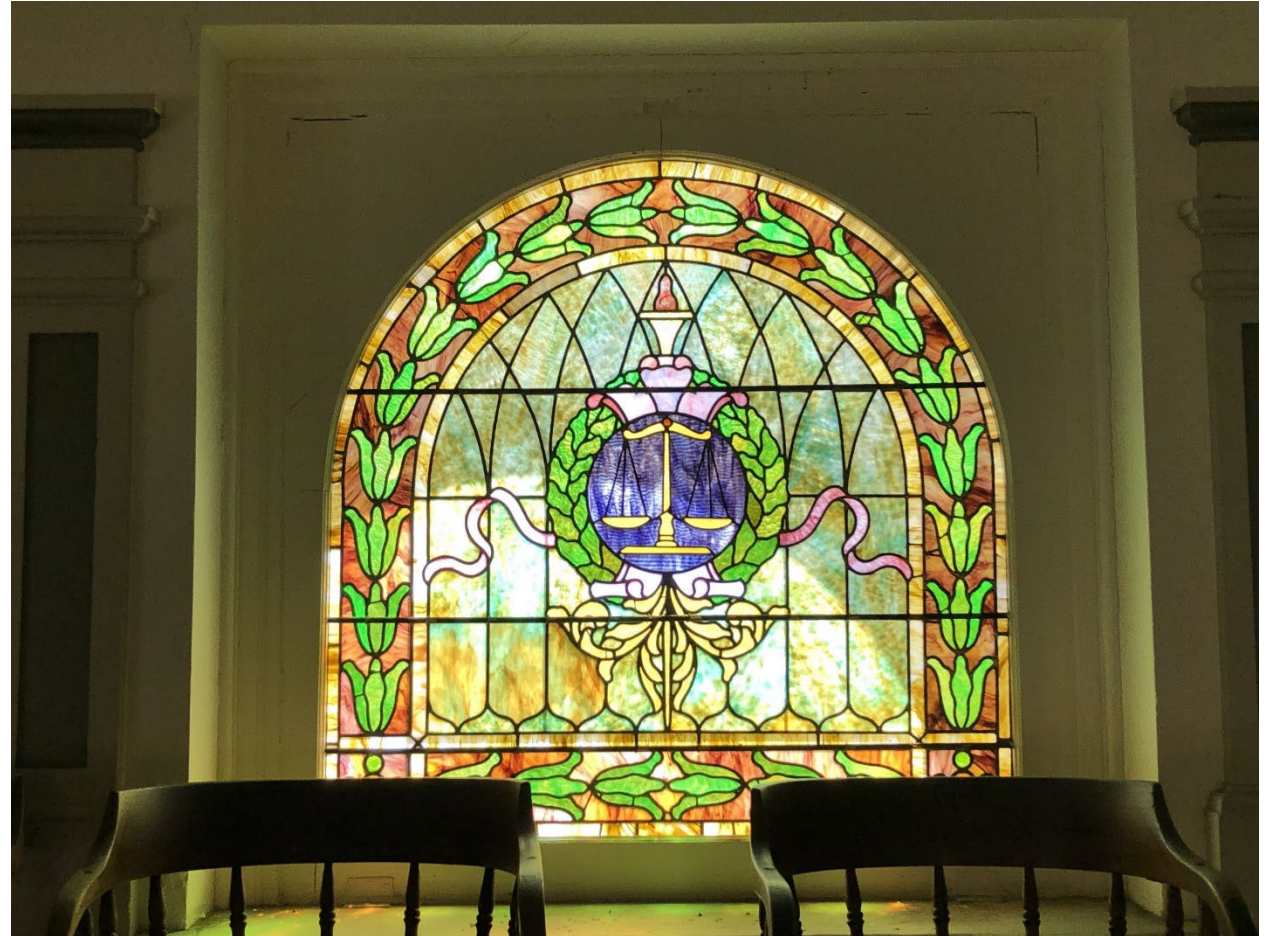
# Windows

Stained glass windows appeared to be in good condition, though their surrounds had developed cracks. All other windows appeared to be in good condition but needed some cosmetic improvement.

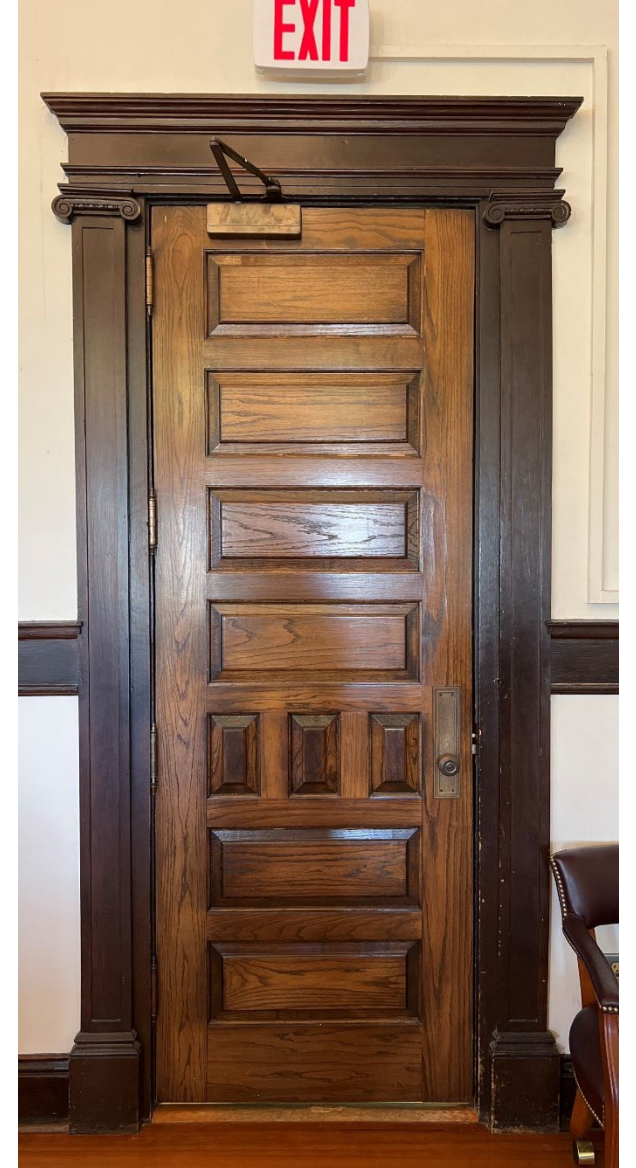
# Doors

Existing doors are not original but are somewhat like the doors that existed in the 1950s. Compare images of the north double doors (below) in the 50s and 2023. See the southwest single door (right) in the 50s and 2024.

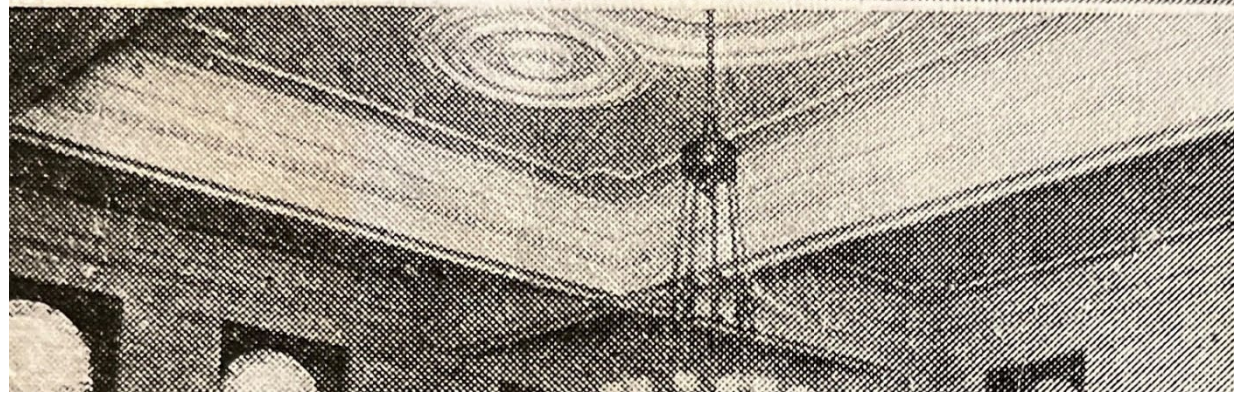
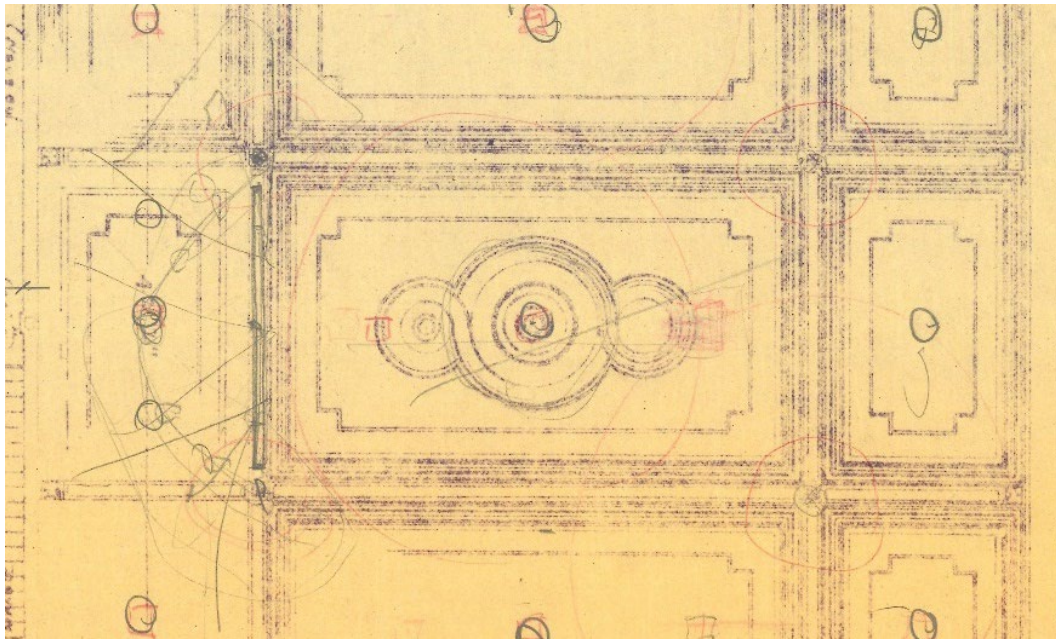
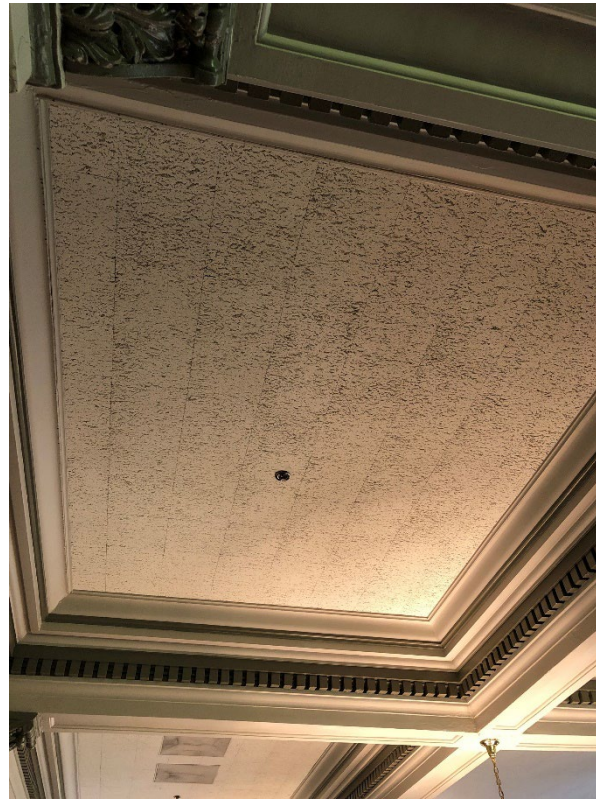
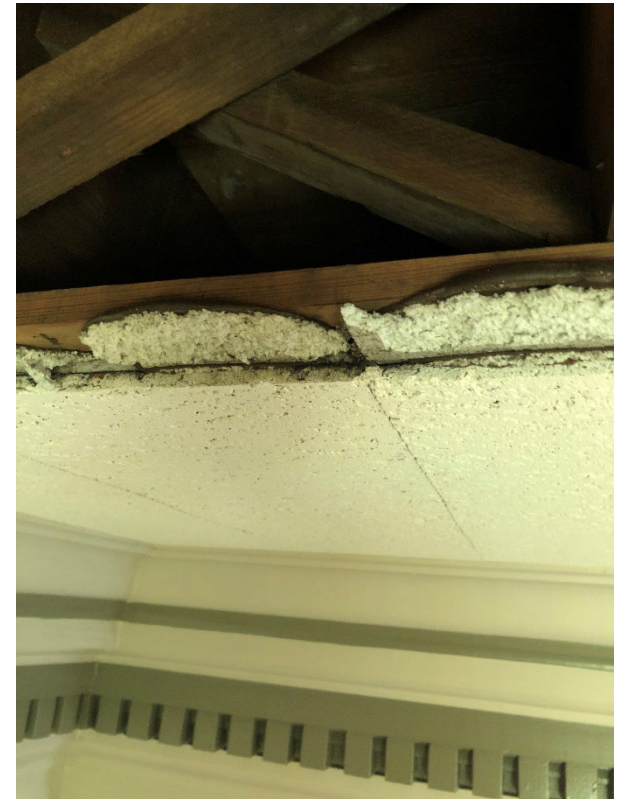
# Plaster Ceiling

The room's plaster ceiling largely survived. However, within the coffers, the historic plaster was replaced by acoustic tile. The historic plaster was destroyed in the process but was replicated with the help of the original drawings, which recorded a reflected ceiling plan, shown below.

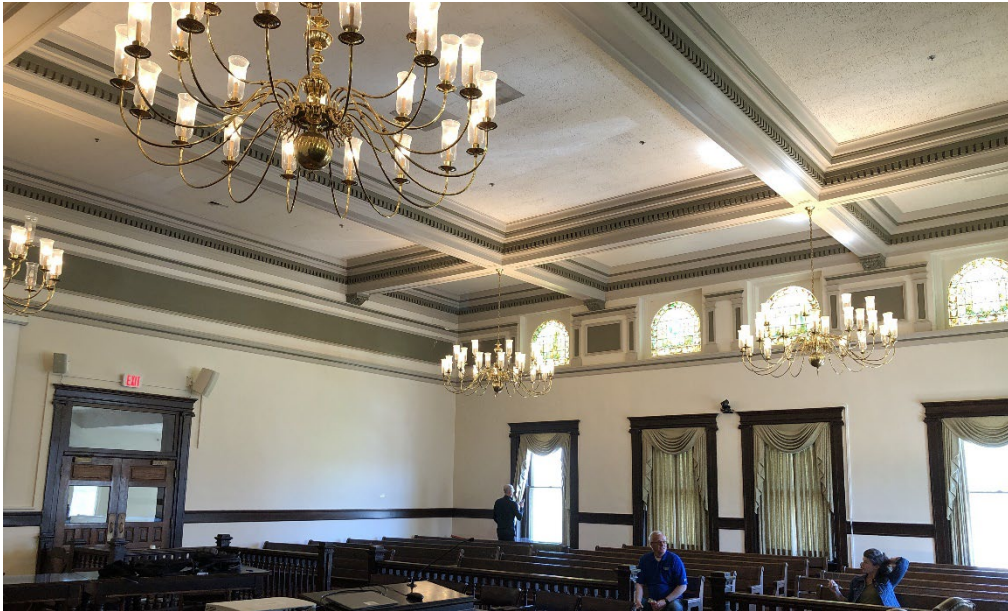
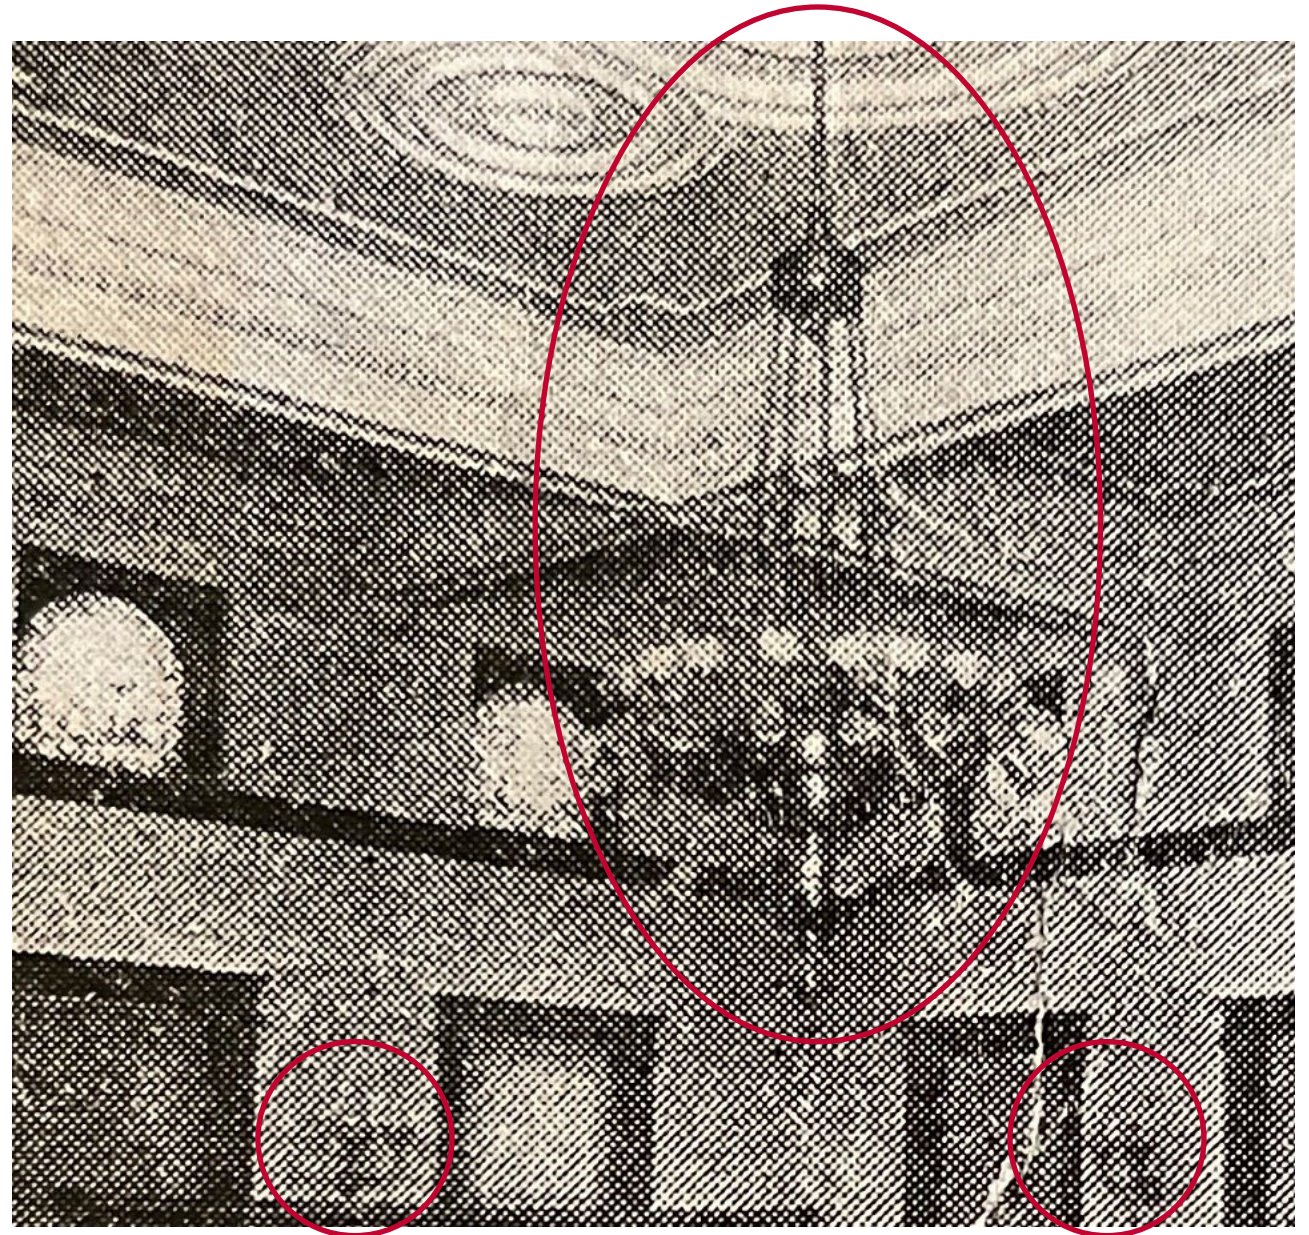
# Chandelier and Sconces

The original central chandelier (*right*), which hung below the ceiling's plaster motif, was at one time replaced by non-historic fixtures (*below*). Lacking original drawings of the fixtures, we used the one existing photo to reconstruct facsimiles of the originals.

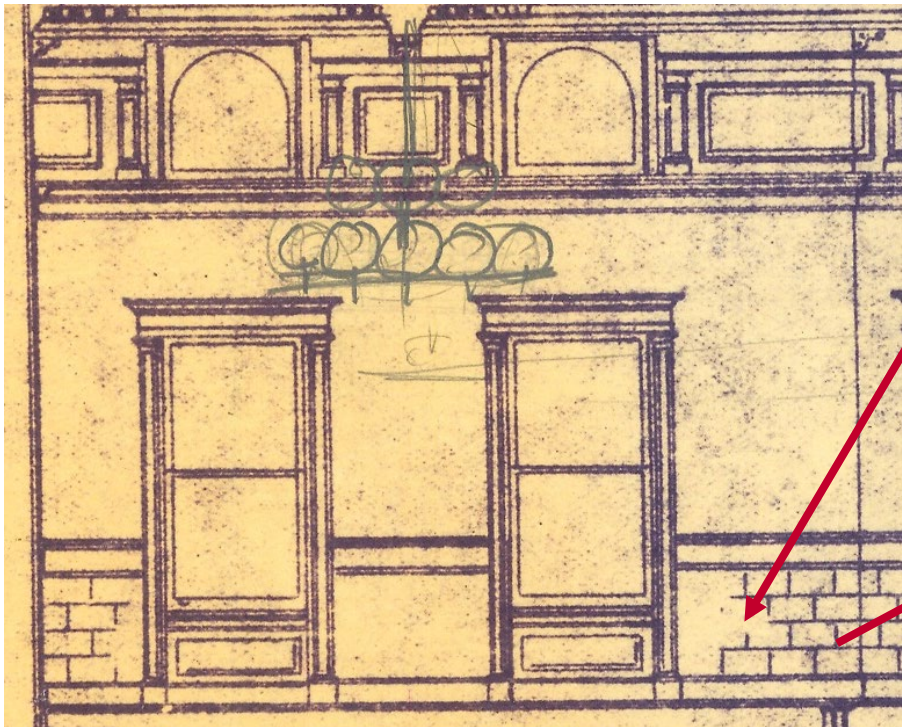
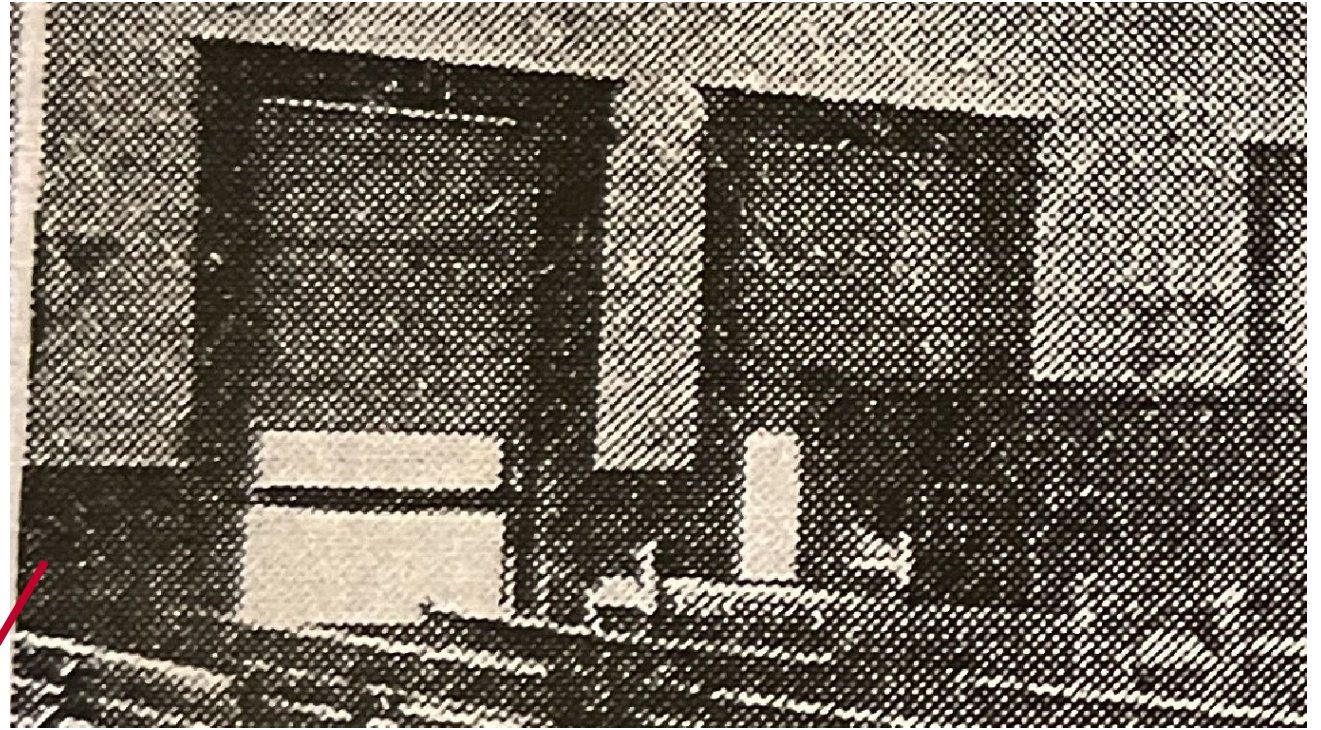
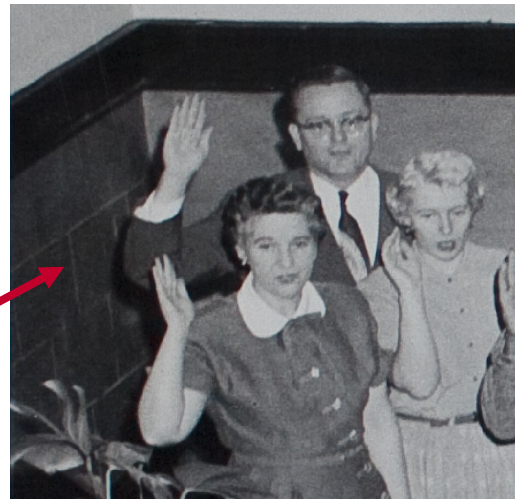
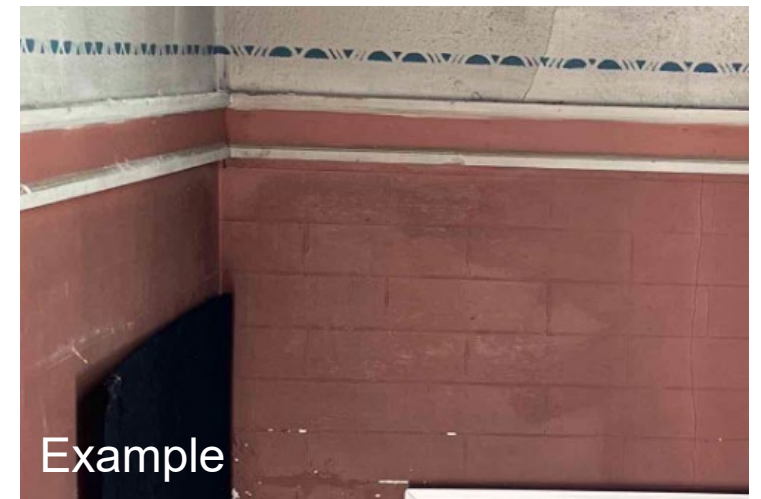
# Wainscot

Based on drawings and photos, the wainscot in this room featured a stone-course pattern on the walls. This was missing but could be restored or replicated.

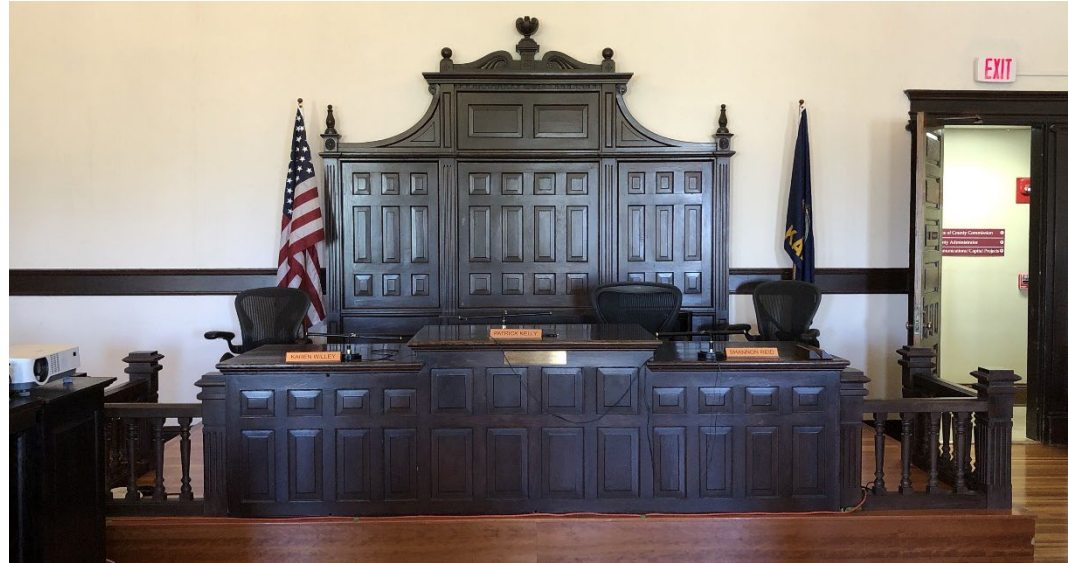
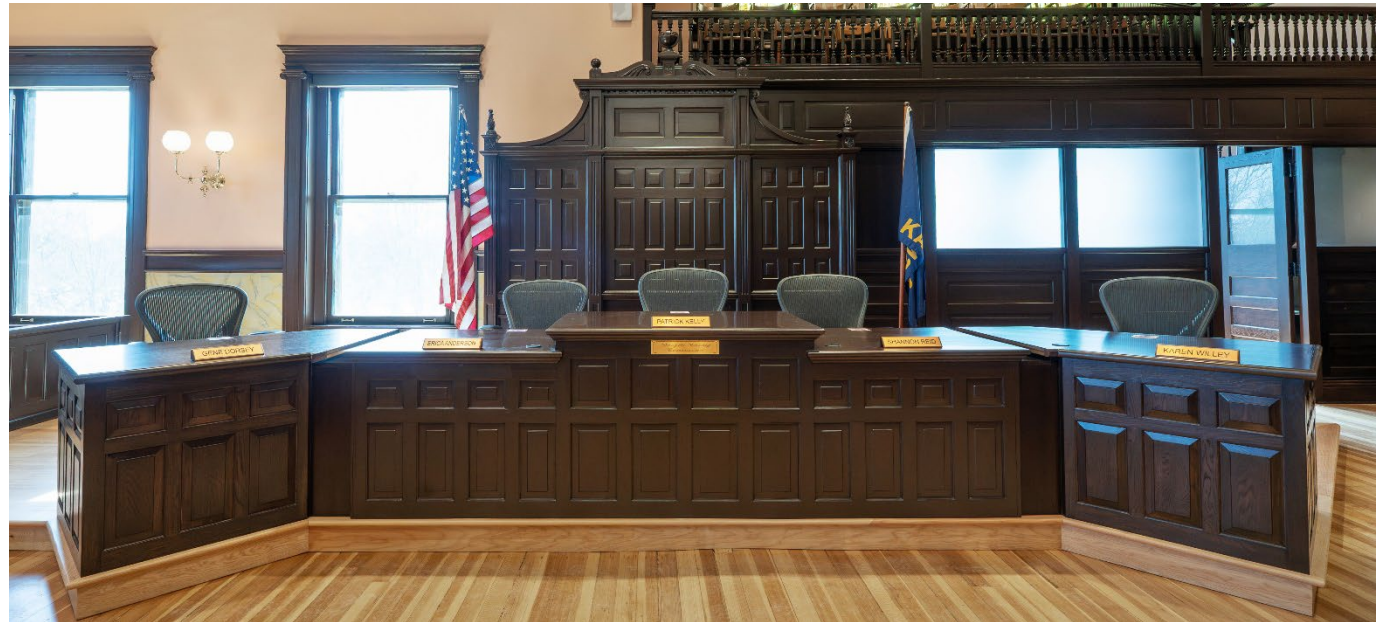
# Dais Expansion

Douglas County voters chose to expand the Board of County Commissioners from three elected officials to five. This necessitated expanding the historic dais, which had once served as the judge's desk when the room was used by the court.

New angled wings were designed and added to the historic bench, and the non-historic platform was replaced. The new wings are designed to blend with the historic desk, sympathetically expanding it to serve the Commission for years to come.
