Douglas County Courthouse
Commission Chamber

Courthouse Background

Built in 1903, the historic Douglas County Courthouse was designed by John G. Haskell and Frederick C. Gunn in the Richardsonian Romanesque style, and it is a late example of the style. The commission chamber, formerly the courtroom, occupies the southeastern corner of the second story.

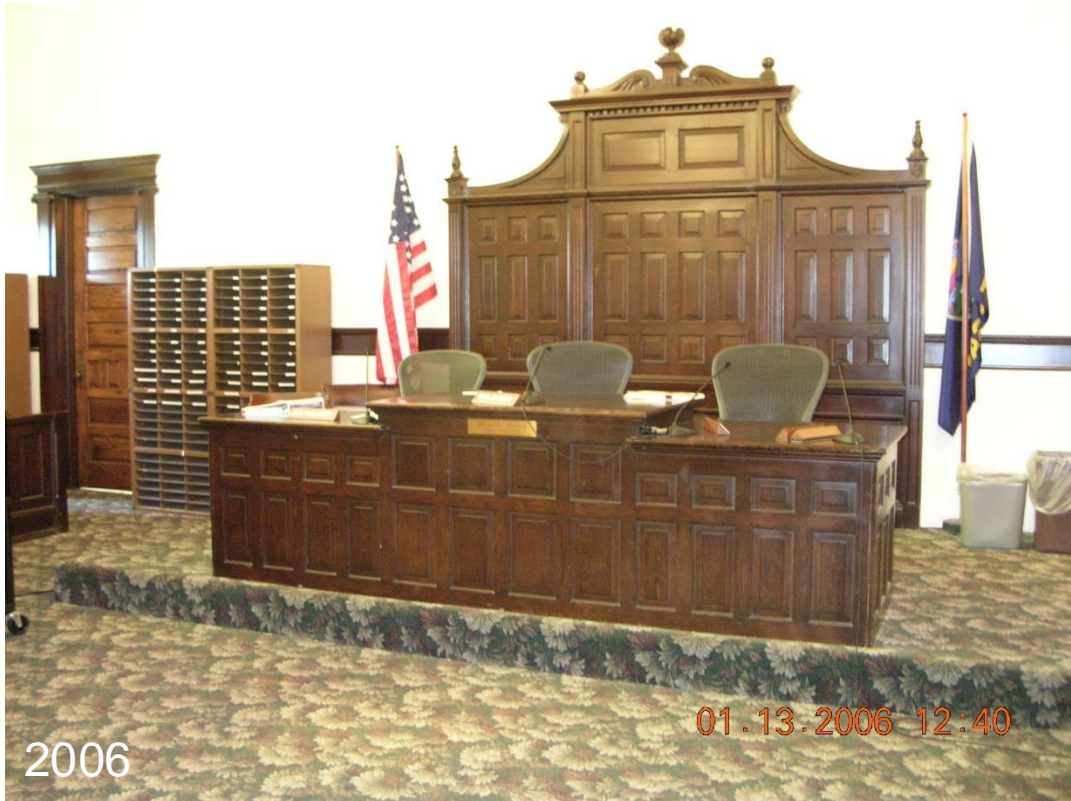
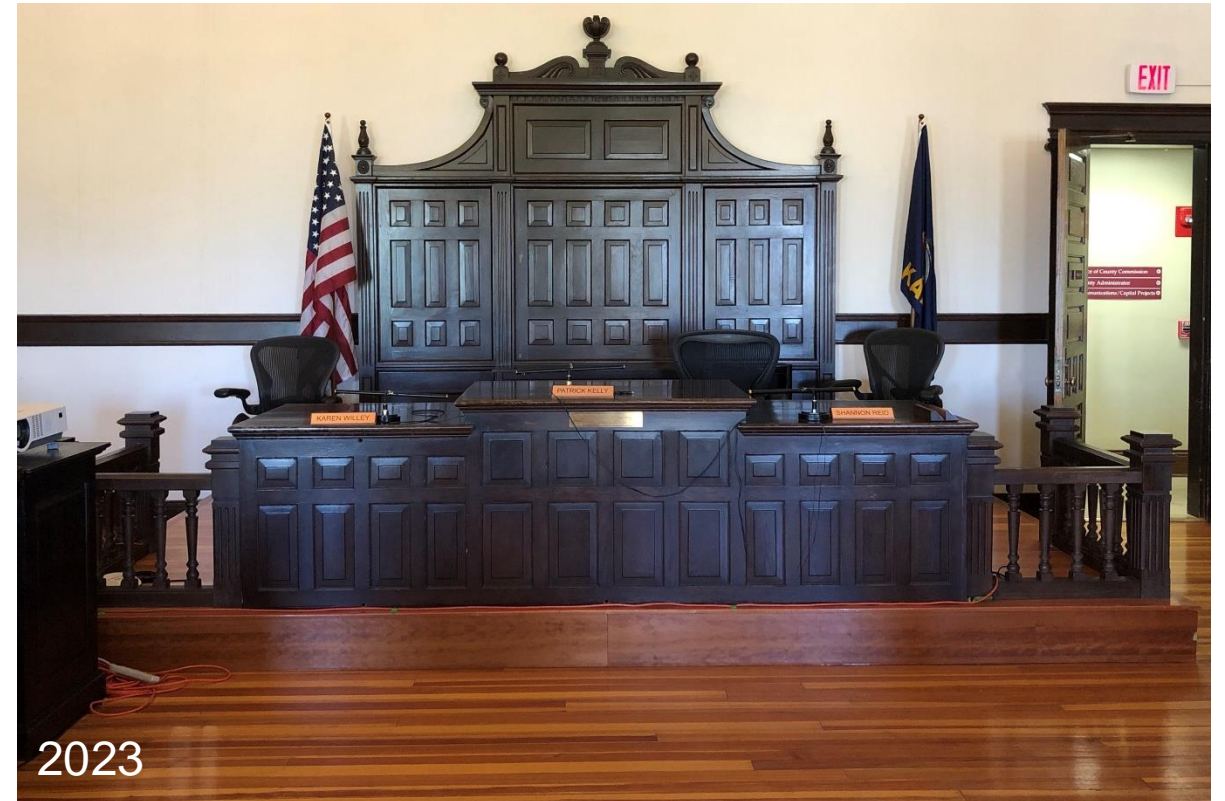
2006 Dais

Between 2006 and 2023, the dais was remodeled, with the carpet stripped off and a new set of railings attached to either end of the desk. Note that the carpet on the floor was removed during that time, exposing the hardwood floors.

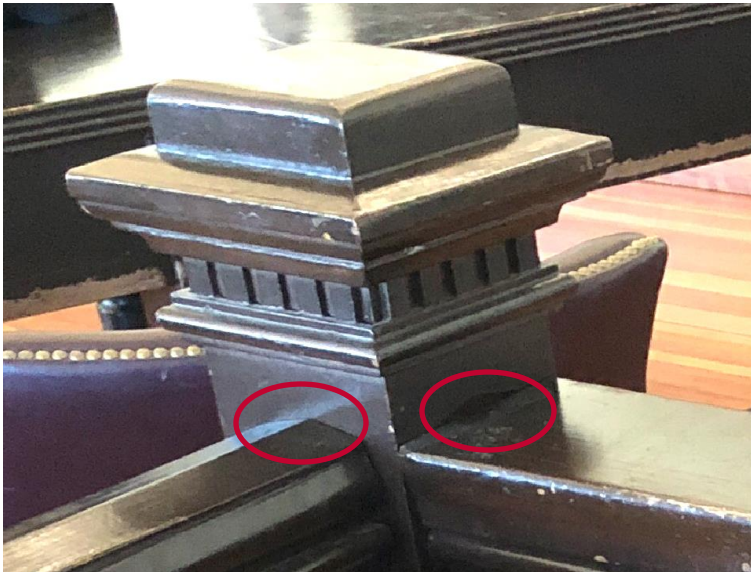
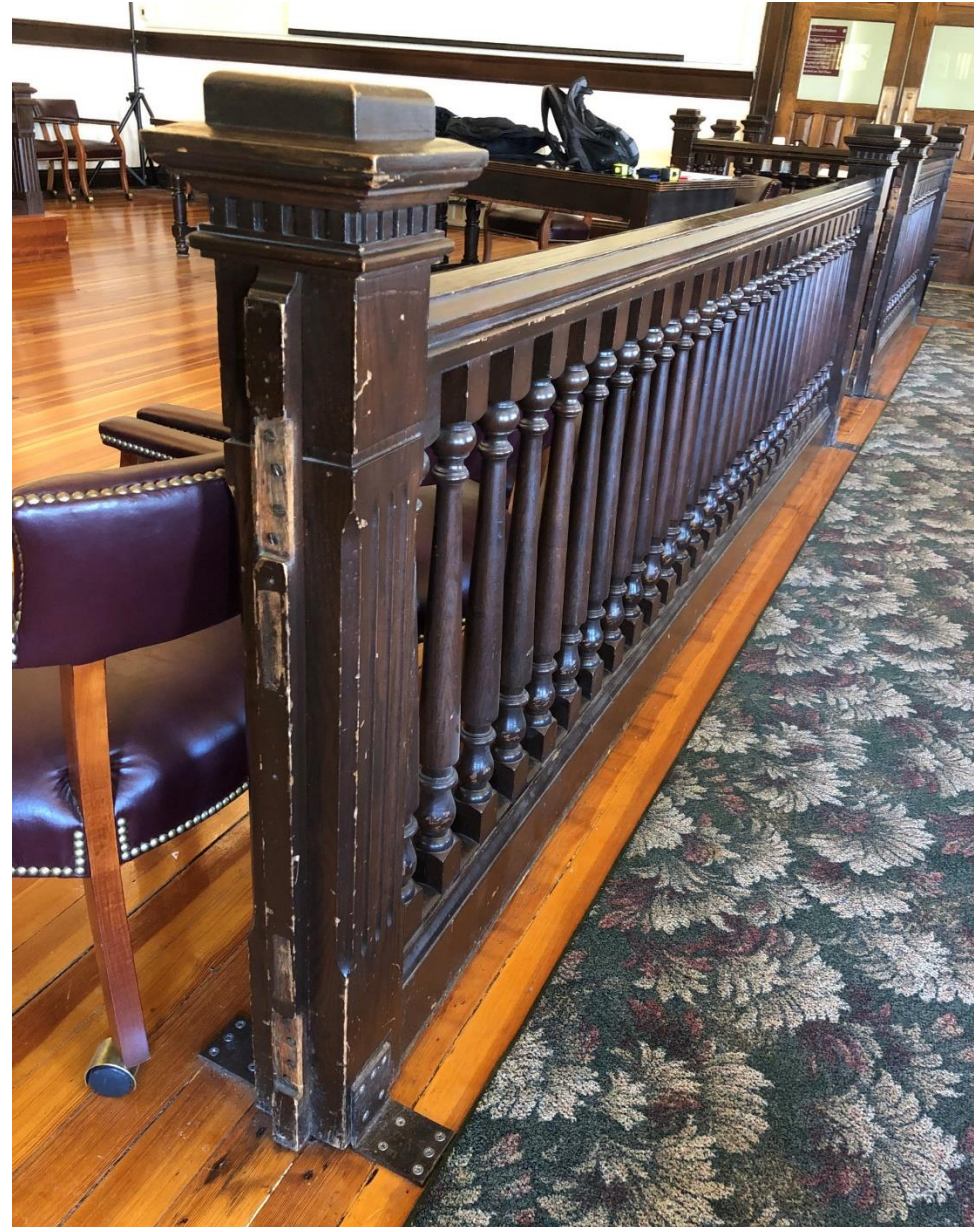
Railing Characteristics

The dividing rail showed signs of its complicated history. Two of the gates were removed and stored in the attic. Scars from the hinges were visible on the insides of the posts. The jog the railing took around the north door was not original, and some damage could be seen on the posts around that location.

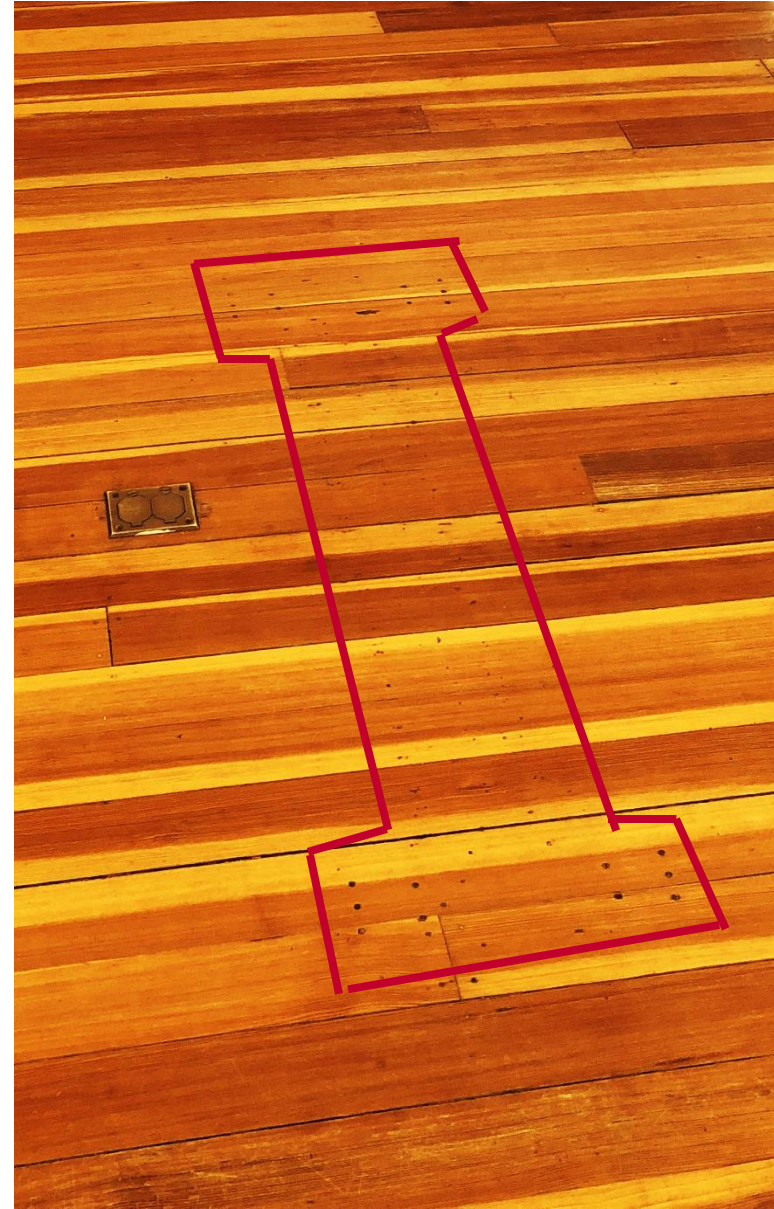
Railing Position

A scar of the original railing location could be seen on the floor, approximately 19' – 11" from the north wall.

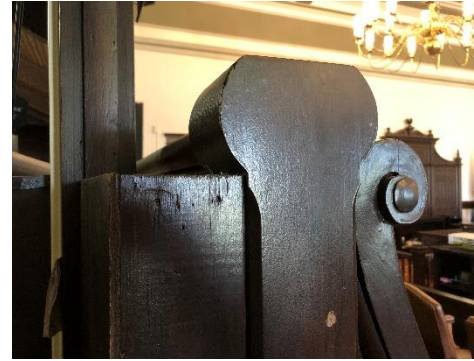
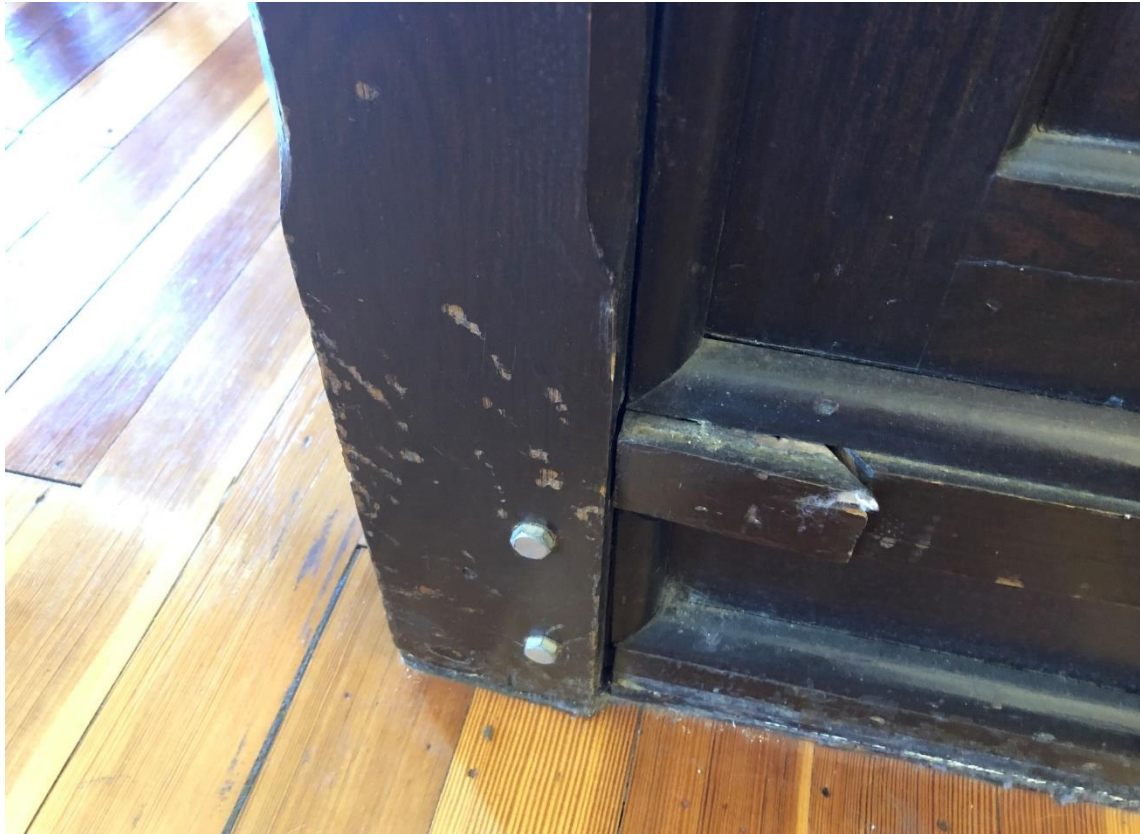
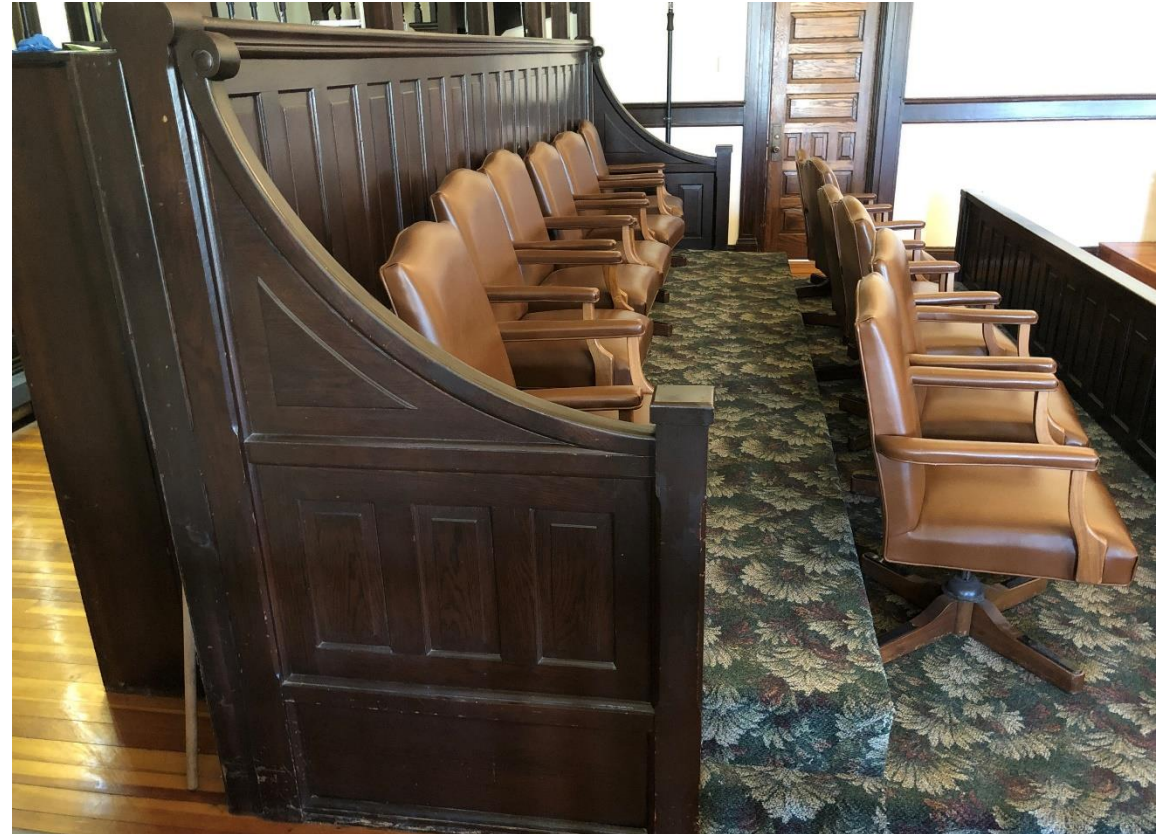
The Jury Bench showed signs of modification, such as non-original wood and anachronistic carpentry.

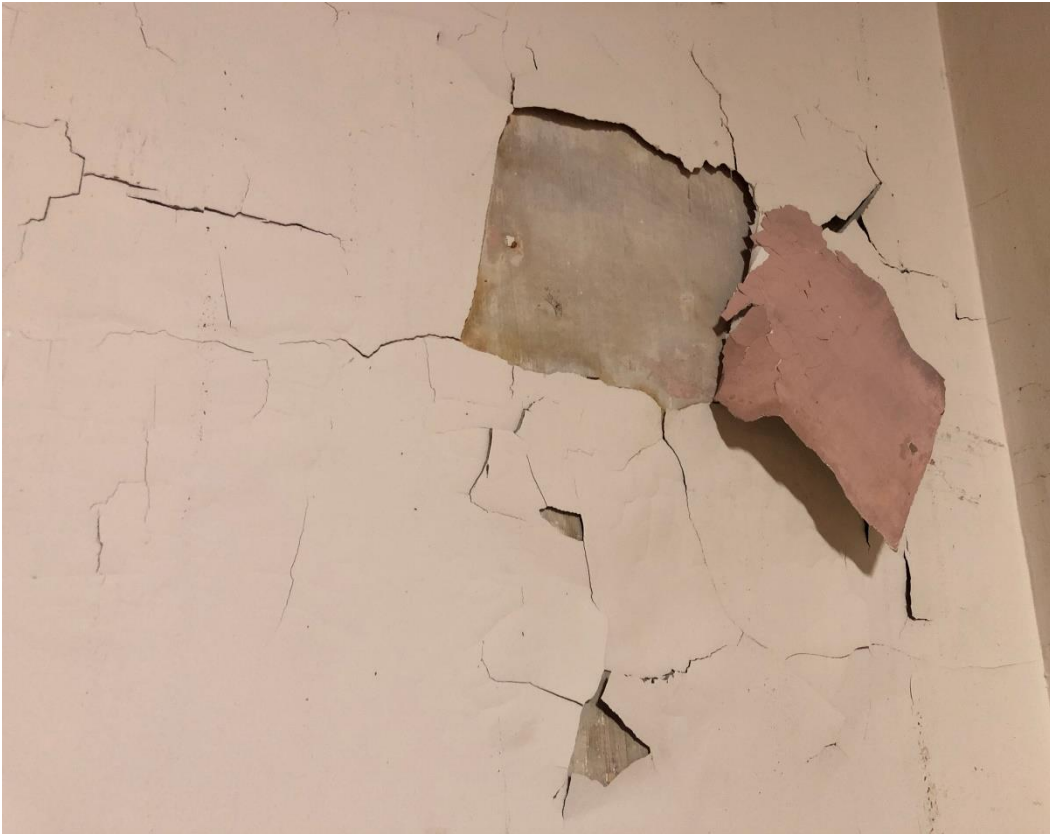
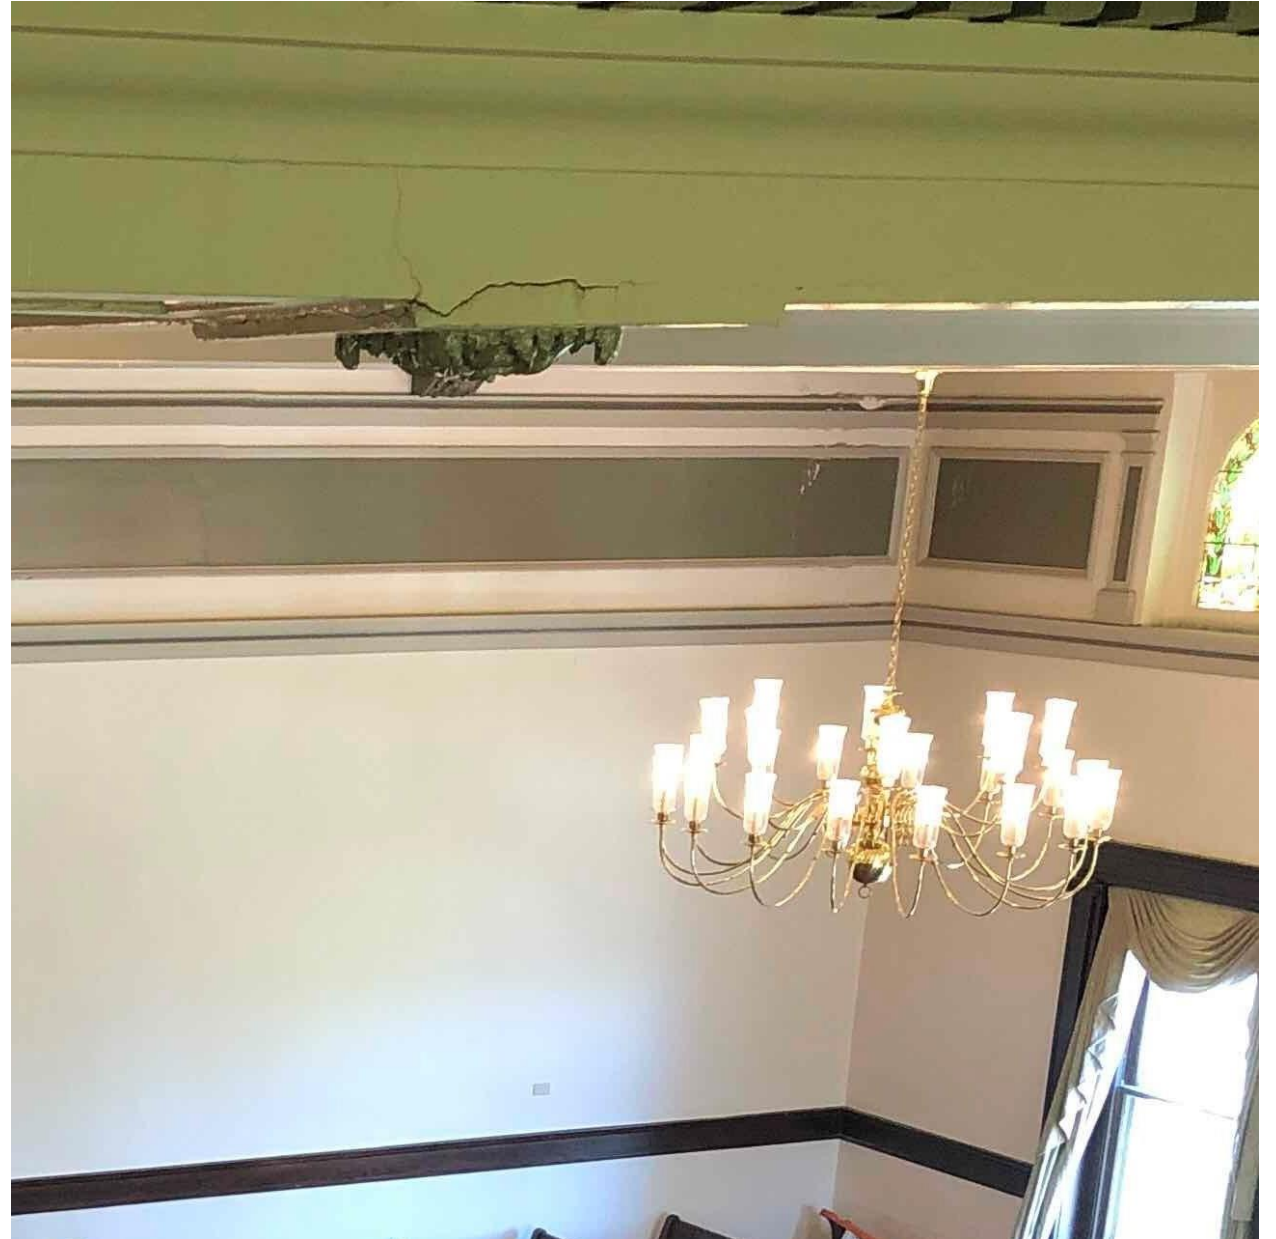
Plaster Condition

The plaster was in fair condition, though serious damage was present in the northeast corner of the room.

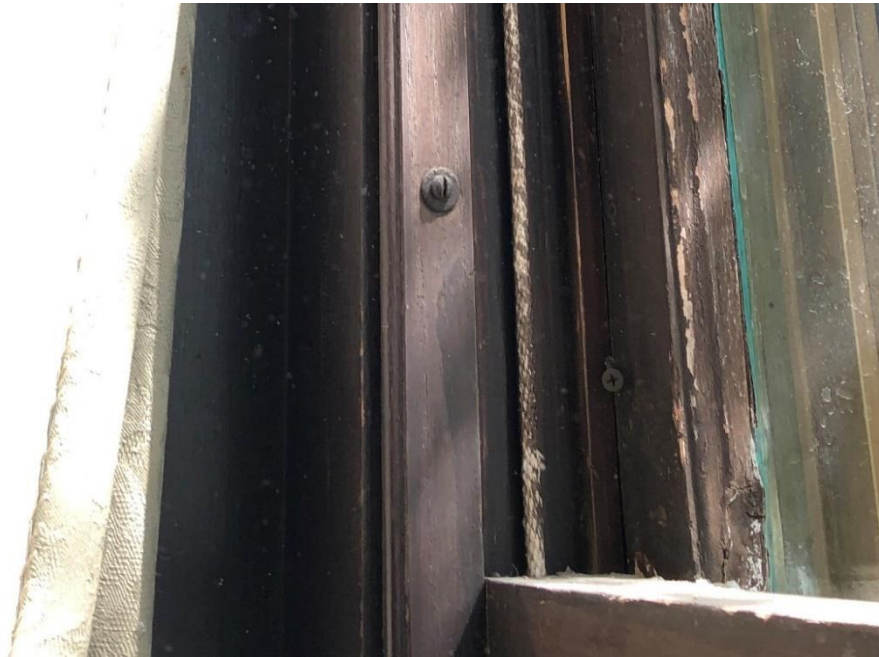
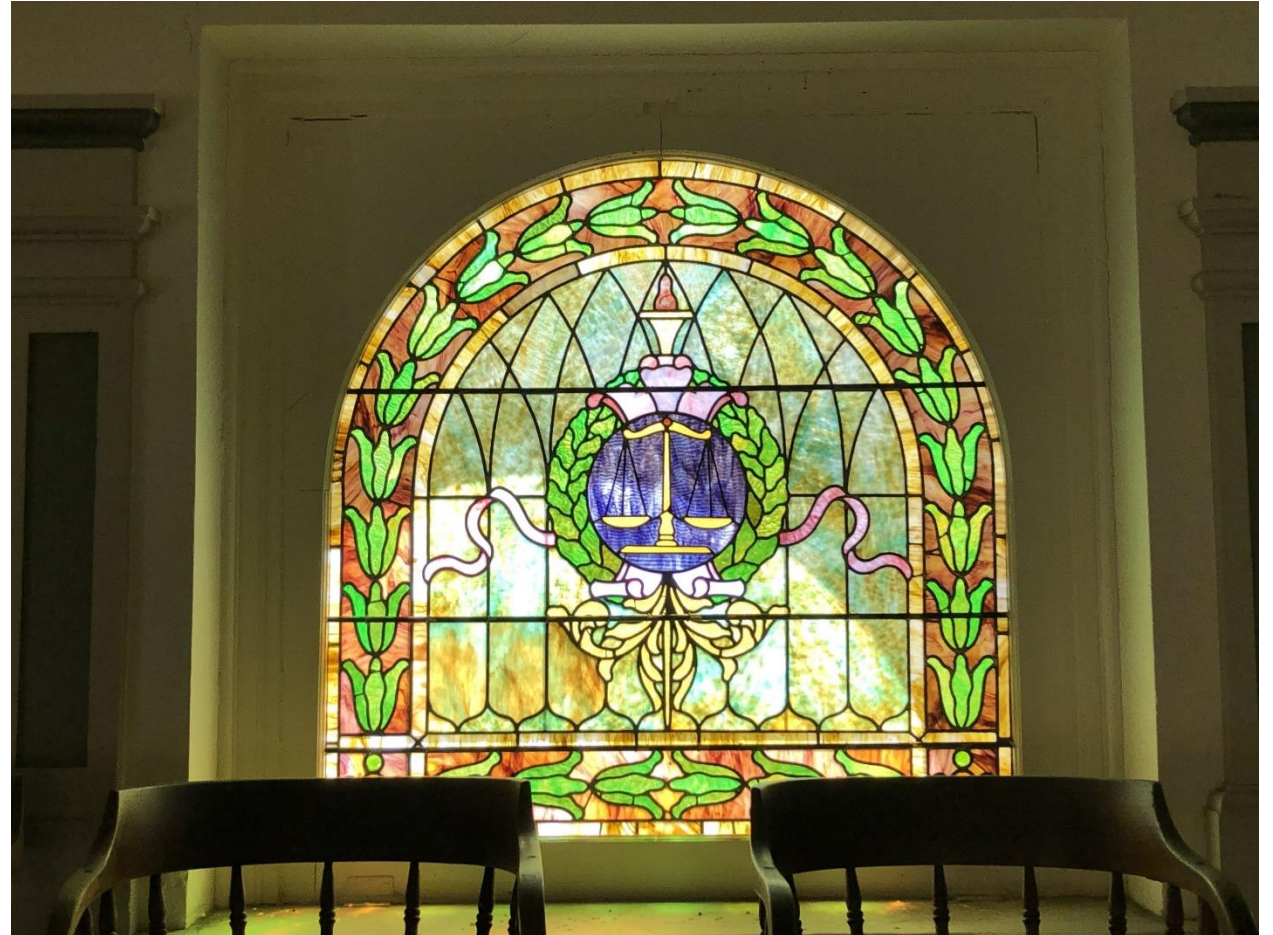
Windows

Stained glass windows appeared to be in good condition, though their surrounds had developed cracks. All other windows appeared to be in good condition but needed some cosmetic improvement.

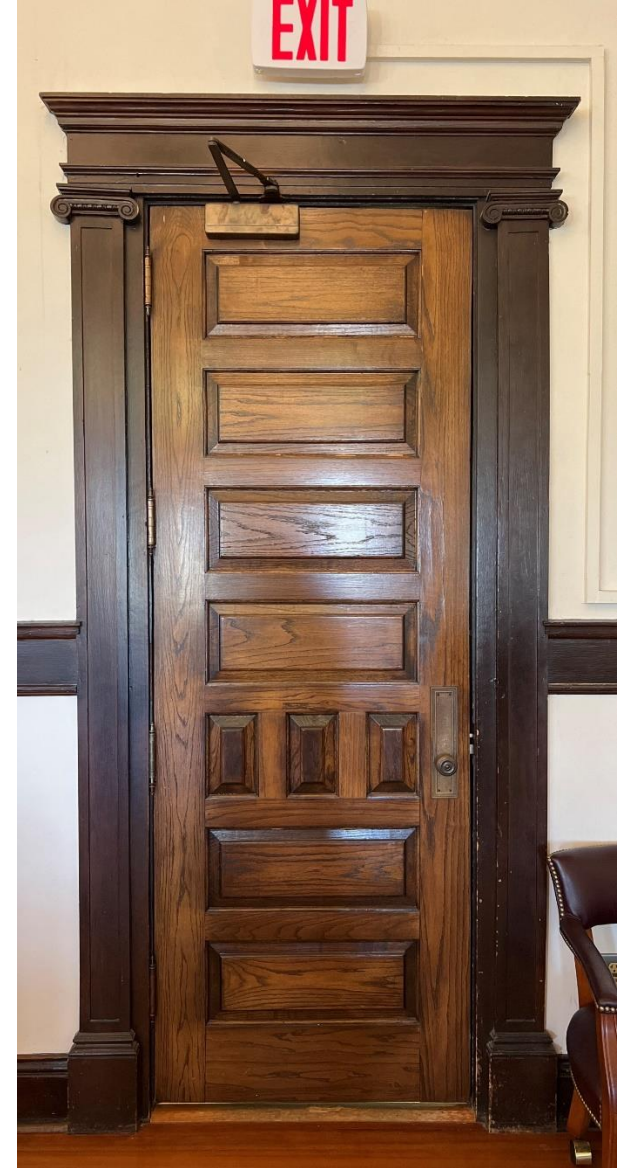
Doors

Existing doors are not original but are somewhat like the doors that existed in the 1950s. Compare images of the north double doors (below) in the 50s and 2023. See the southwest single door (right) in the 50s and 2024.

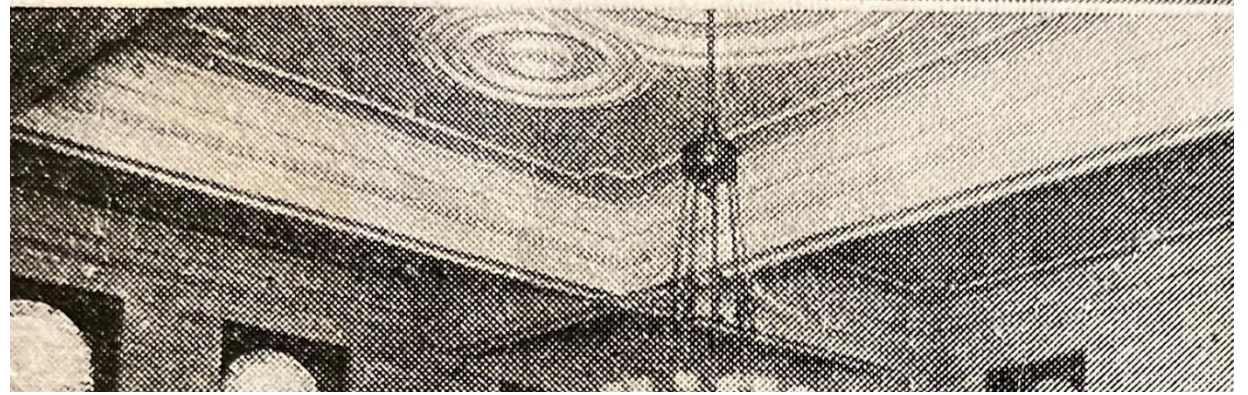
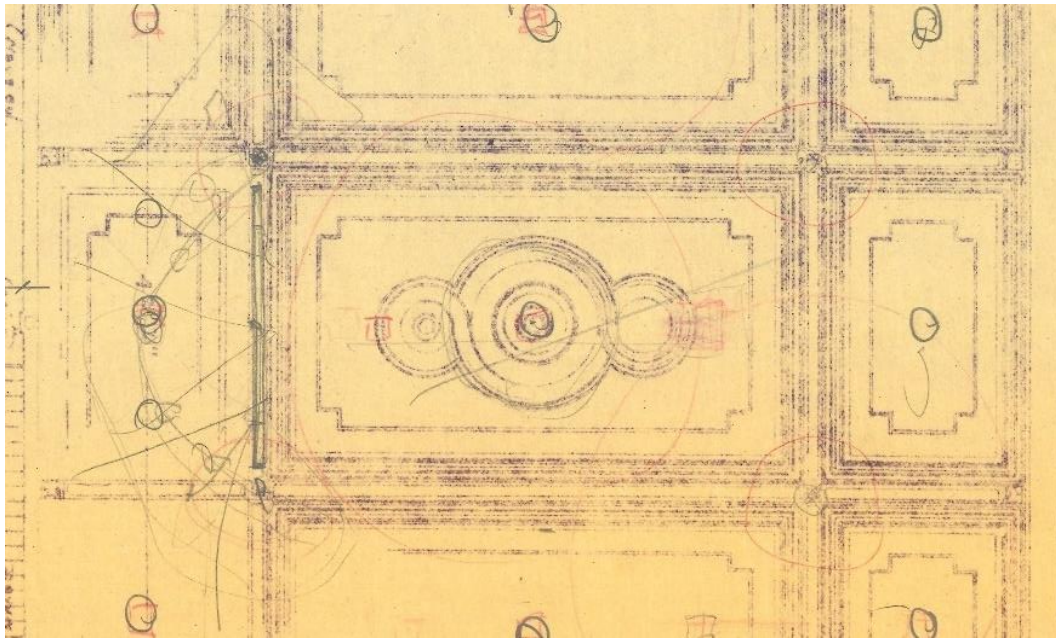
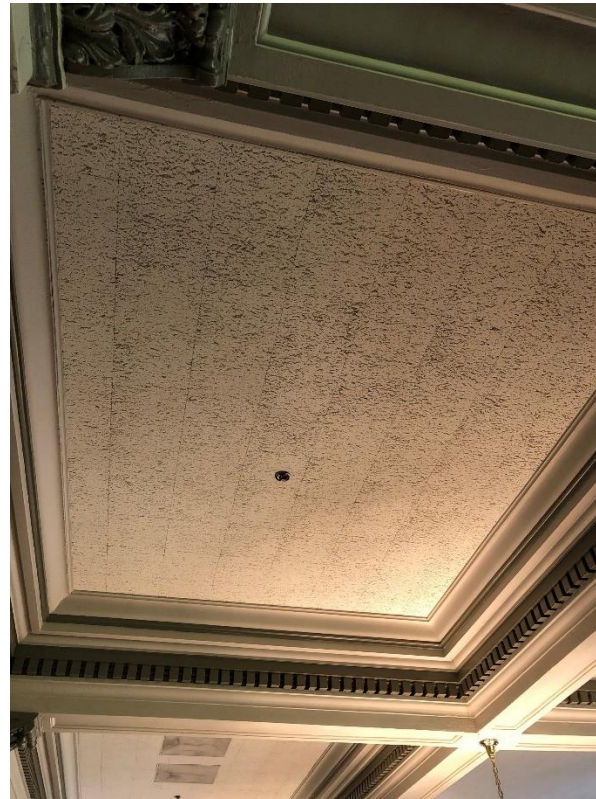
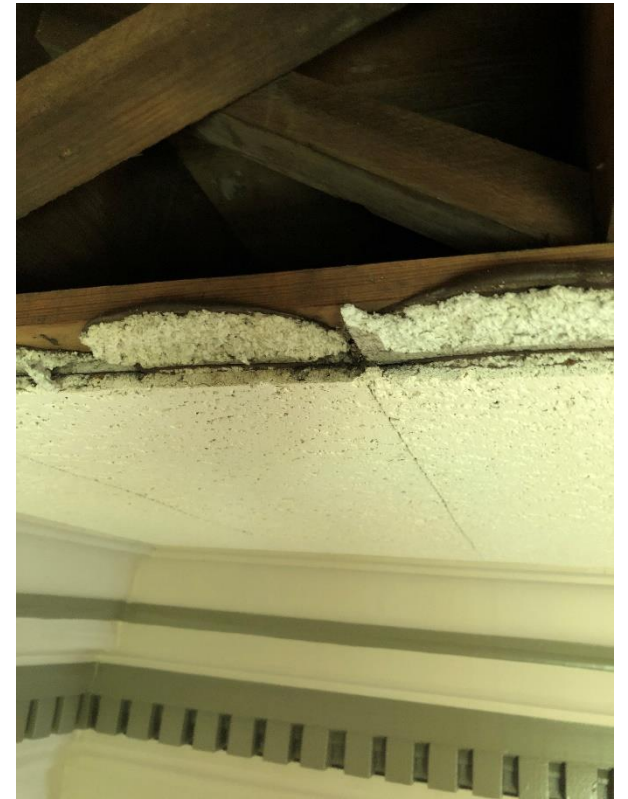
Plaster Ceiling

The room's plaster ceiling largely survived. However, within the coffers, the historic plaster was replaced by acoustic tile. The historic plaster was destroyed in the process but was replicated with the help of the original drawings, which recorded a reflected ceiling plan, shown below.

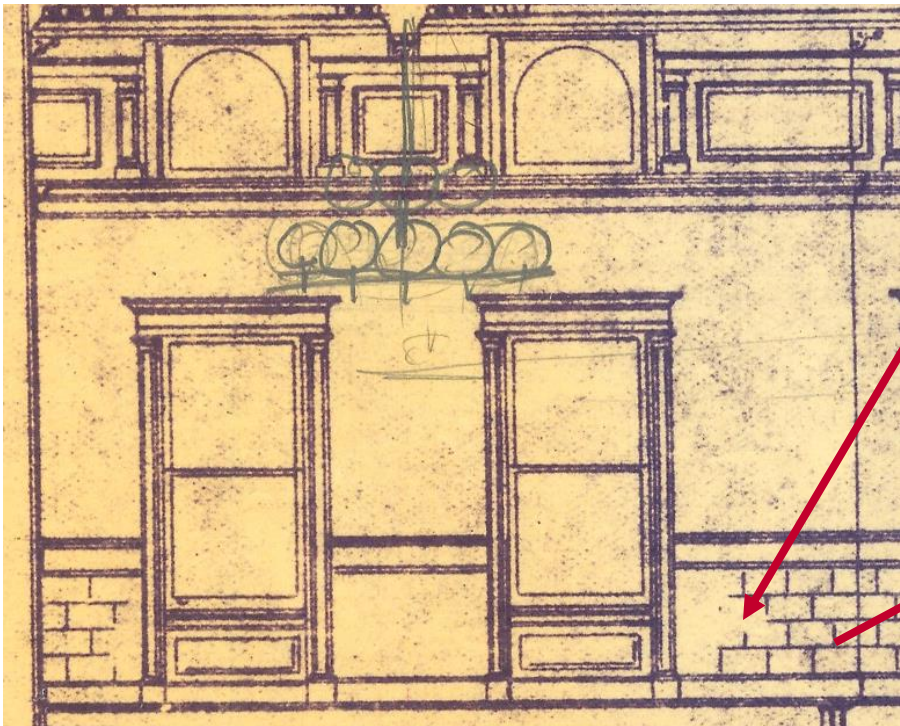
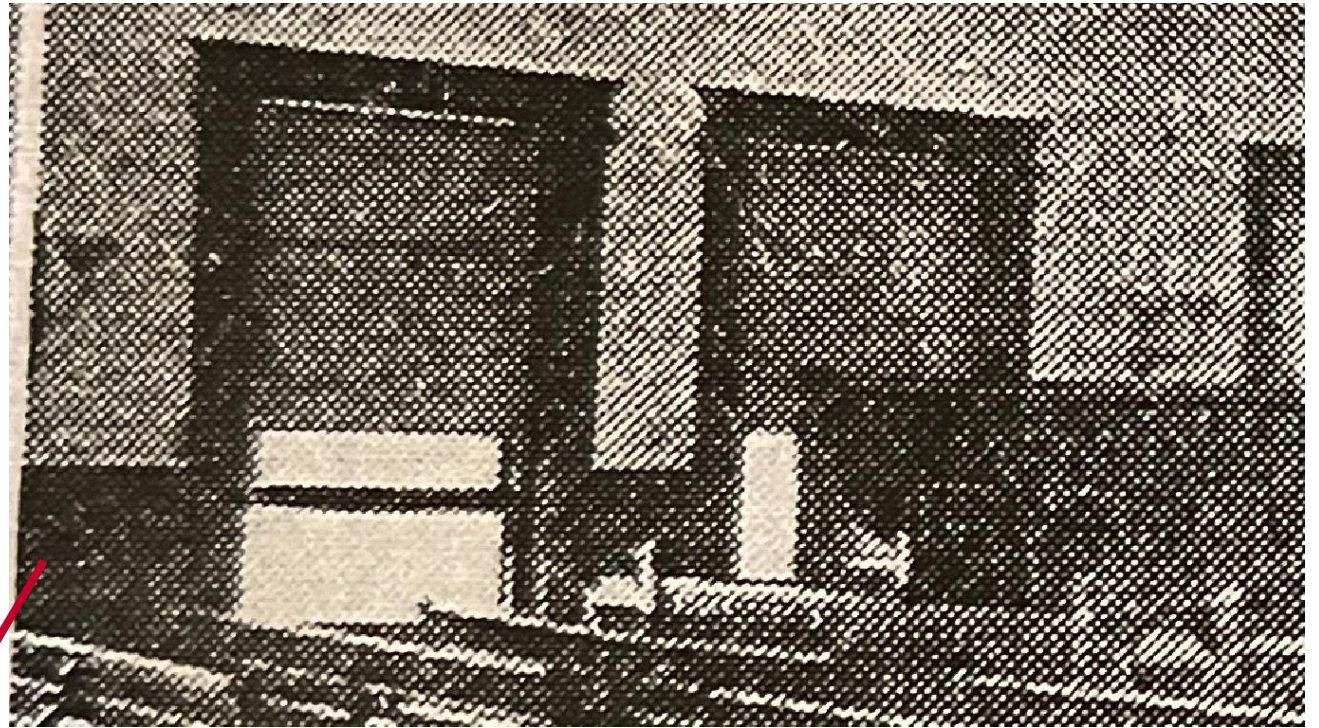
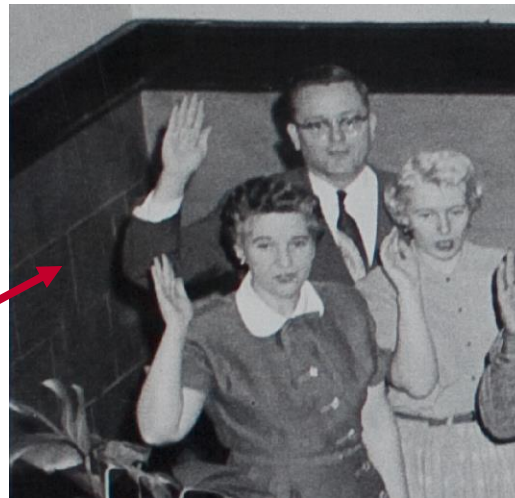
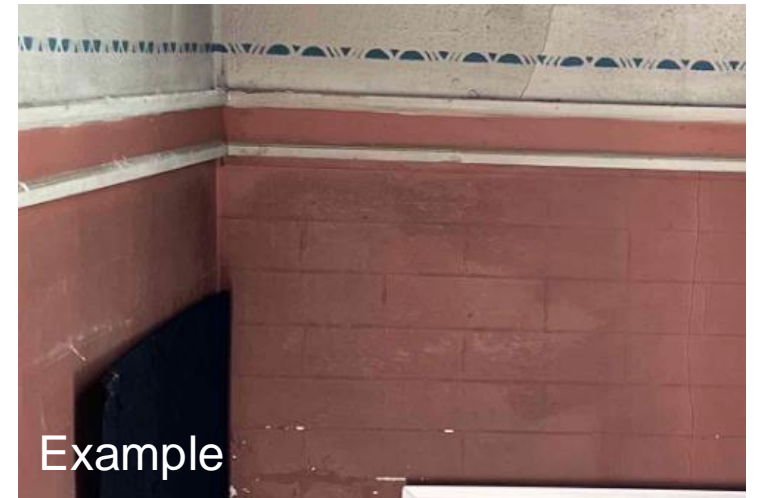
Wainscot

Based on drawings and photos, the wainscot in this room featured a stone-course pattern on the walls. This was missing but could be restored or replicated.
