Douglas County Courthouse  
Commission Chamber

Courthouse Background

Built in 1903, the historic Douglas County Courthouse was designed by John G. Haskell and Frederick C. Gunn in the Richardsonian Romanesque style, and it is a late example of the style. The commission chamber, formerly the courtroom, occupies the southeastern corner of the second story.

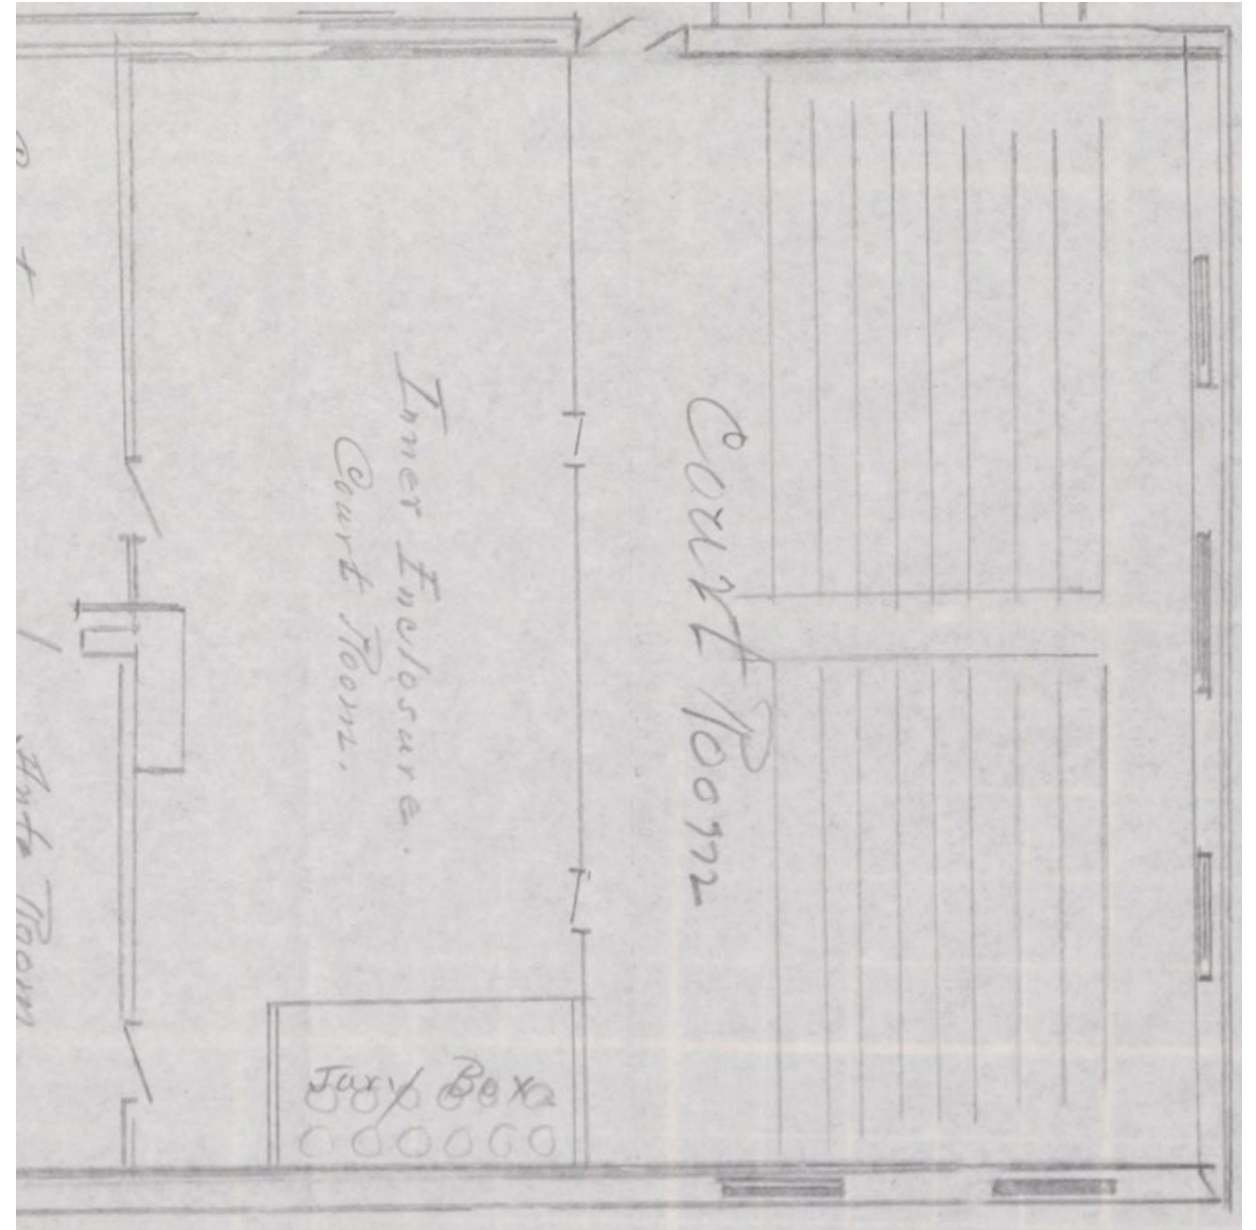
# 1937 Plans

By 1937, according to historic drawings from the Kansas State Historical Society, the courtroom had been reconfigured near its later condition.

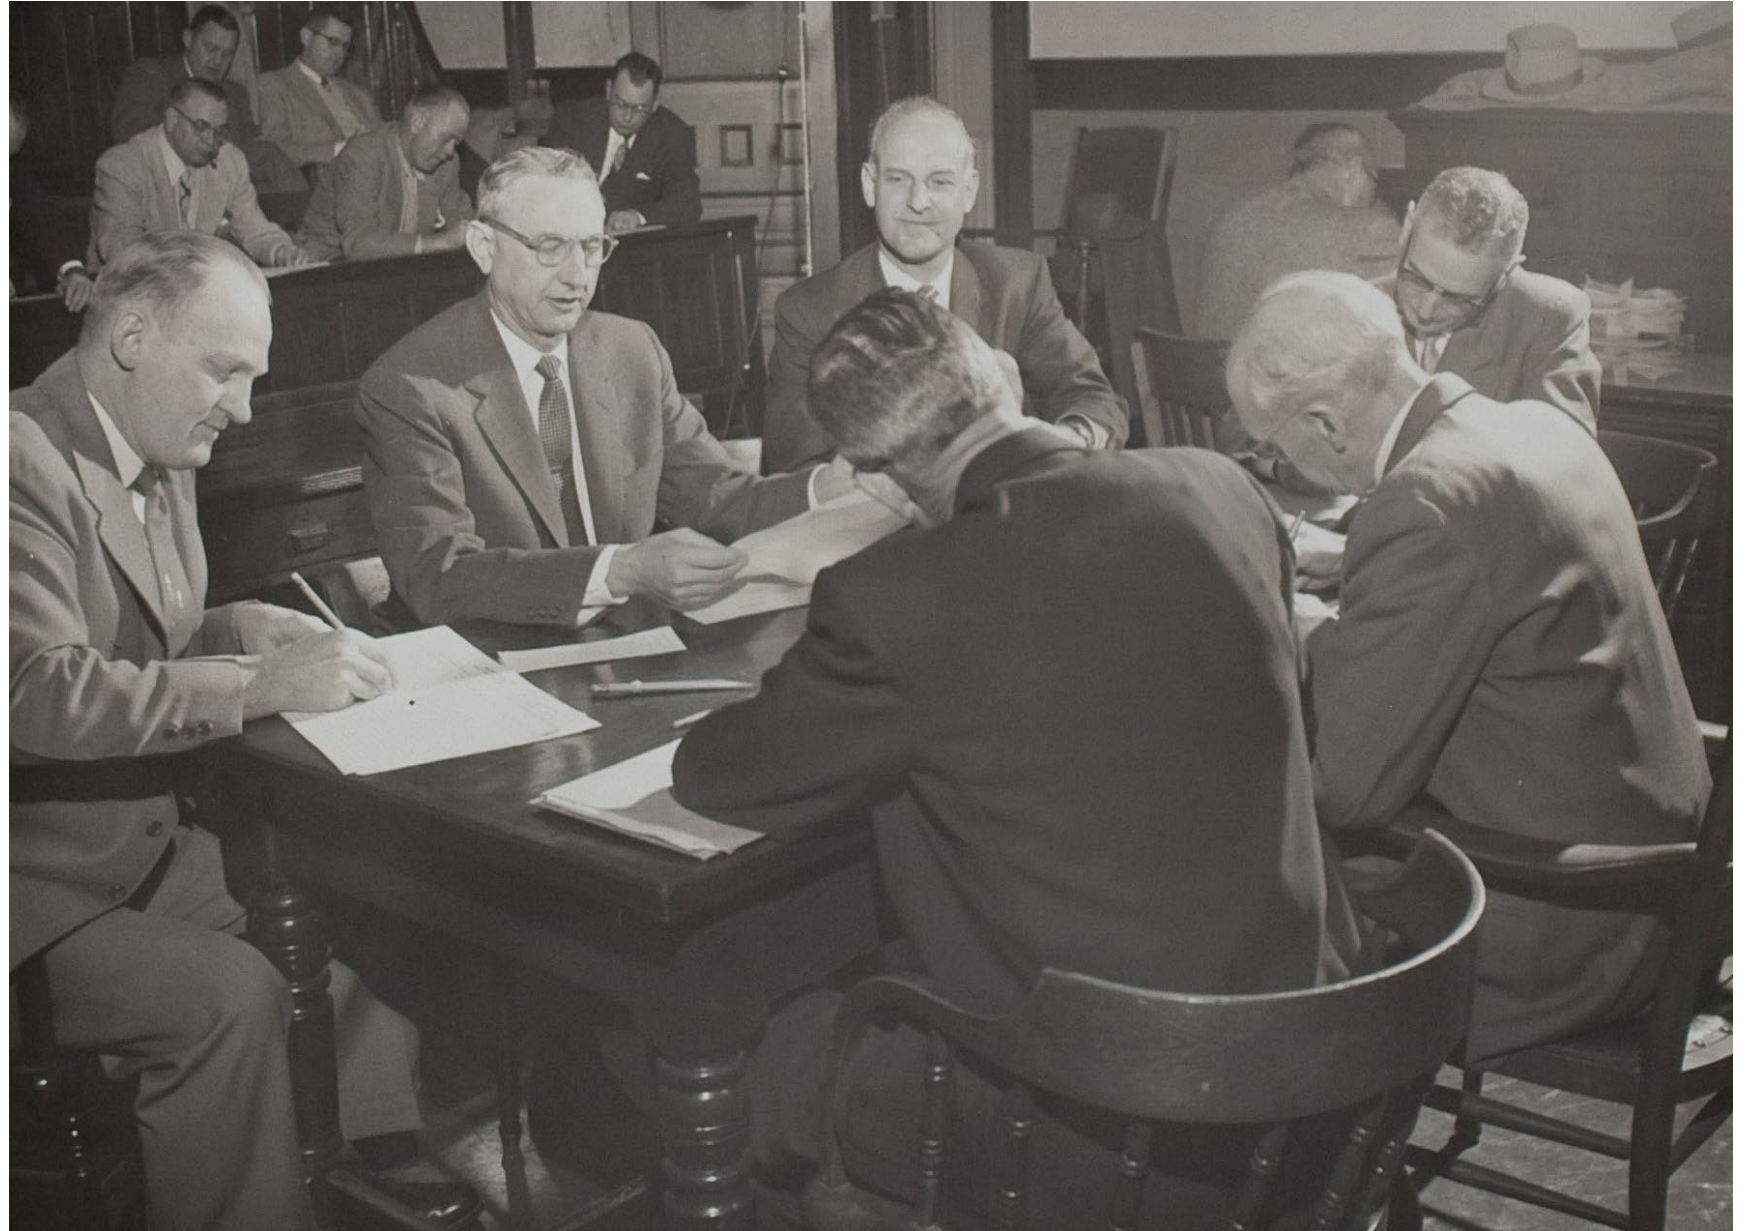
# 1954 Photo

This photo shows the jury bench in its non-historic location, and the dais has been moved to the west wall.

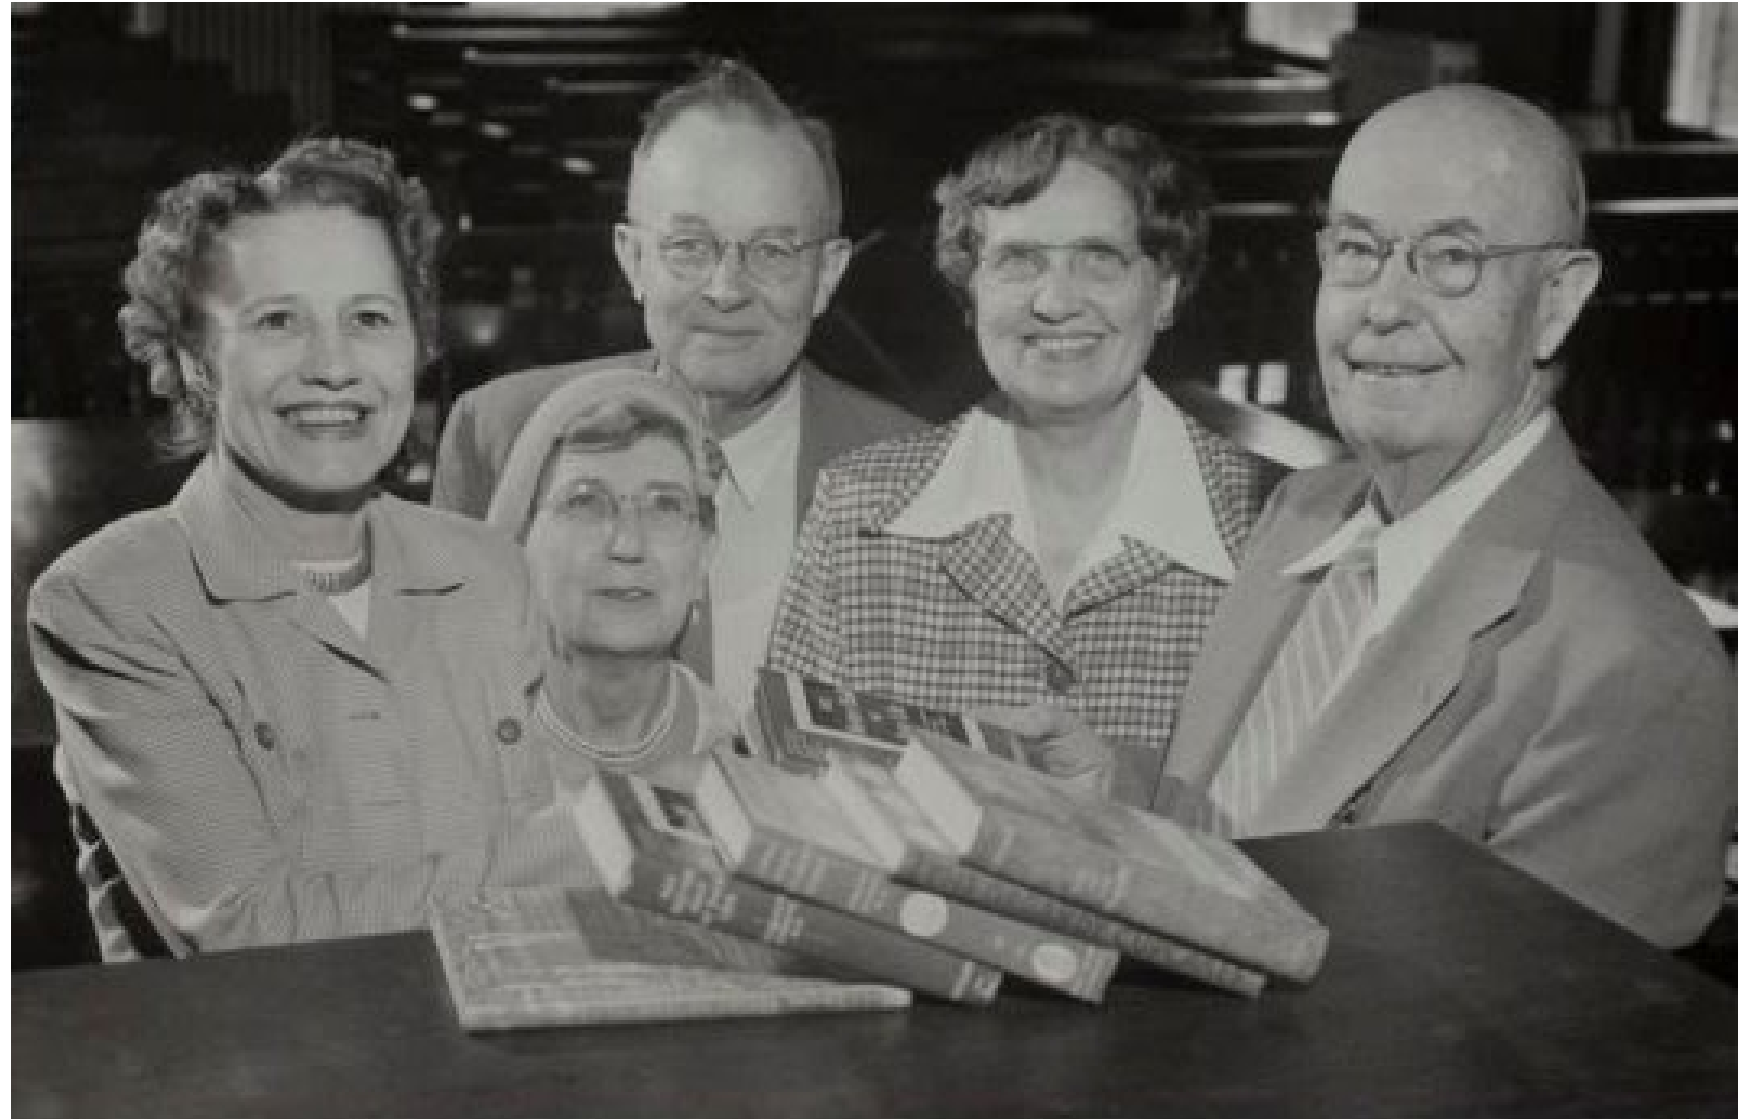
# 1955 Photo

This photo shows the pews and railing in their current configuration but also show what appear to be radiators at the windows, in the background.

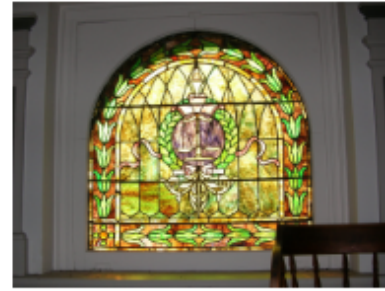
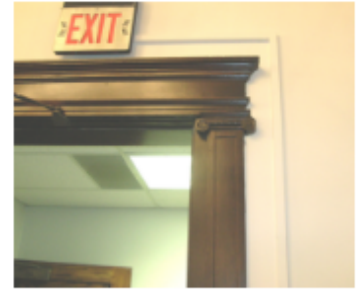
Courtroom – Stained Glass and Door Trim Details

In 2006, Treanor produced a preservation plan for the Douglas County Courthouse, which made observations about the courtroom, and speculated on certain elements. It noted that “the doors have been replaced” and “during the work to expose the wood floor a layer of 6x6 linoleum arranged in red and brown diamond pattern was uncovered (this pattern can still be seen in the County Administrator’s office closet)” and that the platform the desk sits on was “enlarged” in the 1976-78 remodel.

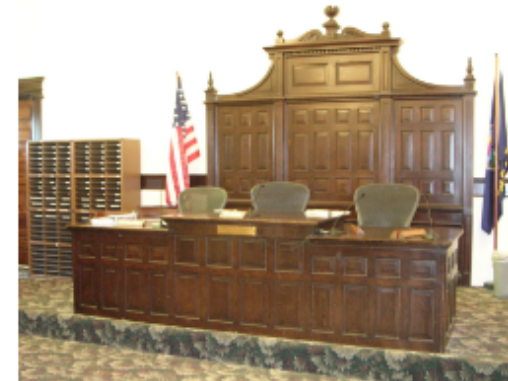
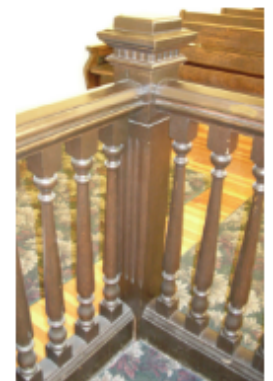
Douglas County Courthouse Courtroom - Judge's Dias and Dividing Rail

Between 2006 and 2023, the dais was remodeled, with the carpet stripped off and a new set of railings attached to either end of the desk. Note that the carpet on the floor was removed during that time, exposing the hardwood floors.

New angled wings were designed and added to the historic bench, and the non-historic platform was replaced. The new wings are designed to blend with the historic desk, sympathetically expanding it to serve the Commission for years to come.

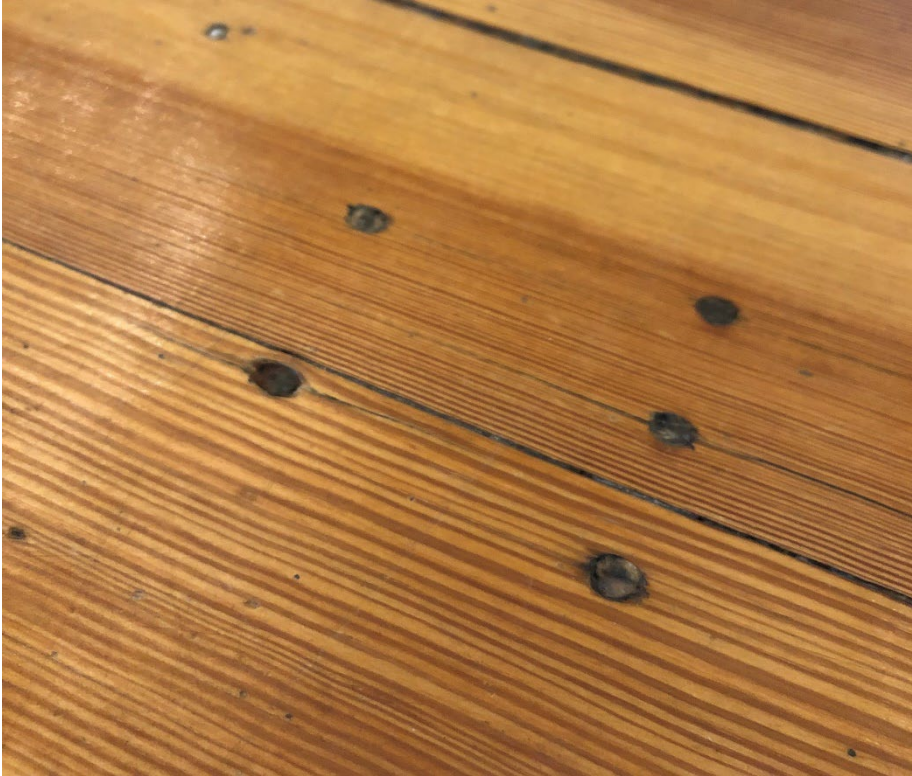
# Railing Position

A scar of the original railing location could be seen on the floor, approximately 19' – 11" from the north wall.

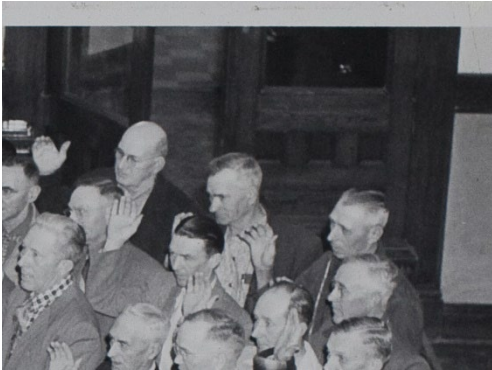
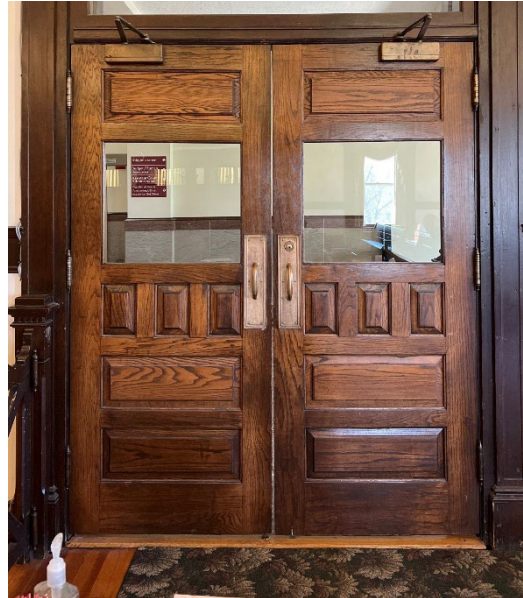
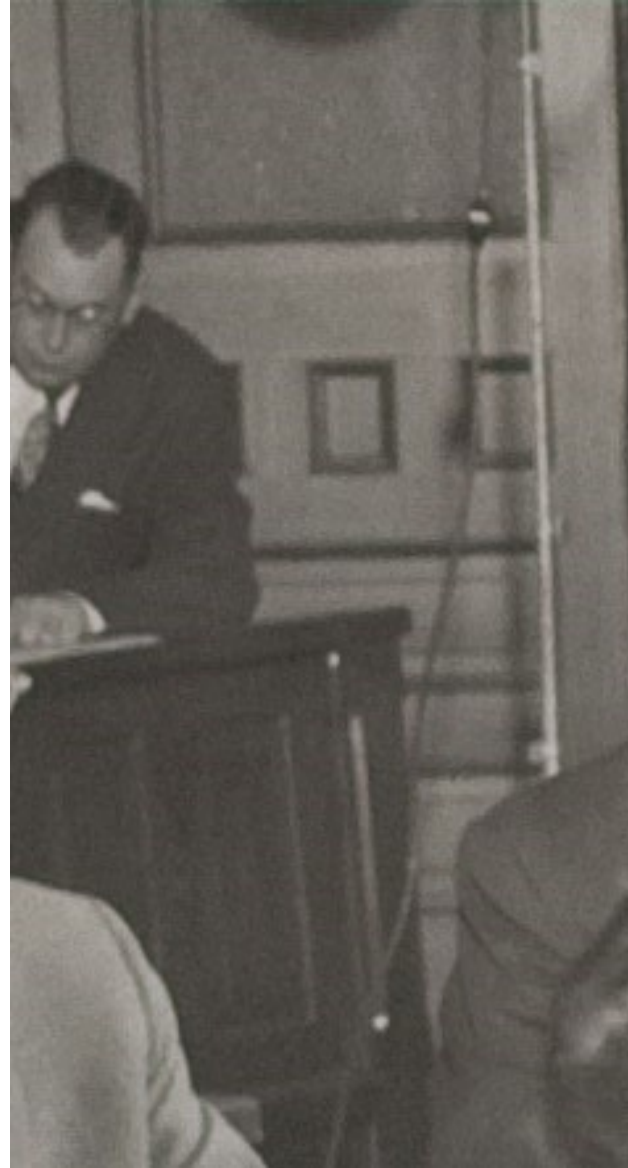
# Doors

Existing doors are not original but are somewhat like the doors that existed in the 1950s. Compare images of the north double doors (below) in the 50s and 2023. See the southwest single door (right) in the 50s and 2024.

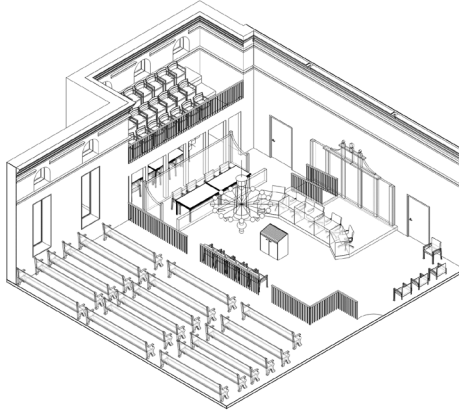
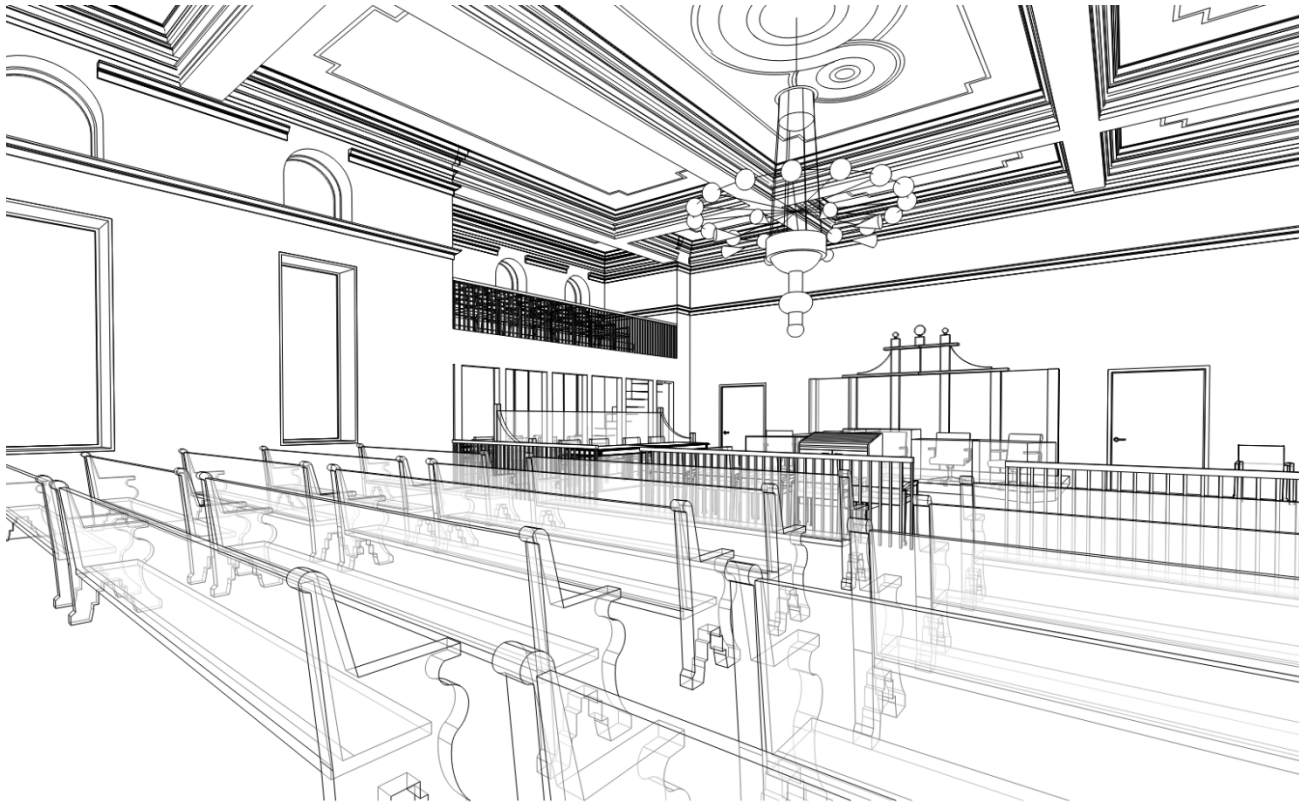
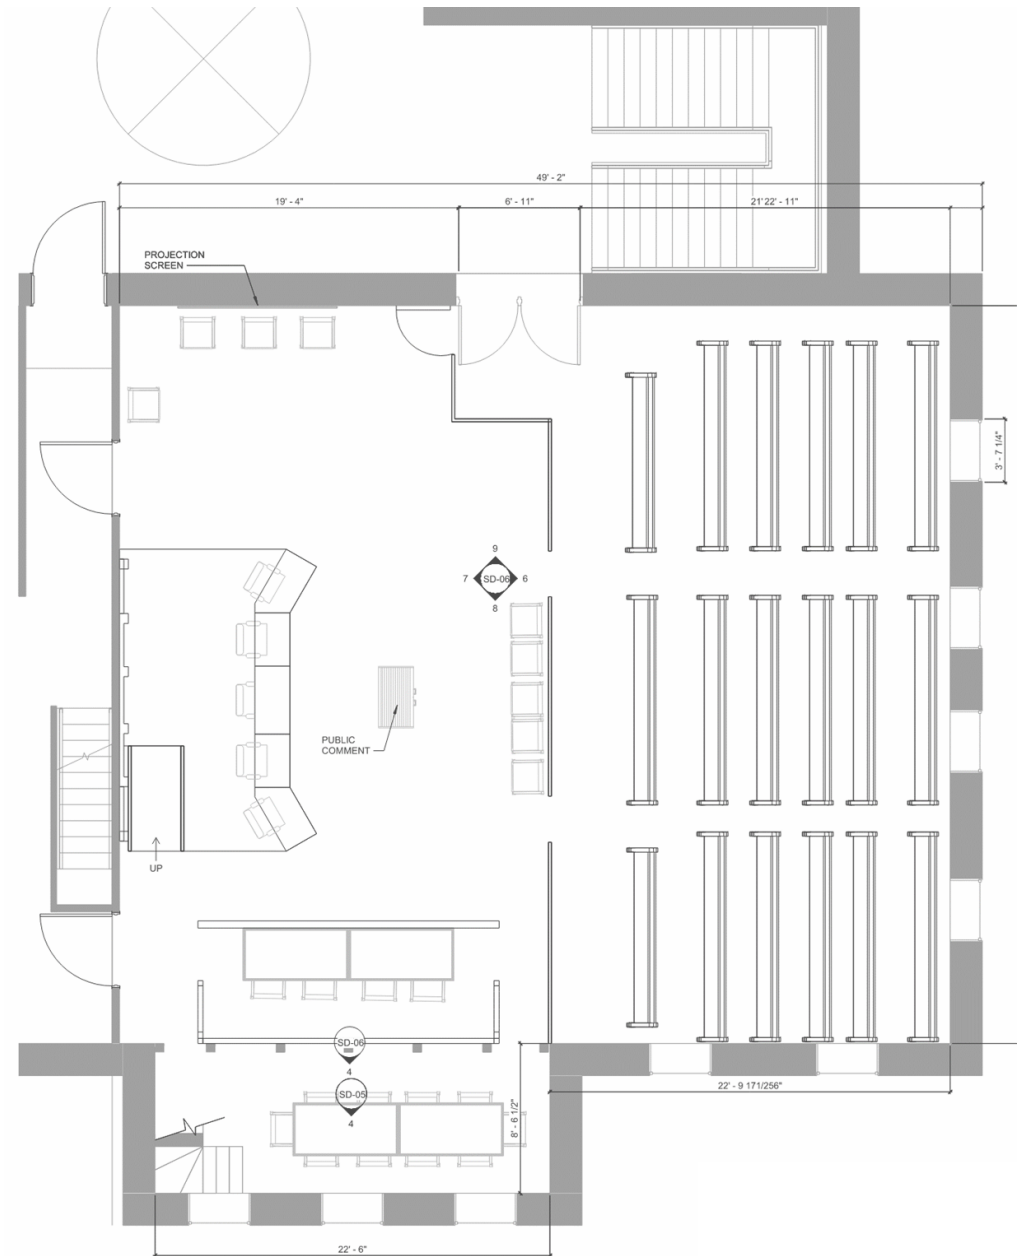
# Renovation Option 2

Option 2 would have retained the pre-renovation arrangement

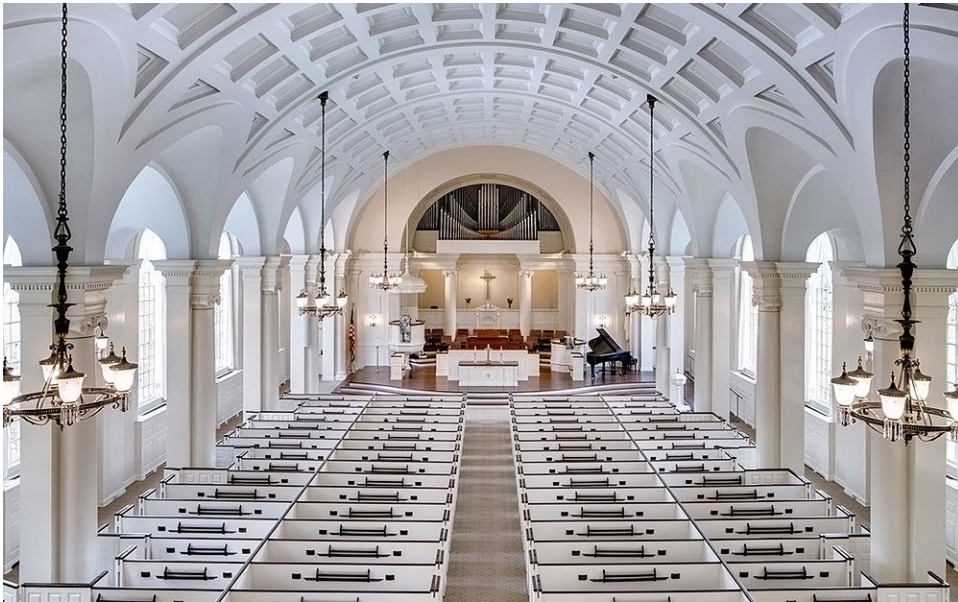
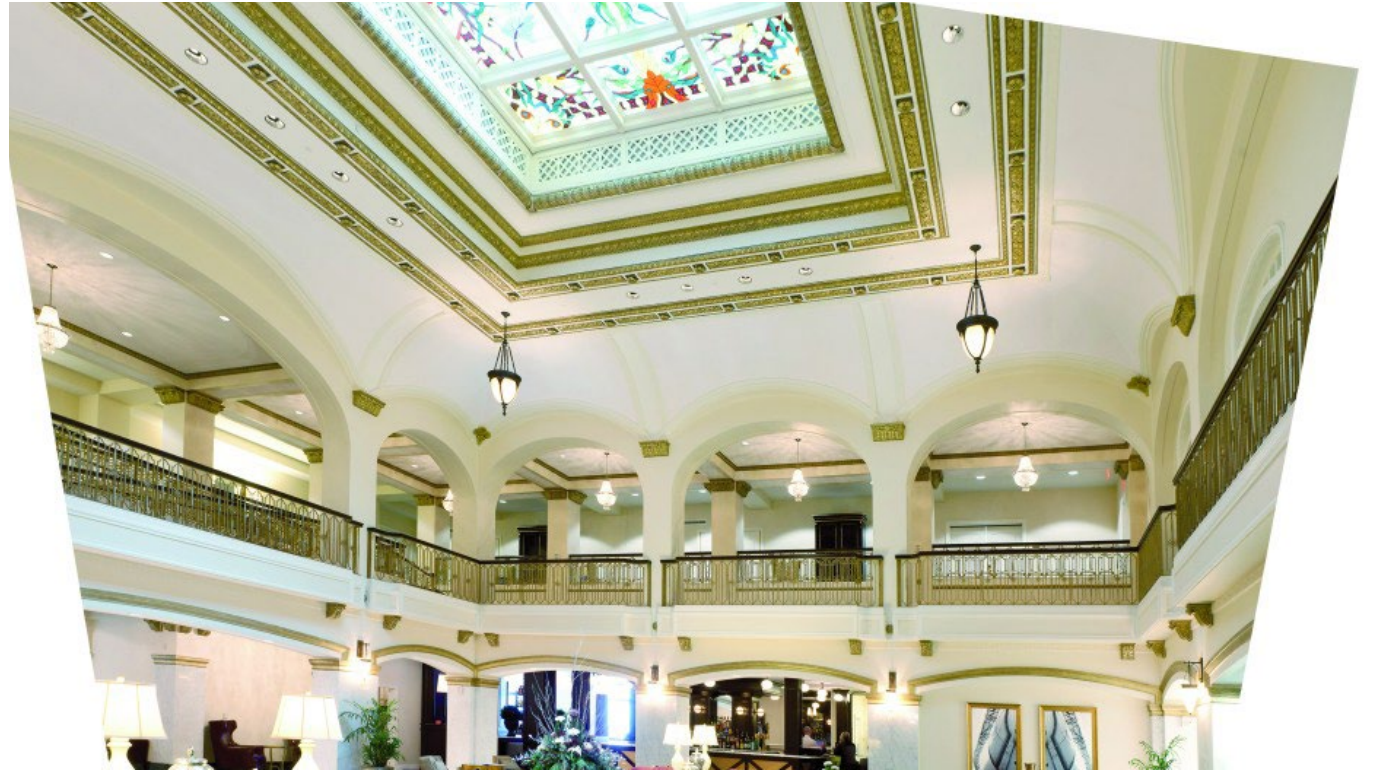
# Acoustical Ceilings

There were acoustical issues with the space that audio equipment could not overcome. Acoustically absorptive materials were researched.

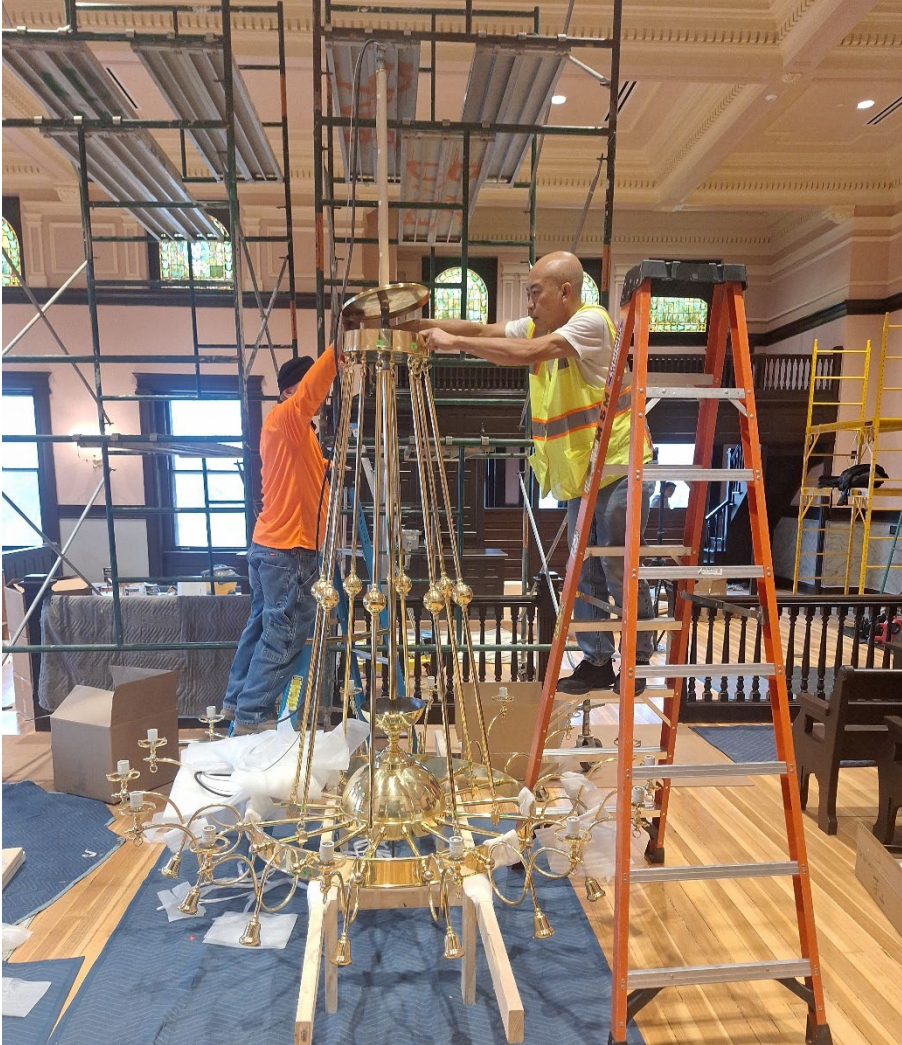
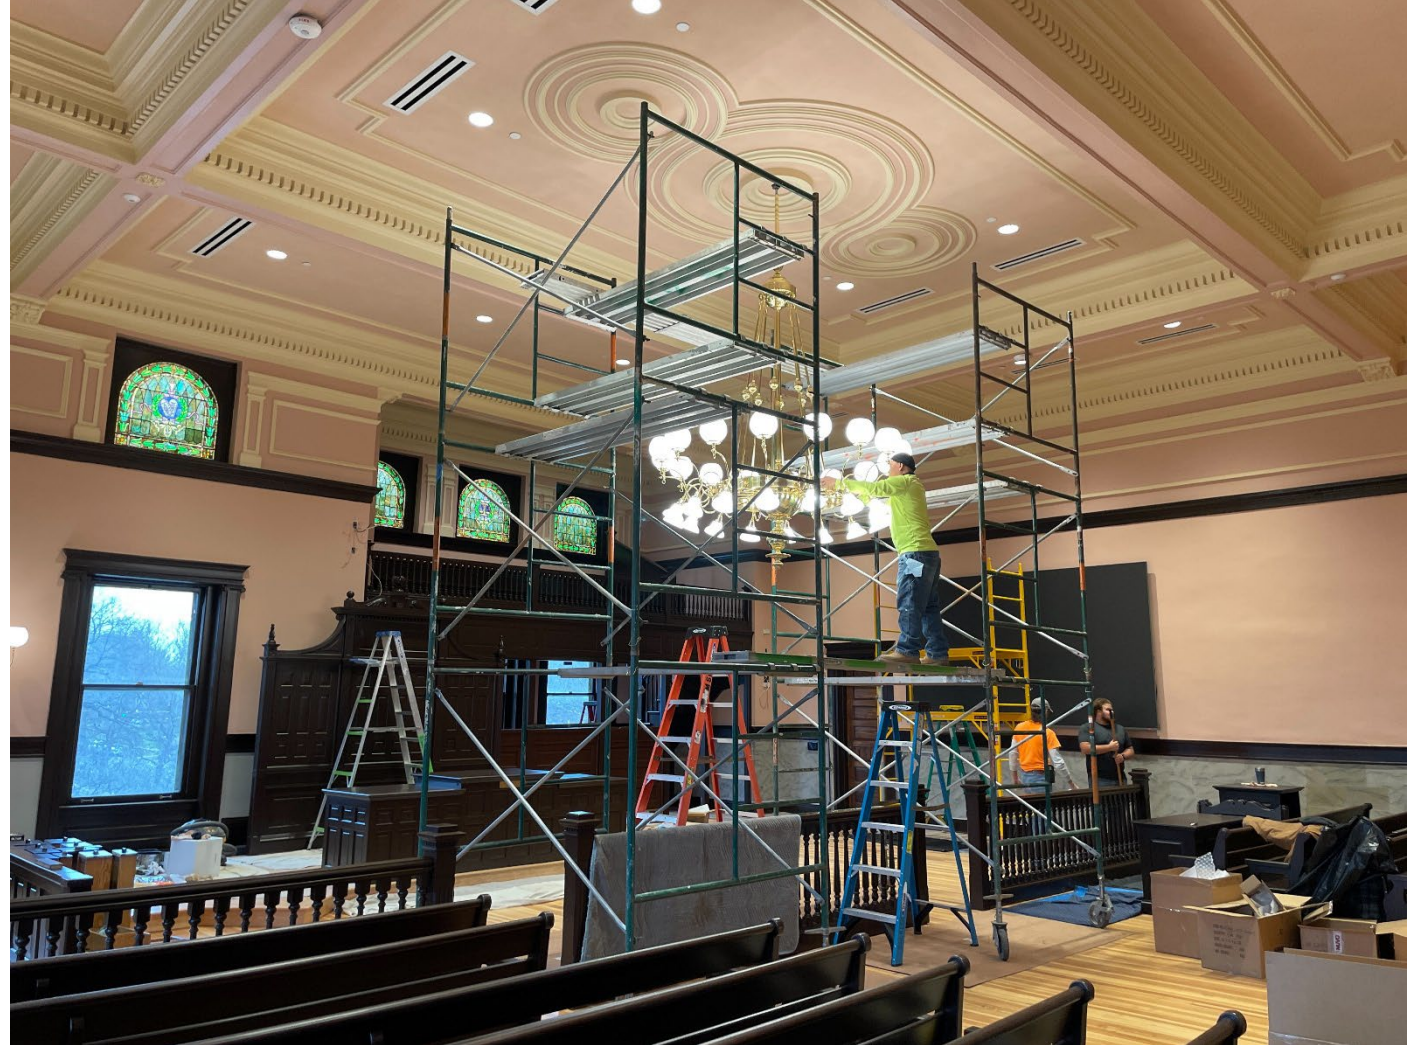
# Chandelier Installation

The original central chandelier (*right*), which hung below the ceiling's plaster motif, was at one time replaced by non-historic fixtures (*below*). Lacking original drawings of the fixtures, we used the one existing photo to reconstruct facsimiles of the originals.

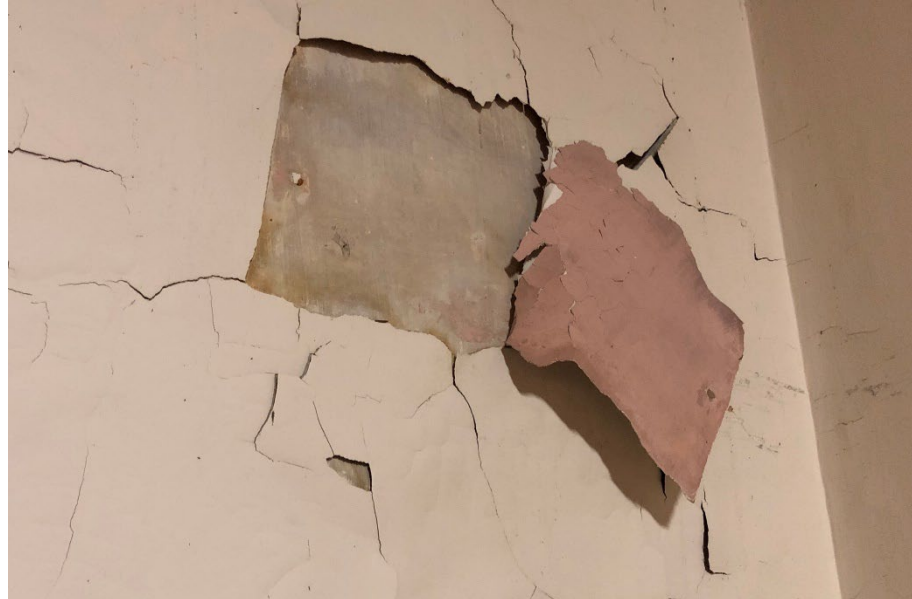
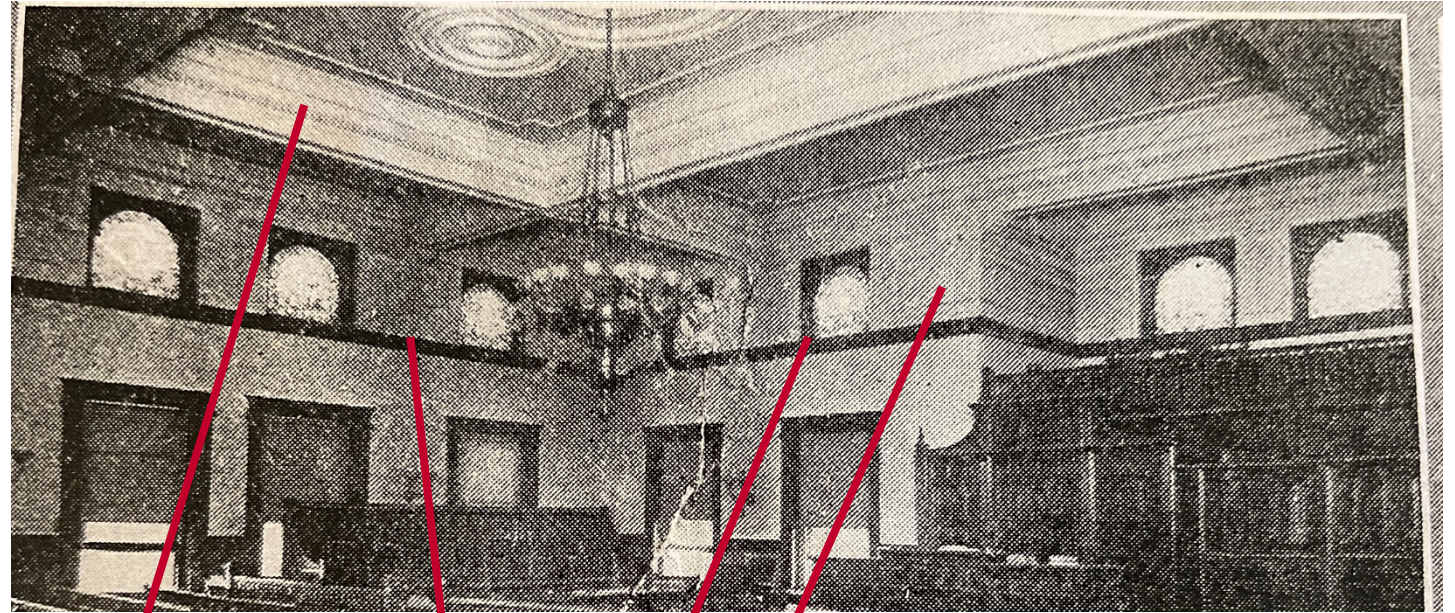
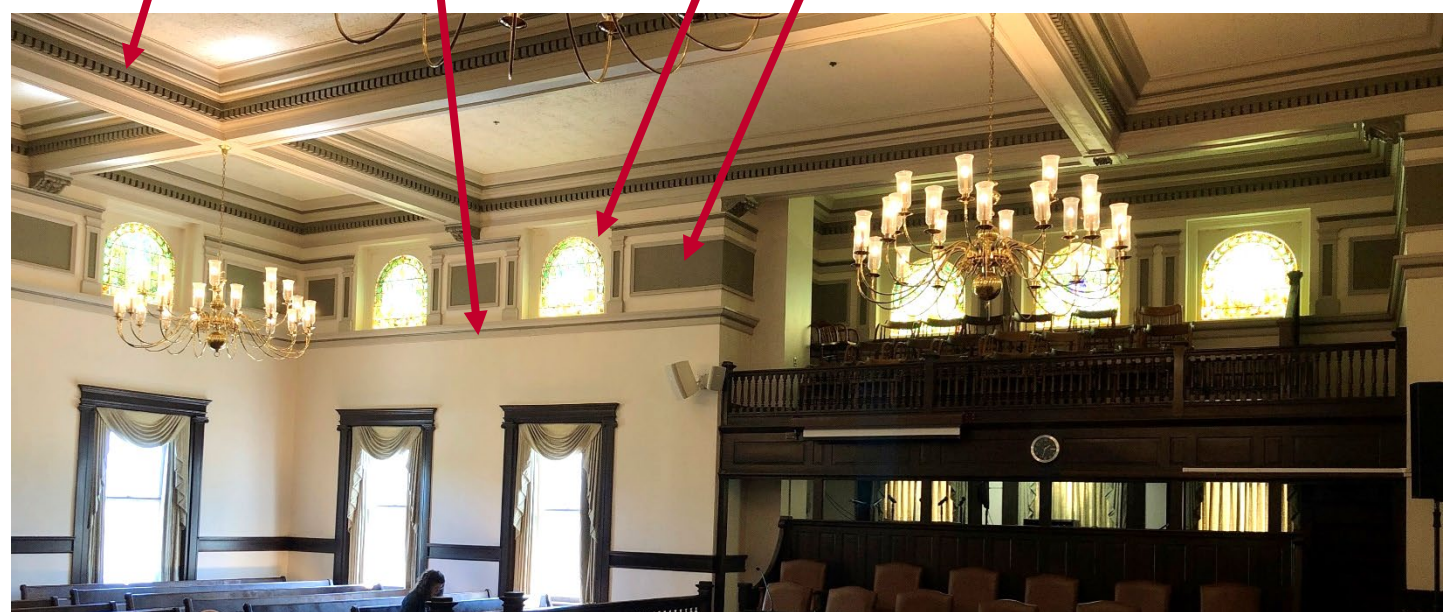
# Colors

Though the 1913 photograph is in black and white, we can tell that the room's colors were originally quite different.

This led our investigation to determine where paint samples need to be taken from, to determine original coloring.

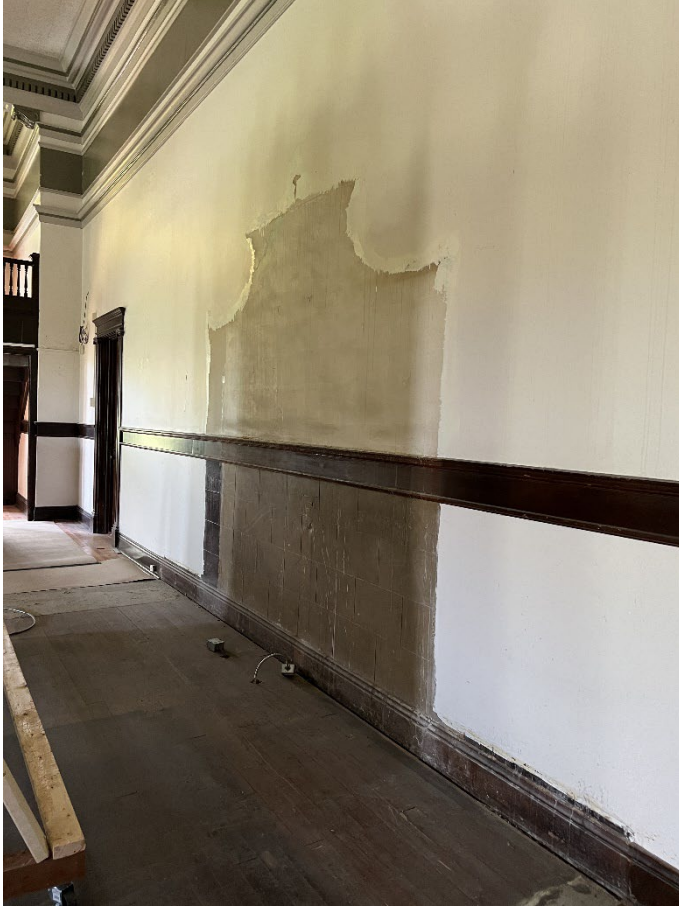
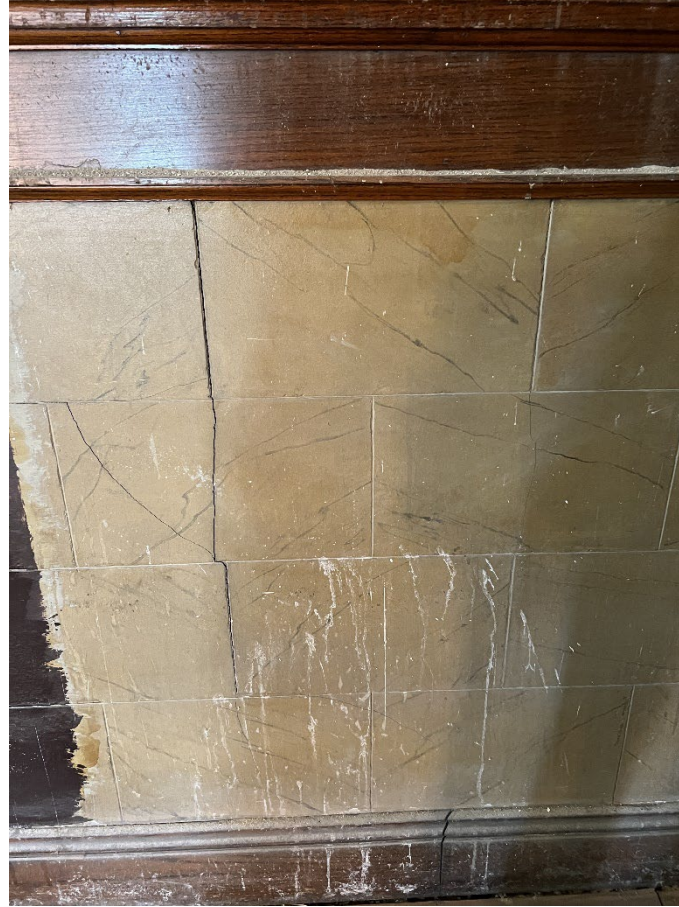
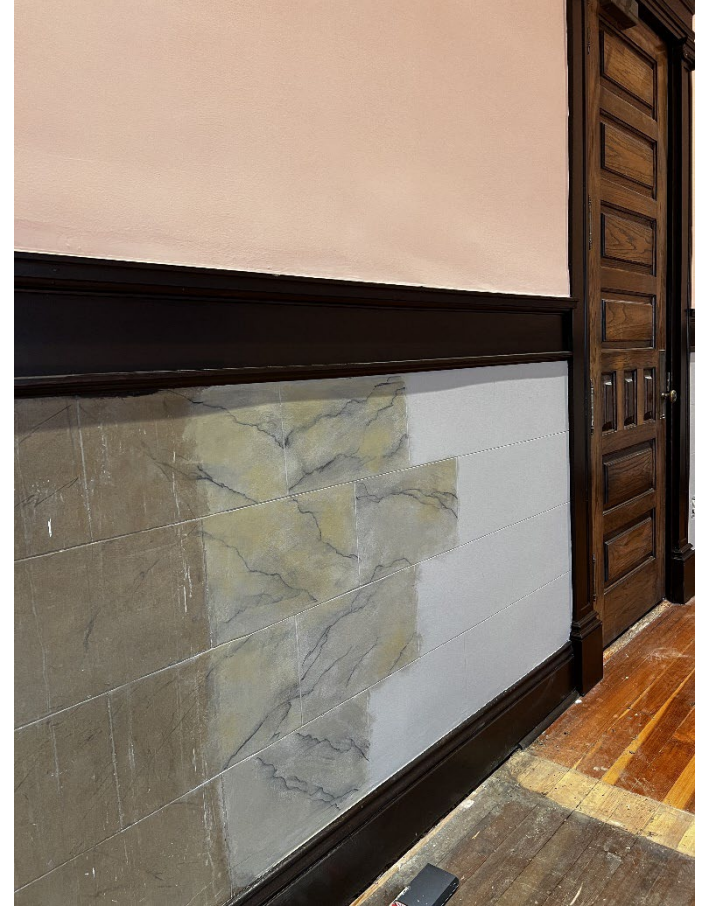
# Discovery and recreation of marbleized wainscot

Based on drawings and photos, the wainscot in this room featured a stone-course pattern on the walls. This was missing but could be restored or replicated.

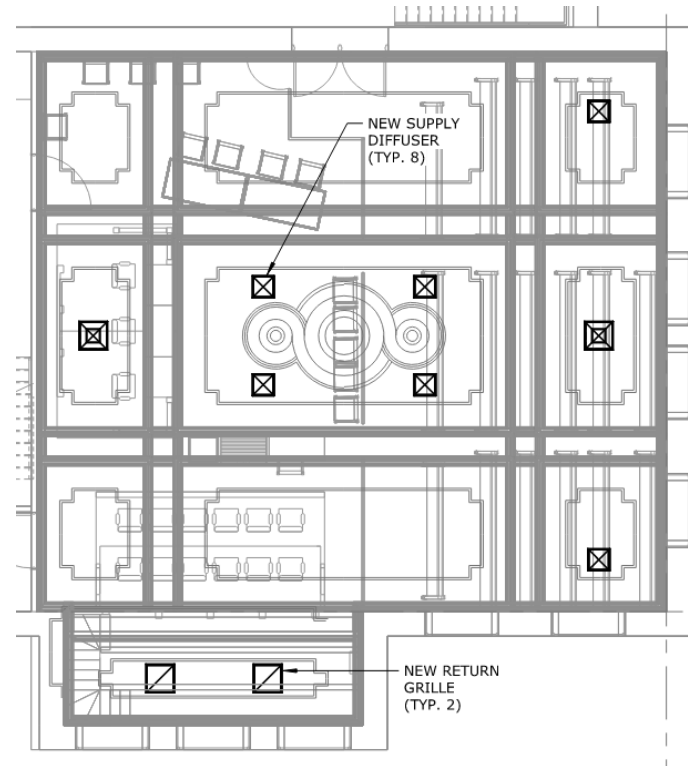
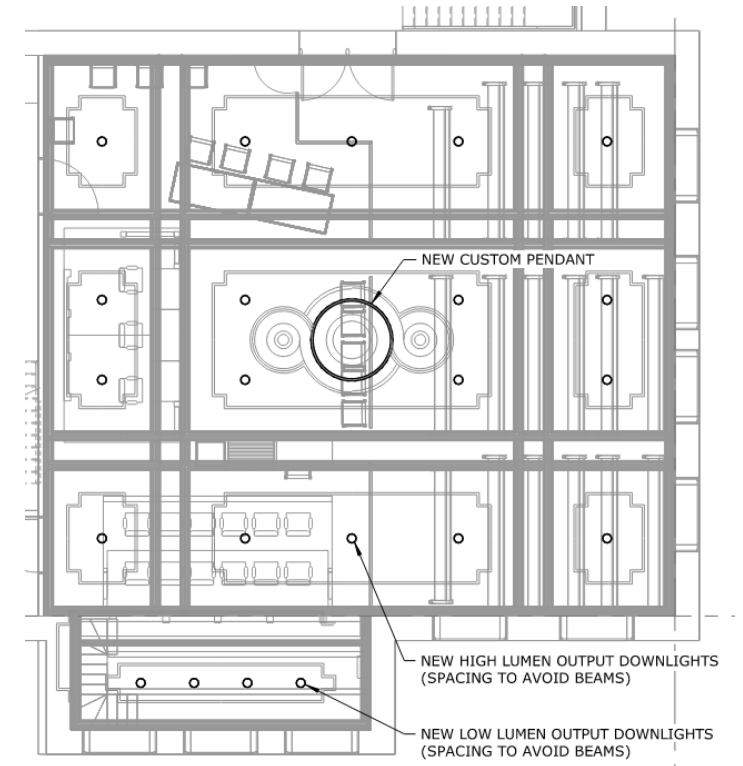
# Lighting and HVAC

In addition to poor acoustics, the air distribution and lighting were not adequate. Mechanical ductwork was reconfigured in the attic above and connected to new devices. The electrical conduit was hidden, and the original lighting was replicated. The reintroduction of lost features such as light fixtures, ceiling ornamentation, and historic finishes enhanced the space, and the addition of improved lighting, systems, and acoustics brought the facility up to current standards.
