Douglas County Courthouse  
Commission Chamber

Courthouse Background

Built in 1903, the historic Douglas County Courthouse was designed by John G. Haskell and Frederick C. Gunn in the Richardsonian Romanesque style, and it is a late example of the style. The commission chamber, formerly the courtroom, occupies the southeastern corner of the second story.

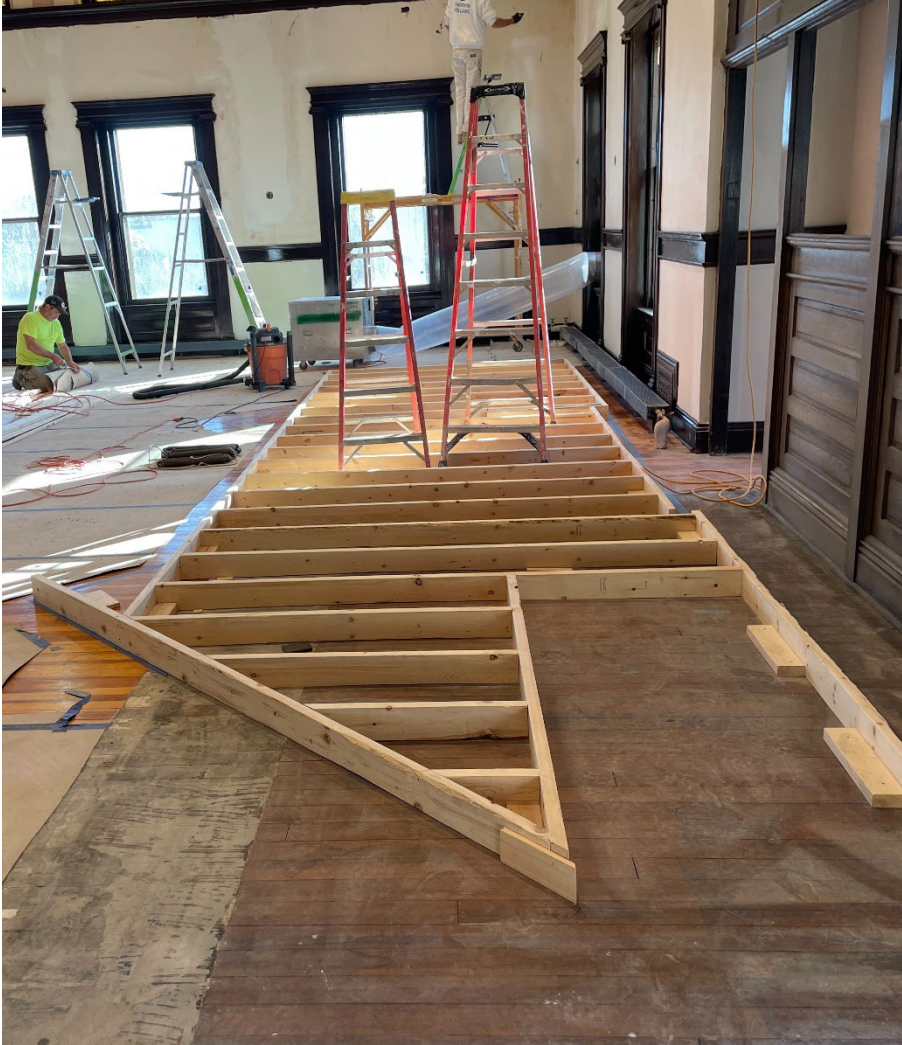
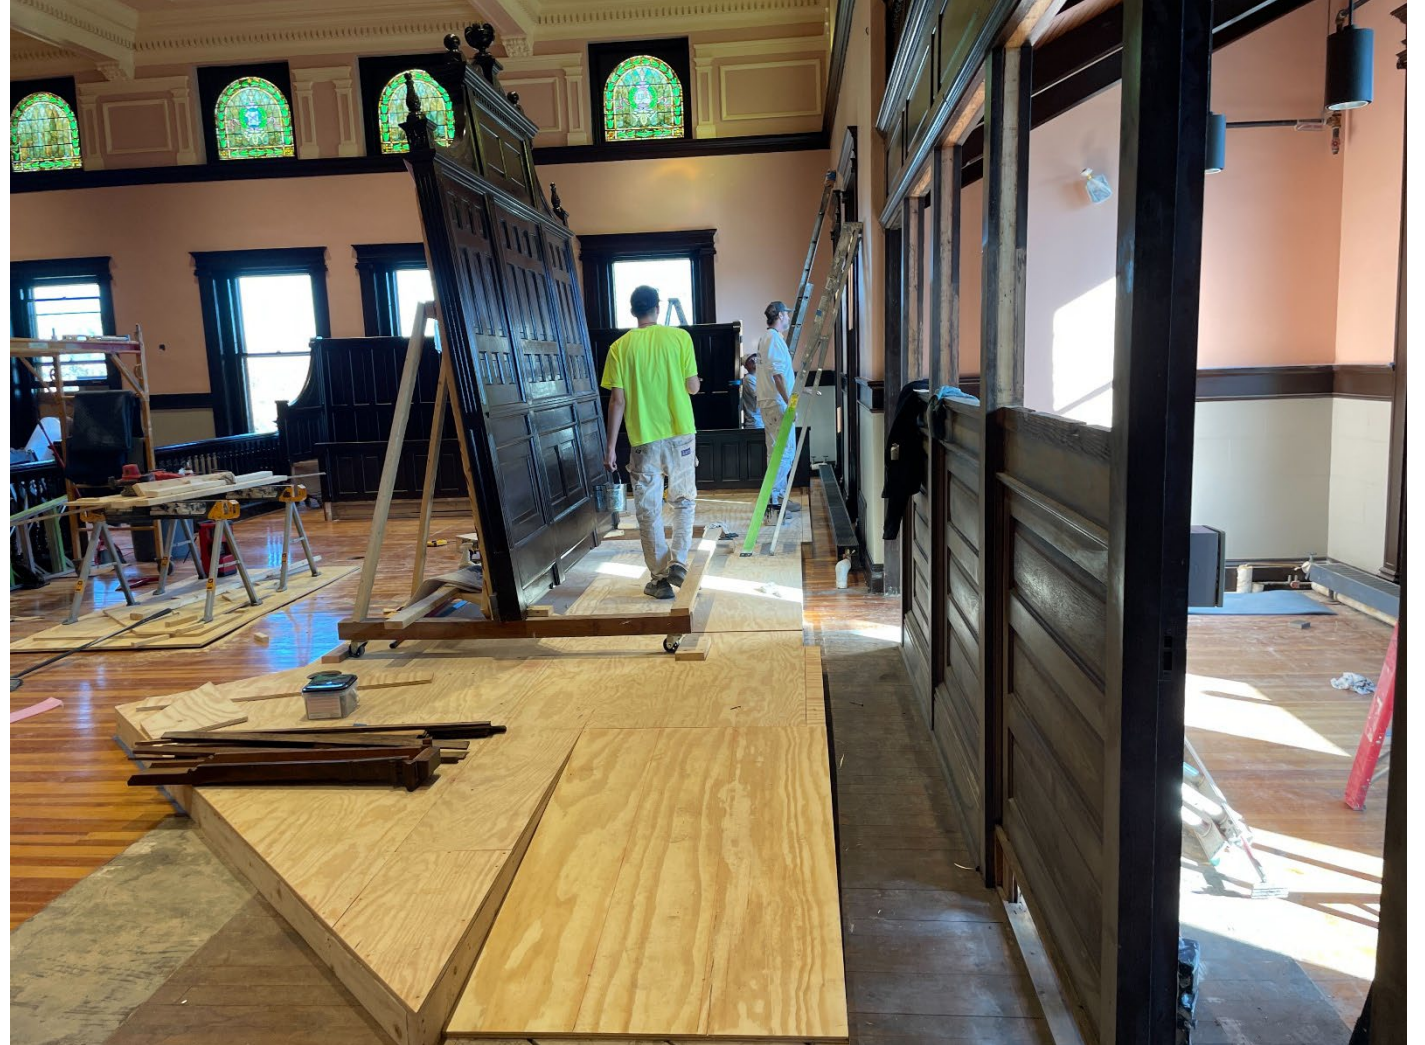
# Dais Construction

Douglas County voters chose to expand the Board of County Commissioners from three elected officials to five. This necessitated expanding the historic dais, which had once served as the judge's desk when the room was used by the court.

New angled wings were designed and added to the historic bench, and the non-historic platform was replaced. The new wings are designed to blend with the historic desk, sympathetically expanding it to serve the Commission for years to come.
