Douglas County Courthouse
Commission Chamber

Courthouse Background

Built in 1903, the historic Douglas County Courthouse was designed by John G. Haskell and Frederick C. Gunn in the Richardsonian Romanesque style, and it is a late example of the style. The commission chamber, formerly the courtroom, occupies the southeastern corner of the second story.

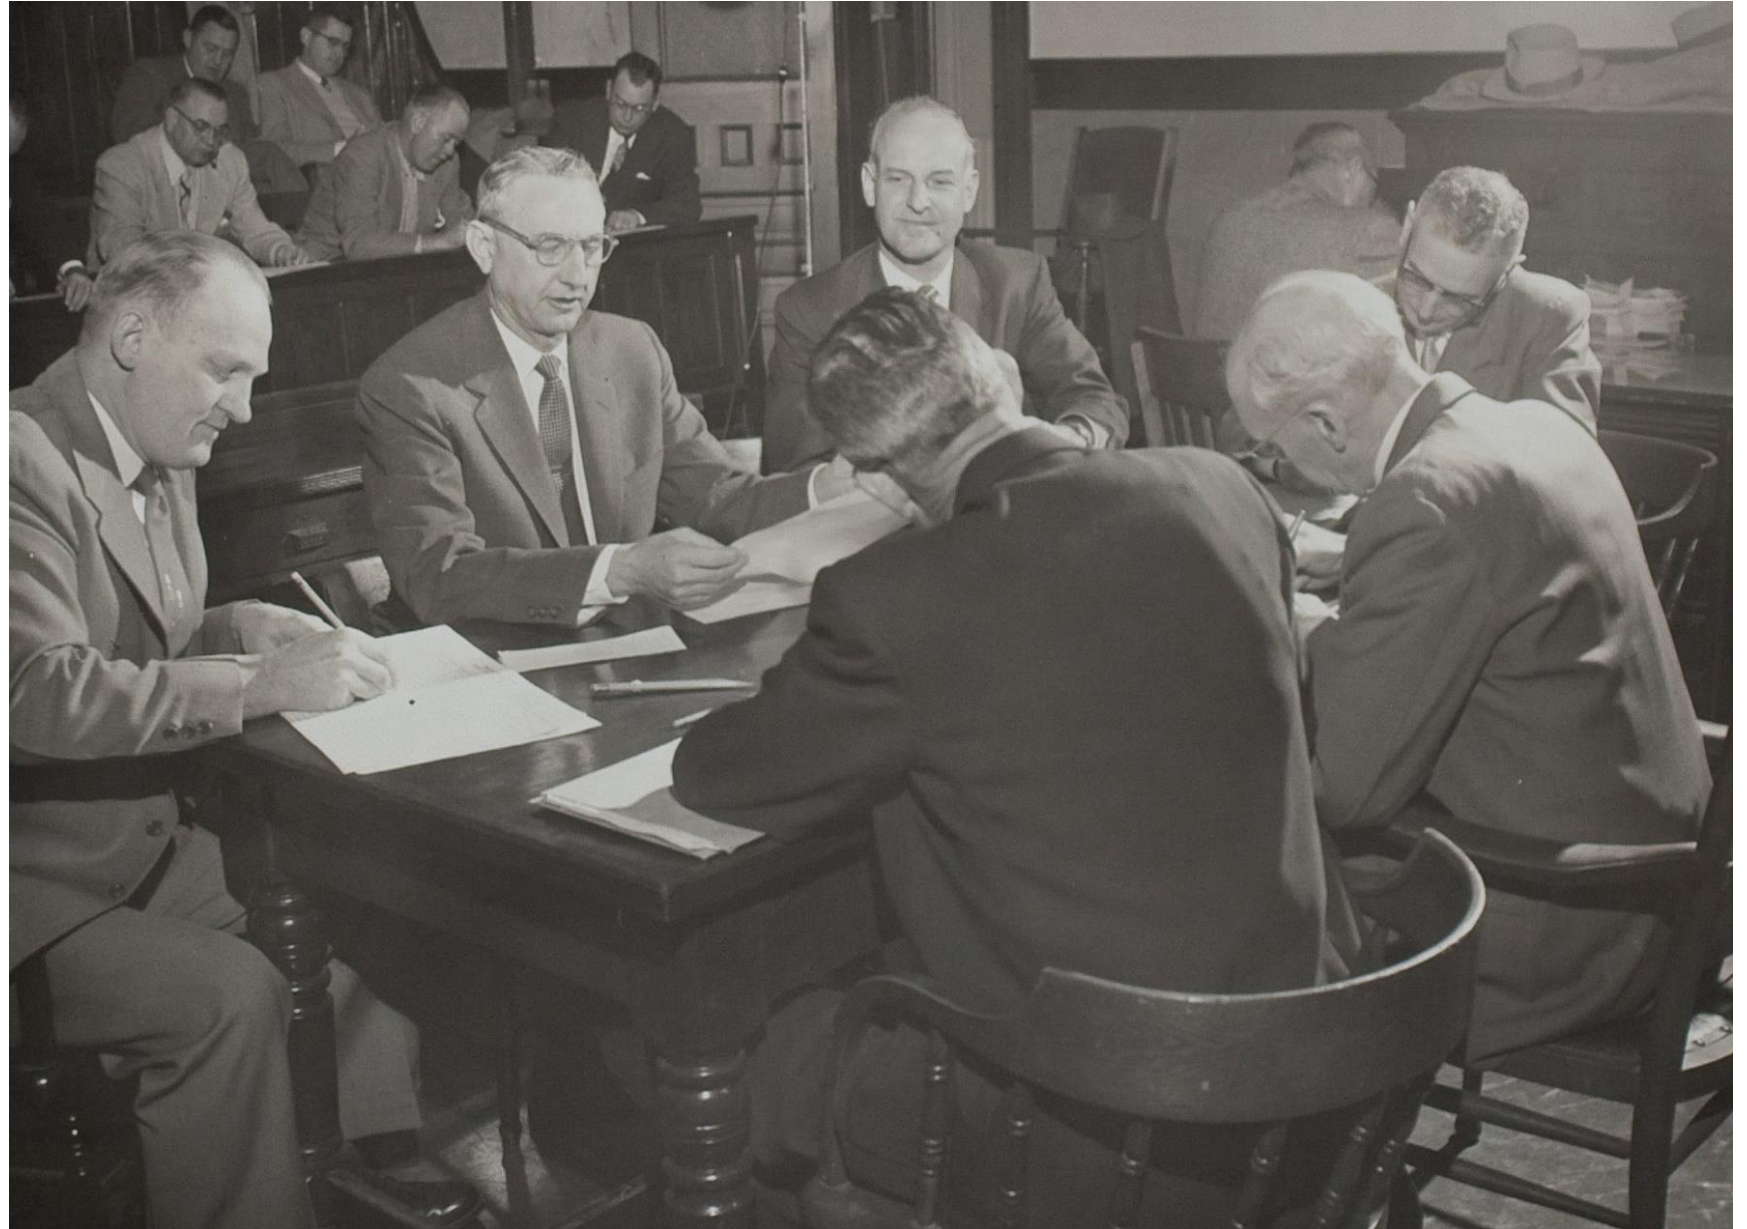
1954 Photo

This photo shows the jury bench in its non-historic location, and the dais has been moved to the west wall.

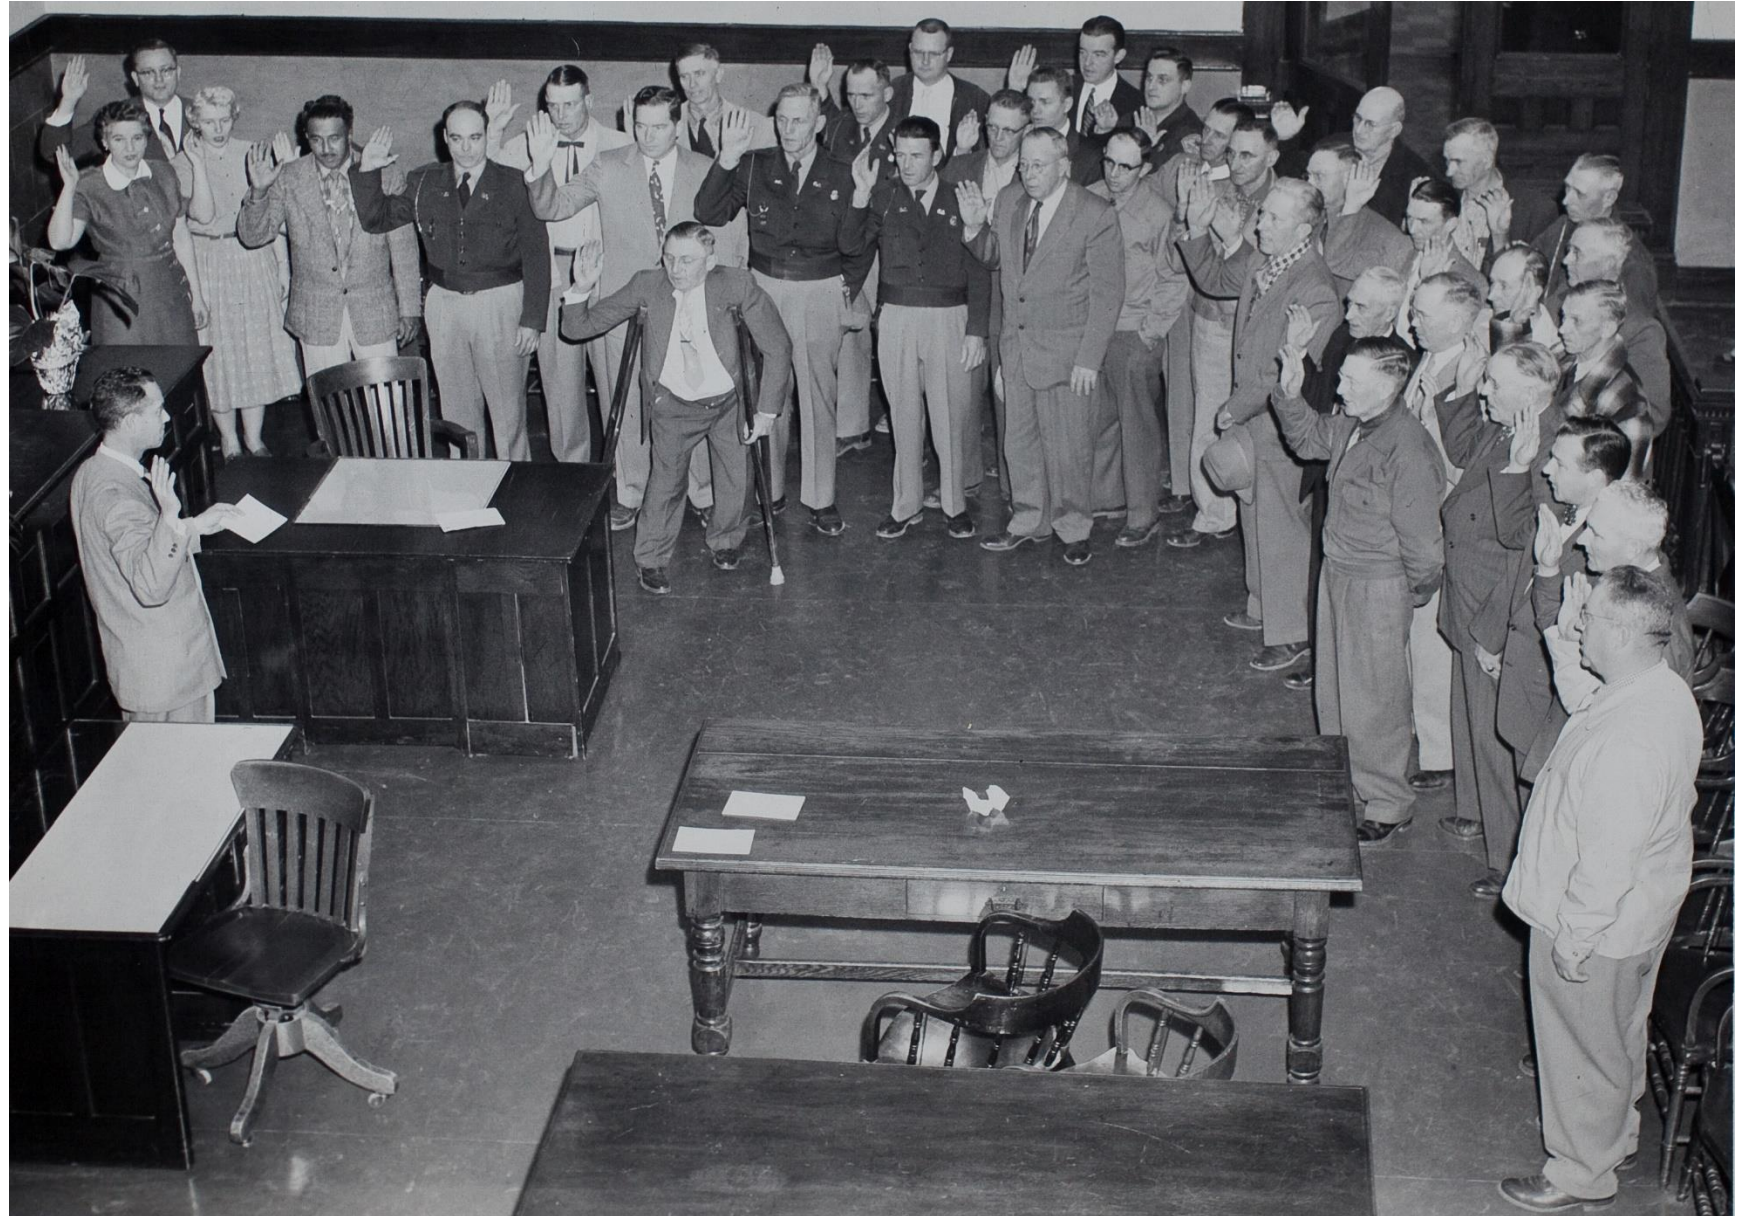
1955 Photo

This photo gives a good view of the court – or business side of the courtroom. At the lefthand side of the image, the dais is pressed against the west wall. The floor is covered with a material that appears to be a linoleum tile, instead of or installed over the historic hardwood floors.

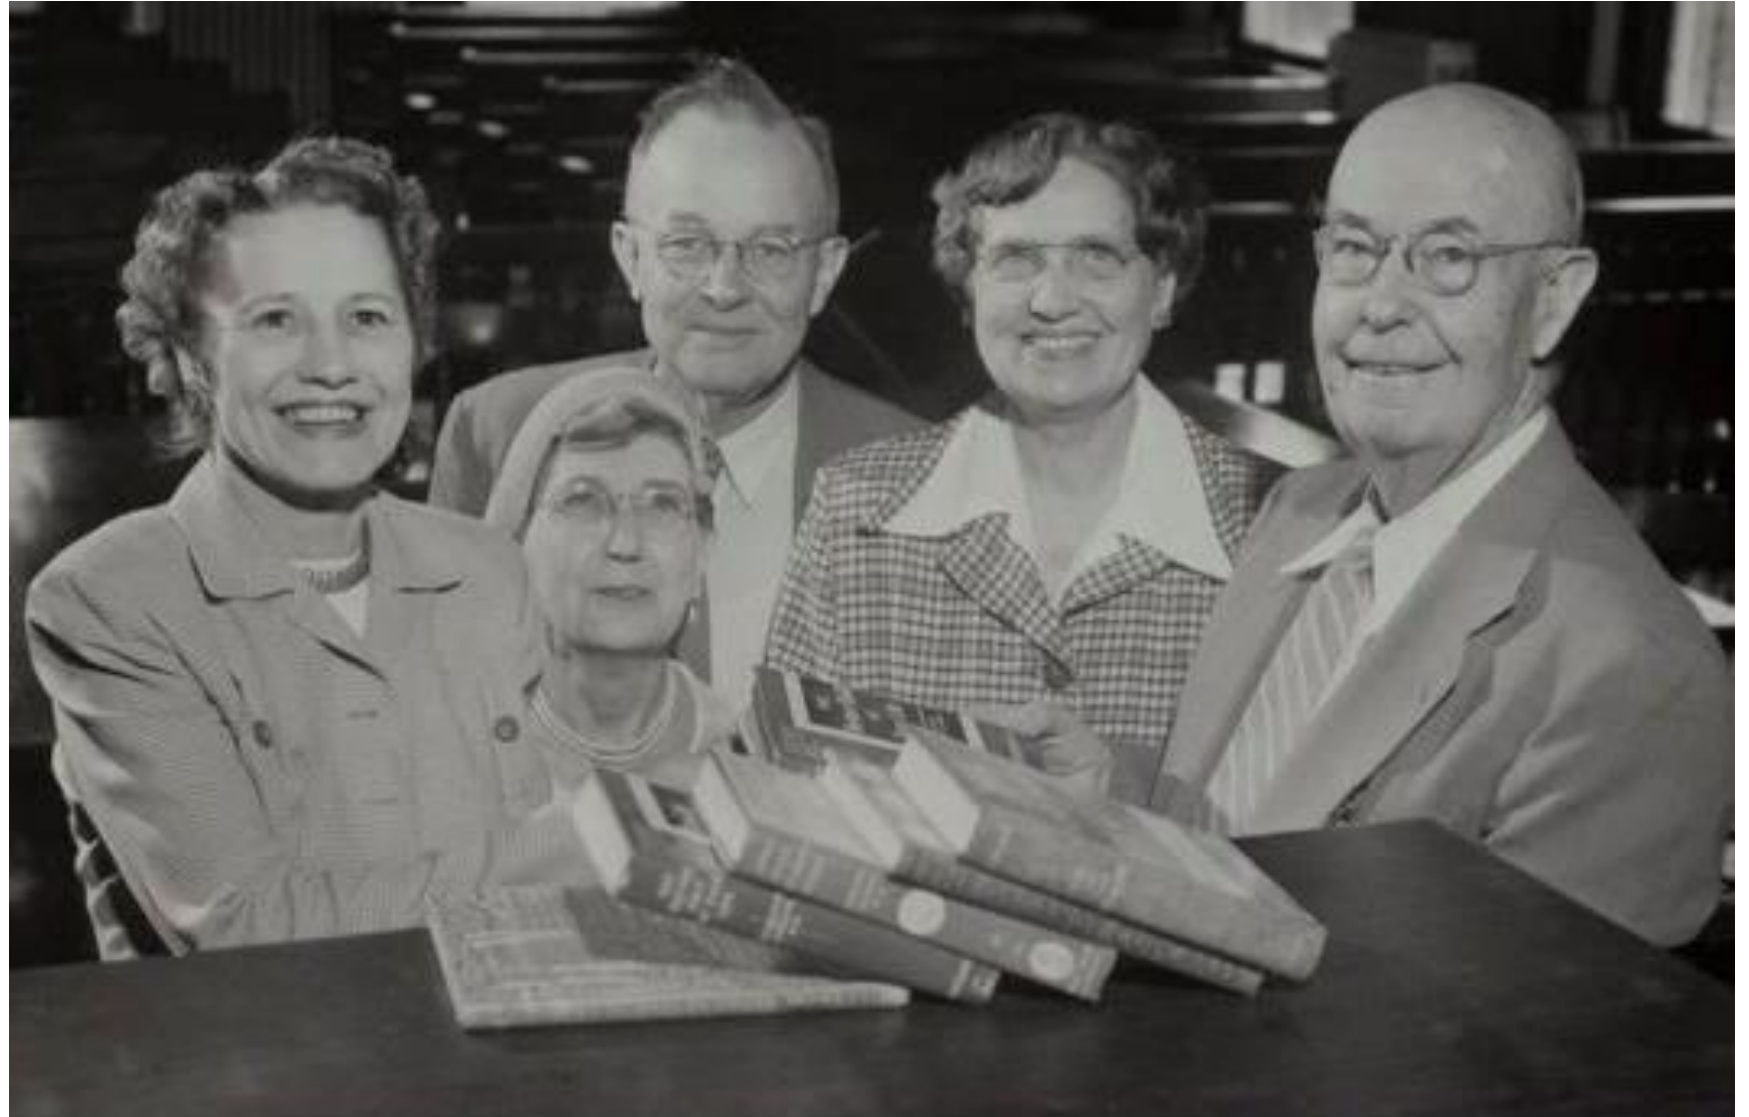
1955 Photo

This photo shows the pews and railing in their current configuration but also show what appear to be radiators at the windows, in the background.

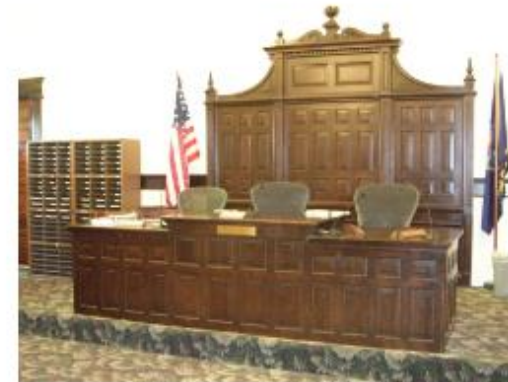
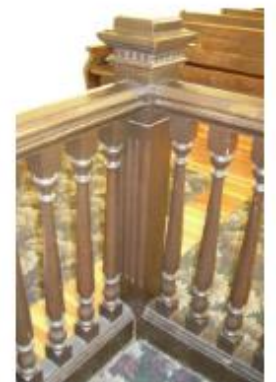
Douglas County Courthouse Courtroom - Judge’s Dias and Dividing Rail

Between 2006 and 2023, the dais was remodeled, with the carpet stripped off and a new set of railings attached to either end of the desk. Note that the carpet on the floor was removed during that time, exposing the hardwood floors.

New angled wings were designed and added to the historic bench, and the non-historic platform was replaced. The new wings are designed to blend with the historic desk, sympathetically expanding it to serve the Commission for years to come.

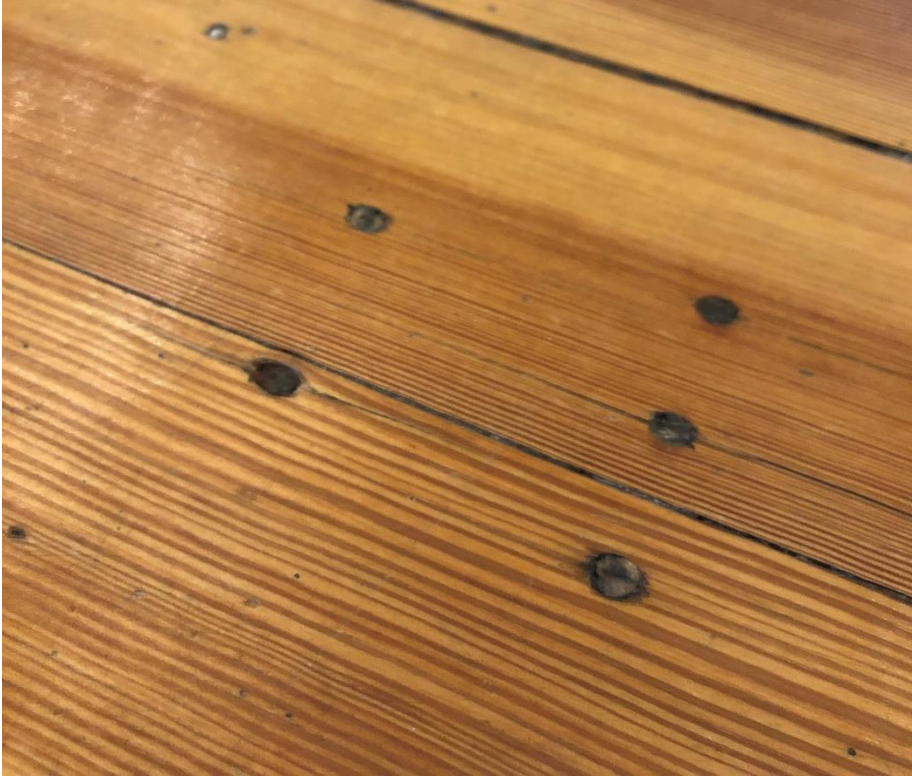
Railing Position

A scar of the original railing location could be seen on the floor, approximately 19' – 11" from the north wall.

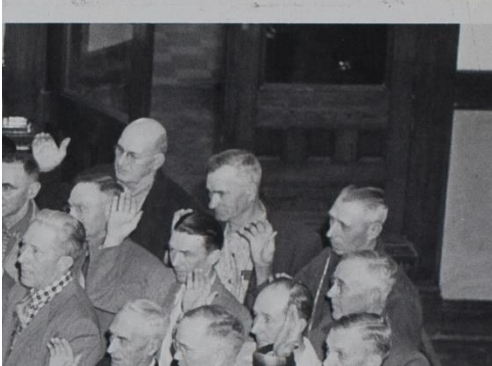
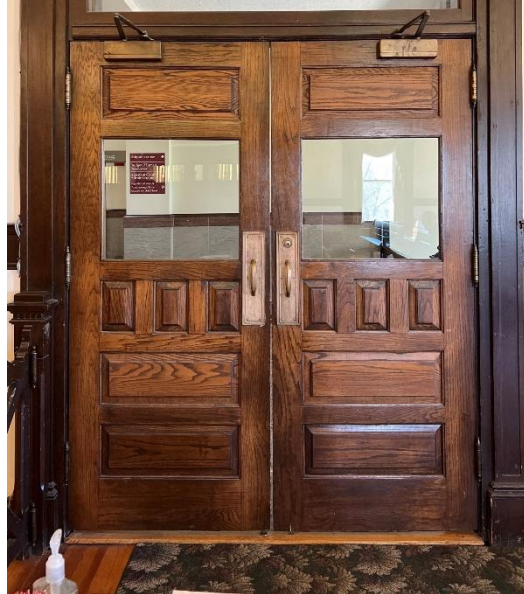
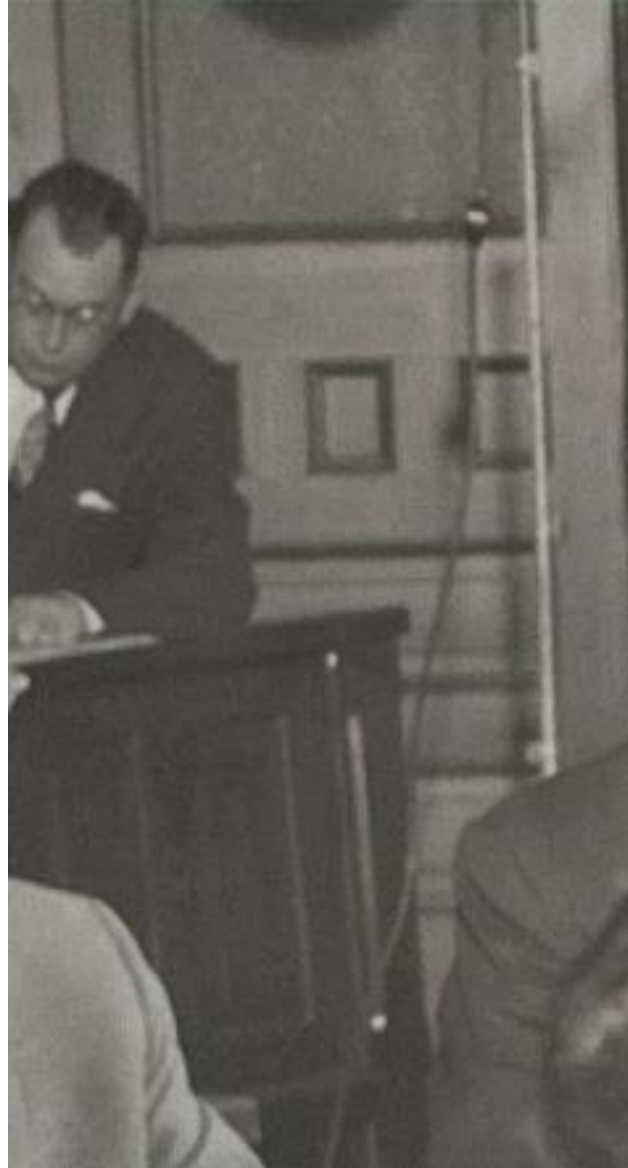
Doors

Existing doors are not original but are somewhat like the doors that existed in the 1950s. Compare images of the north double doors (below) in the 50s and 2023. See the southwest single door (right) in the 50s and 2024.

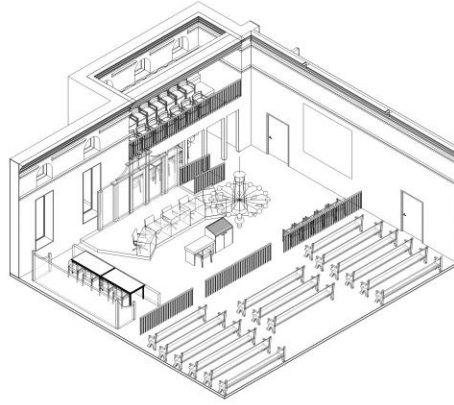
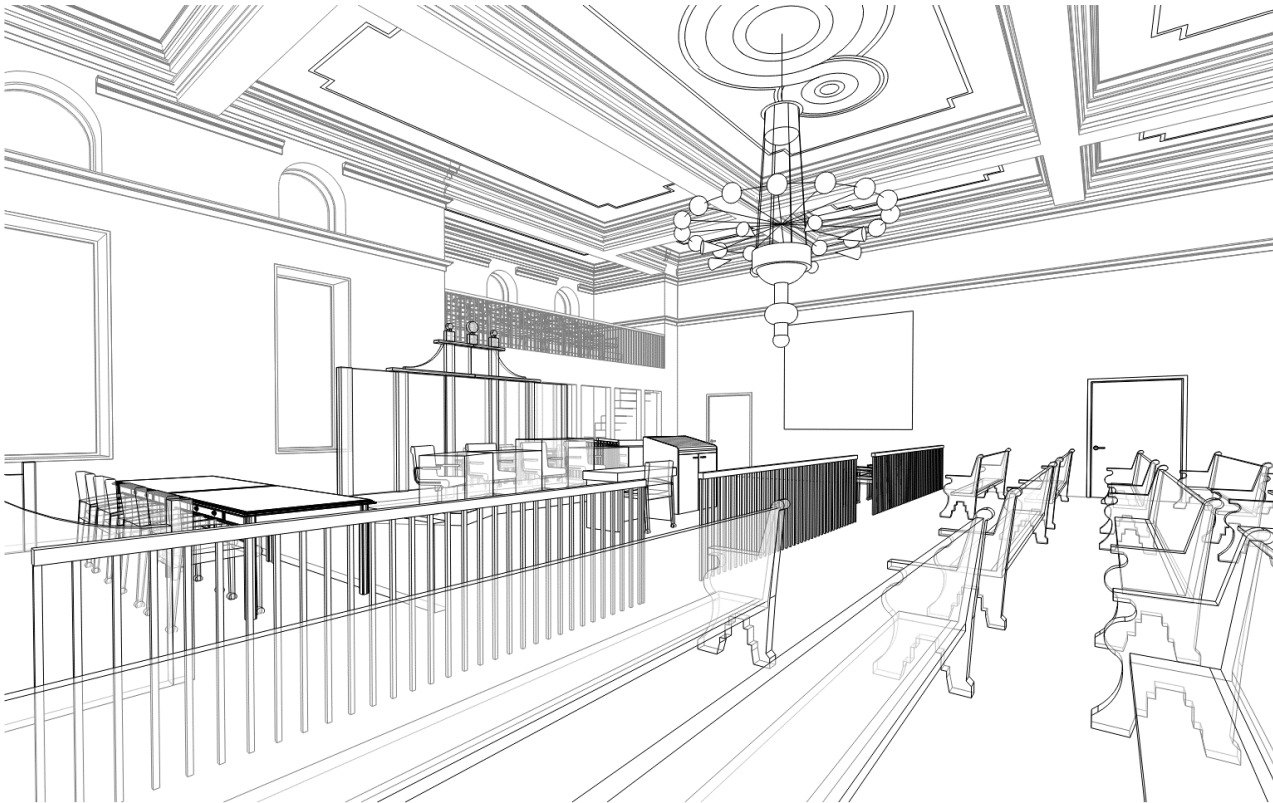
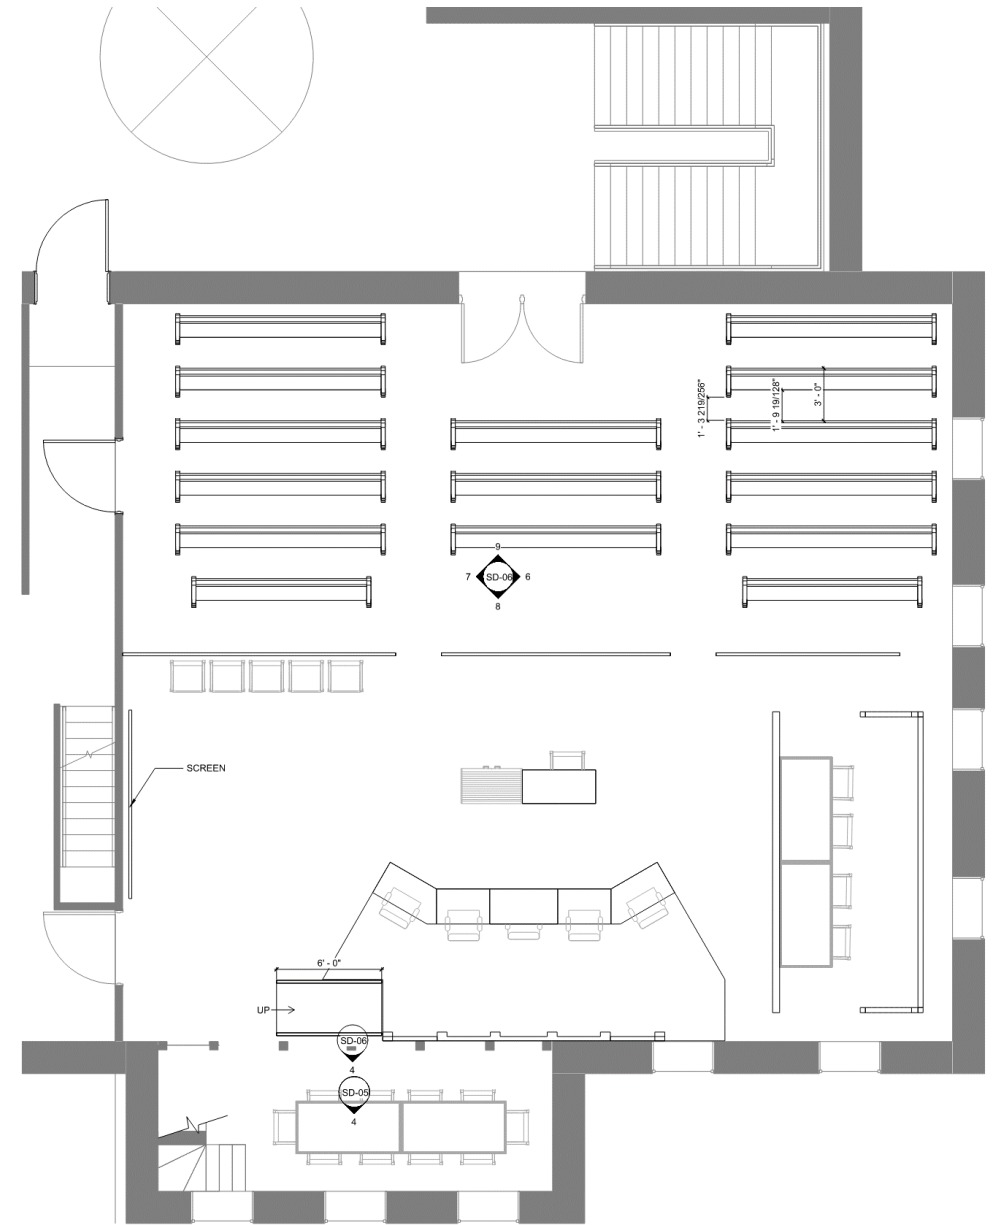
Layout Option 1

This option returns the chamber to a configuration closely resembling the 1913 layout.

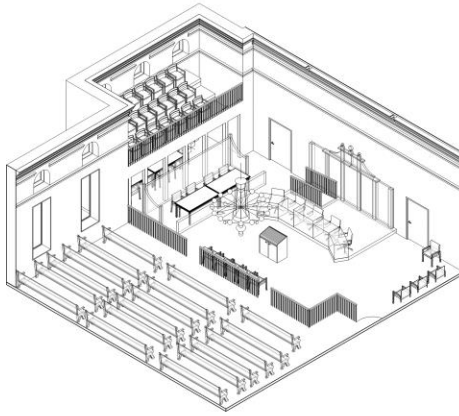
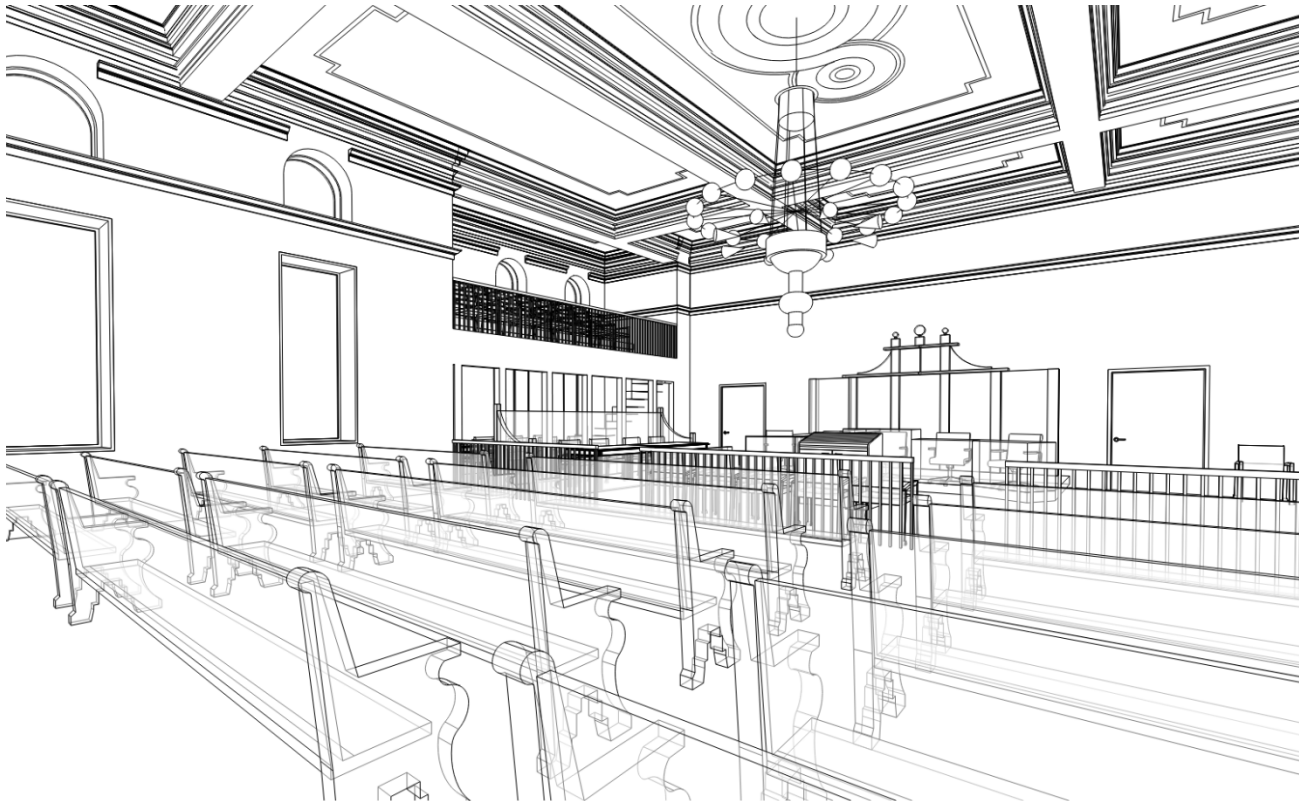
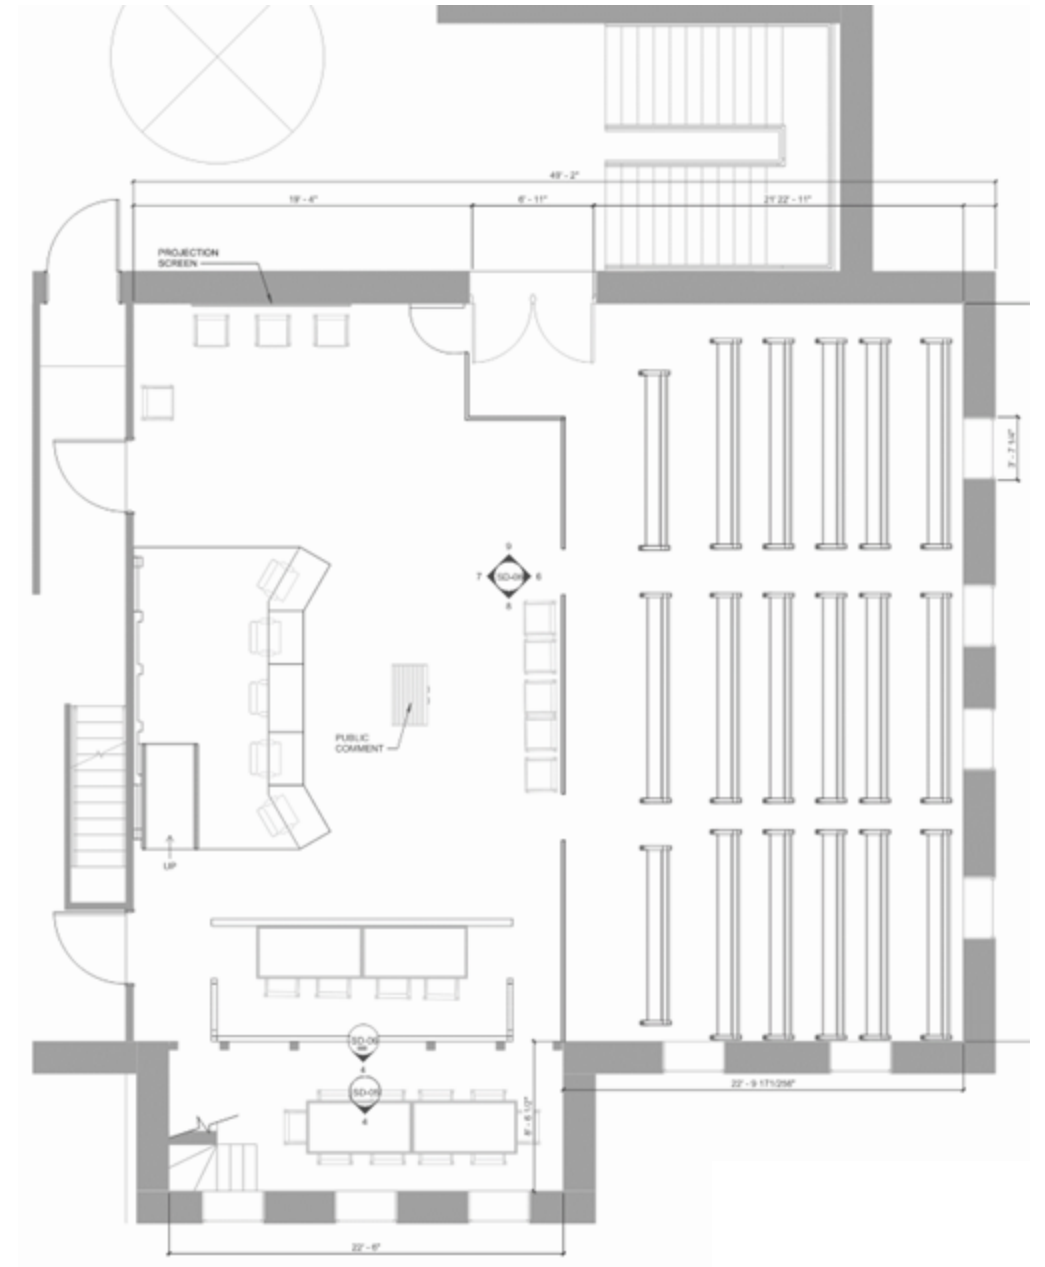
Renovation Option 2

Option 2 would have retained the pre-renovation arrangement

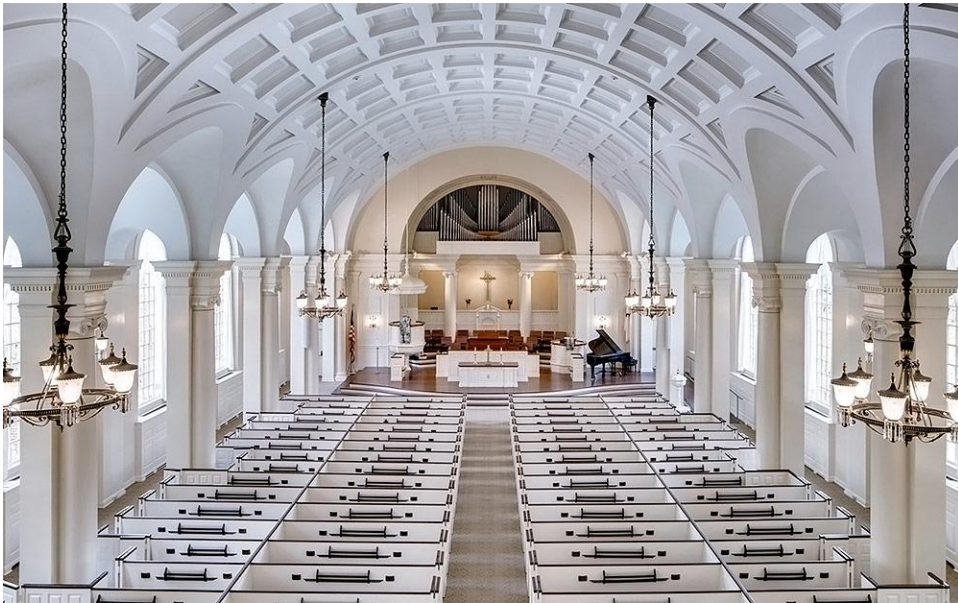
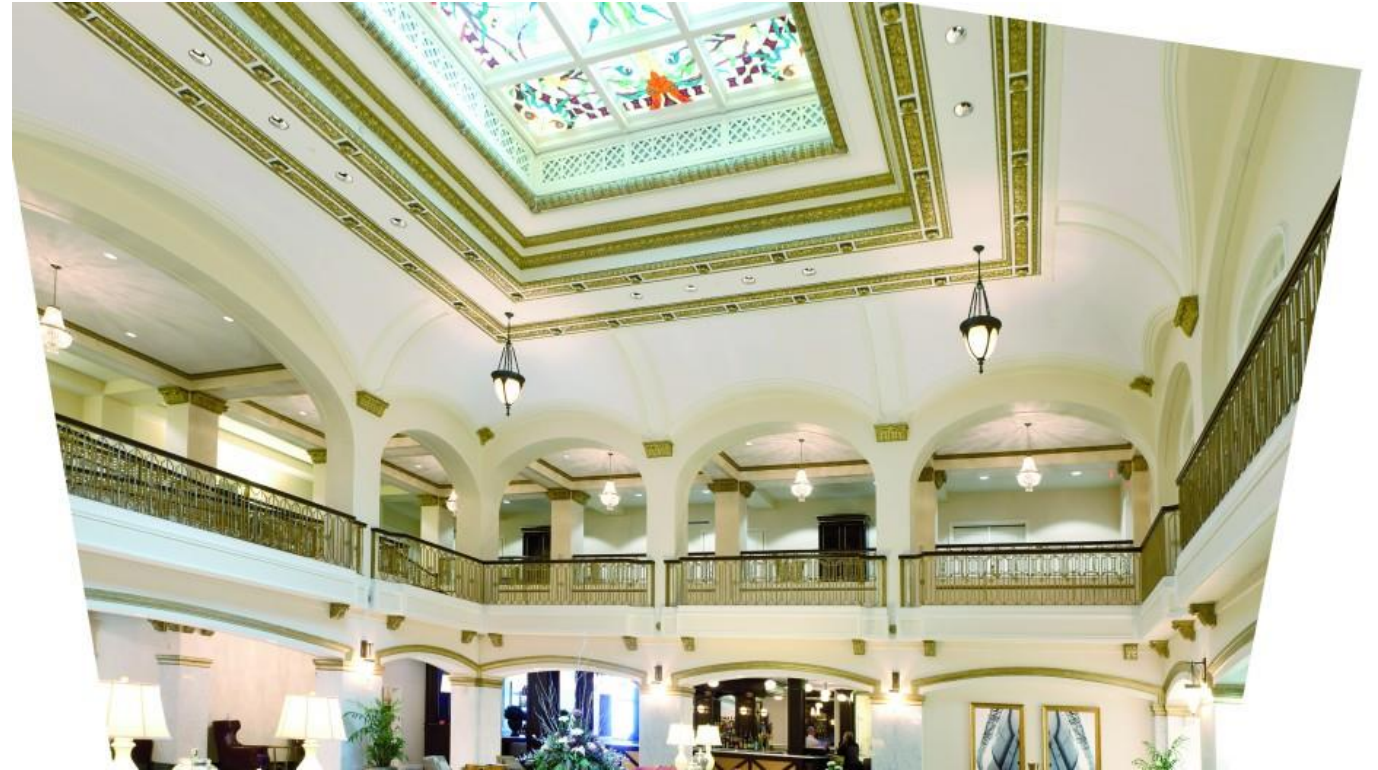
Acoustical Ceilings

There were acoustical issues with the space that audio equipment could not overcome. Acoustically absorptive materials were researched.

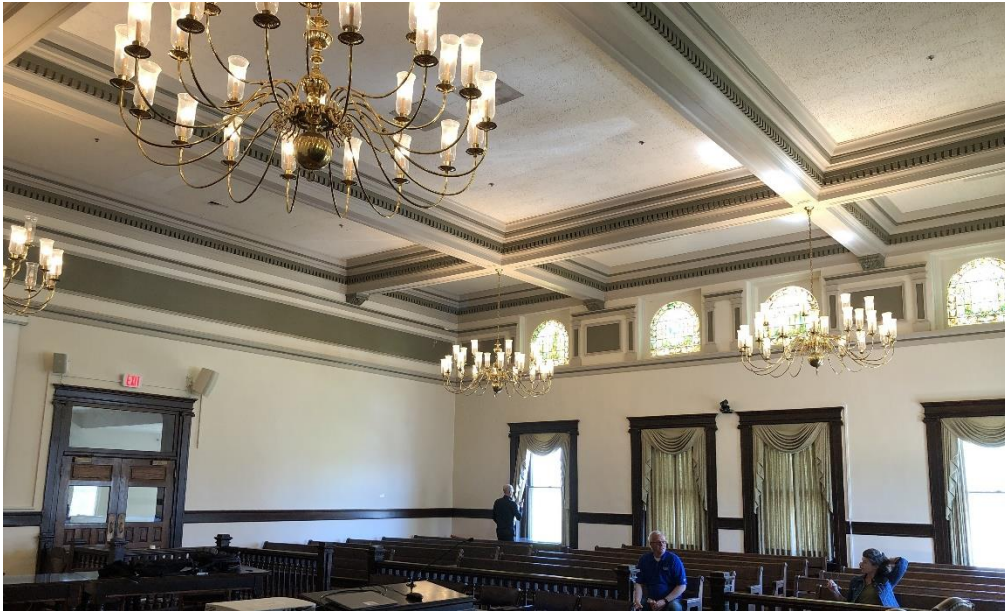
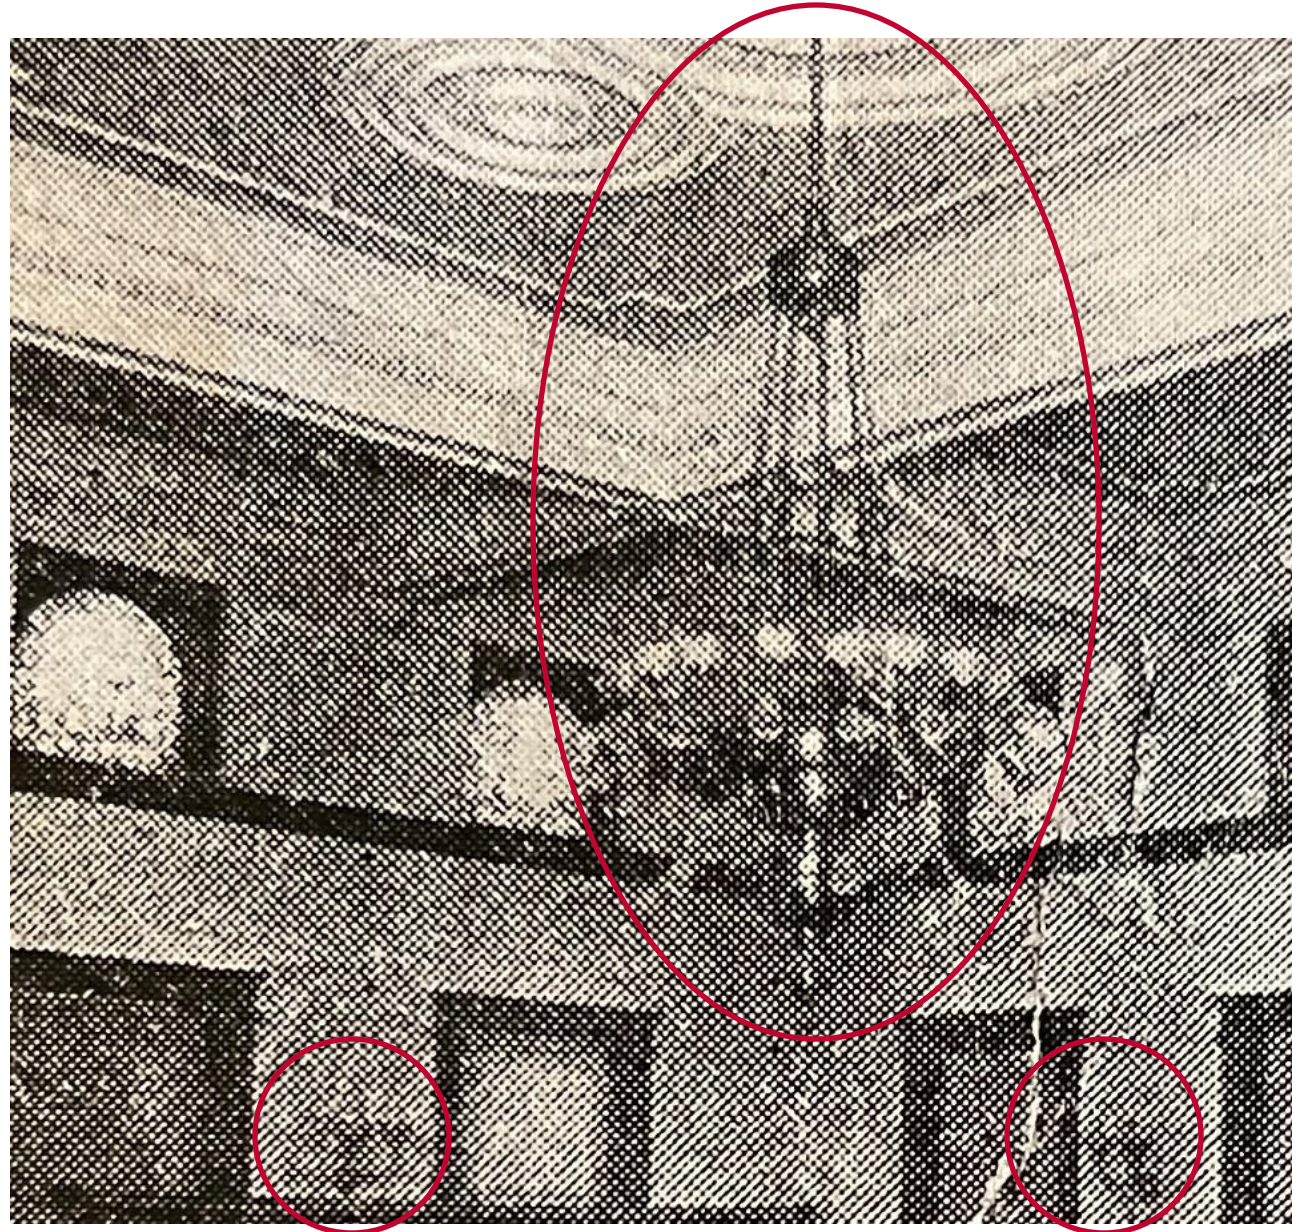
Chandelier and Sconces

The original central chandelier (*right*), which hung below the ceiling's plaster motif, was at one time replaced by non-historic fixtures (*below*). Lacking original drawings of the fixtures, we used the one existing photo to reconstruct facsimiles of the originals.

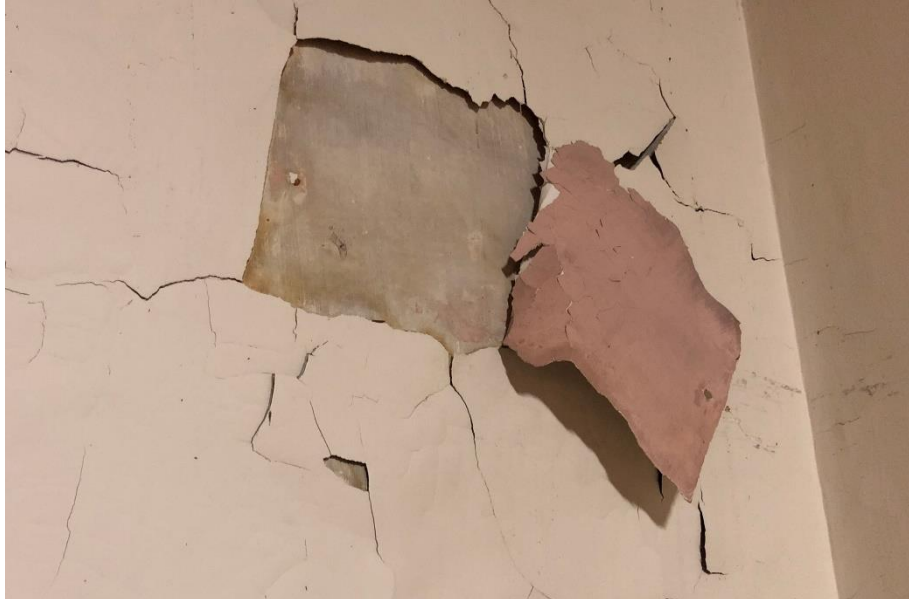
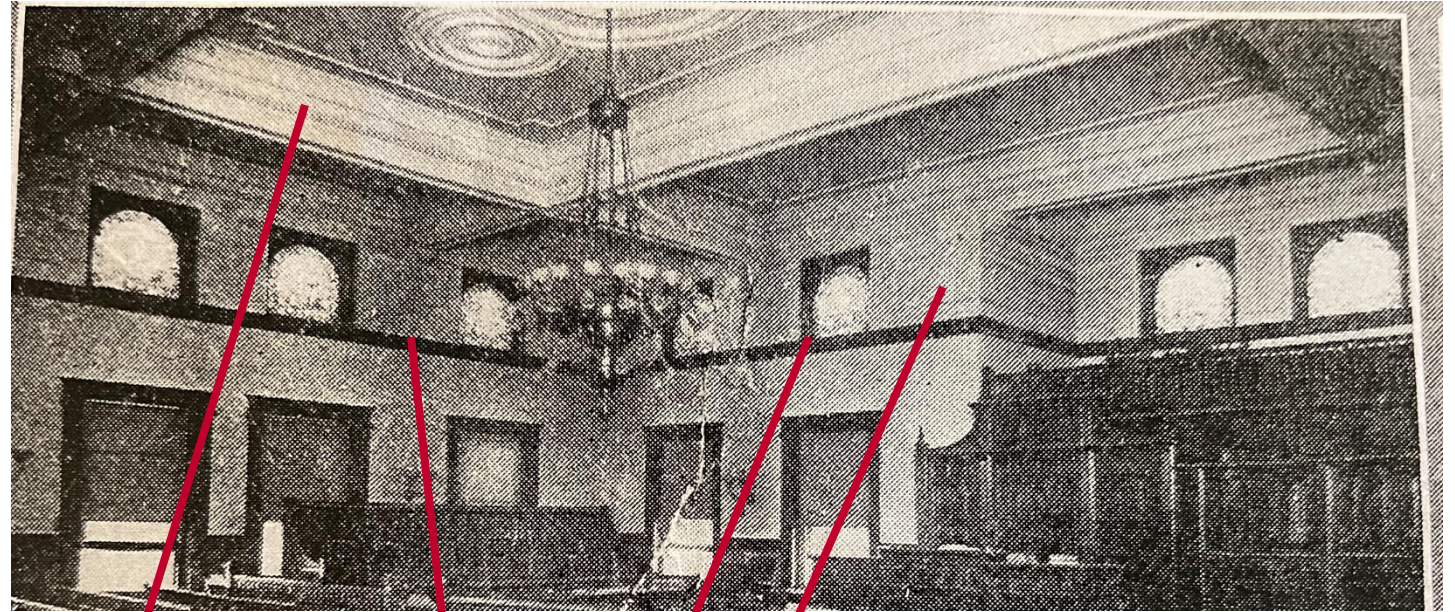
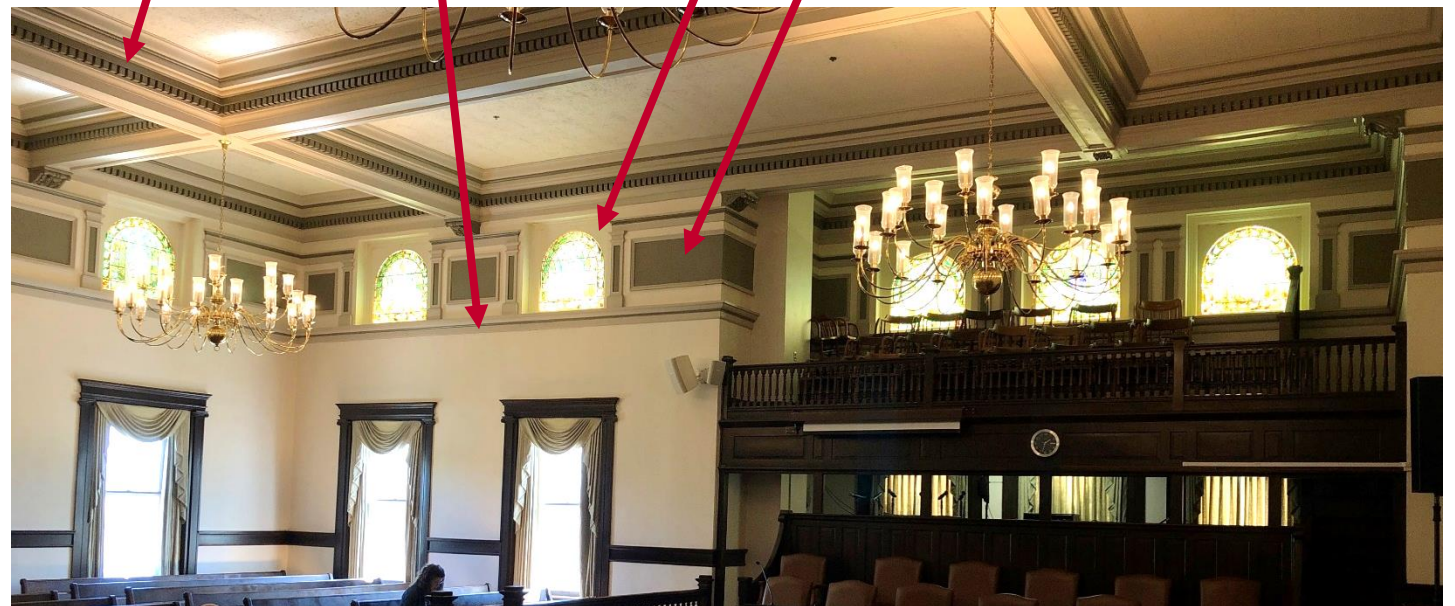
Colors

Though the 1913 photograph is in black and white, we can tell that the room's colors were originally quite different.

This led our investigation to determine where paint samples need to be taken from, to determine original coloring.

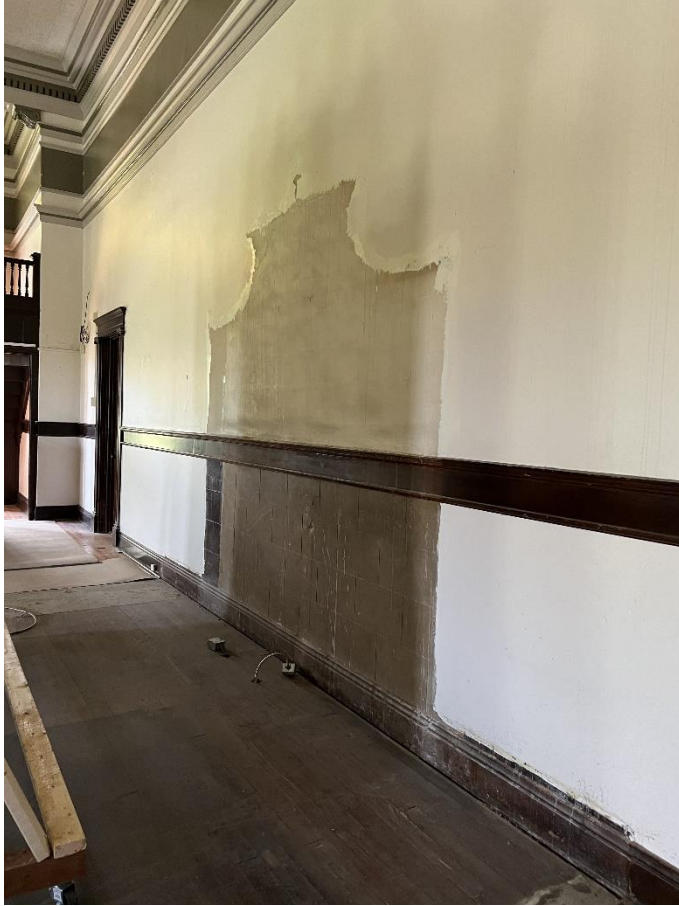
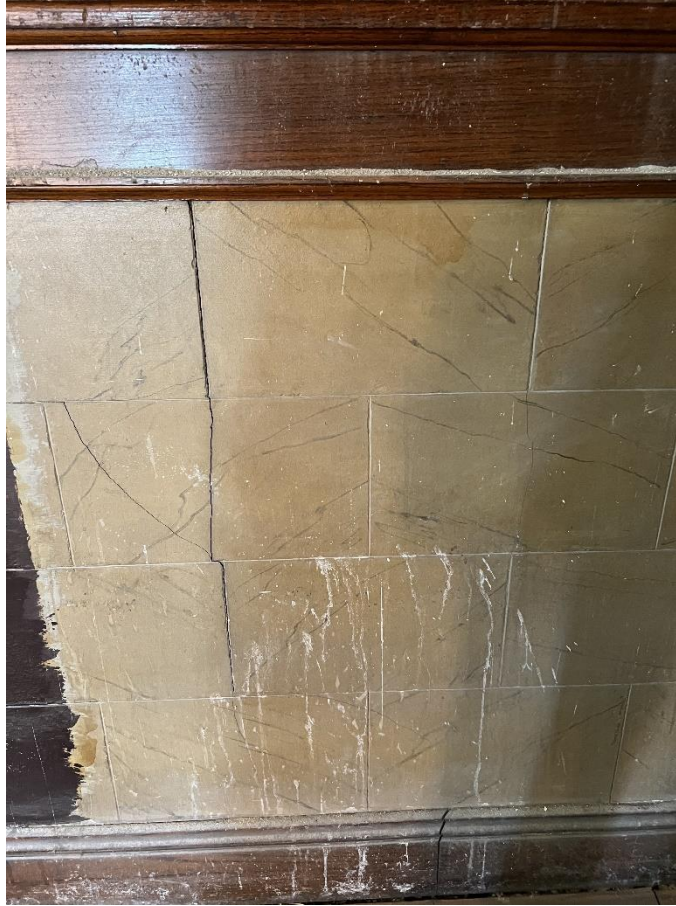
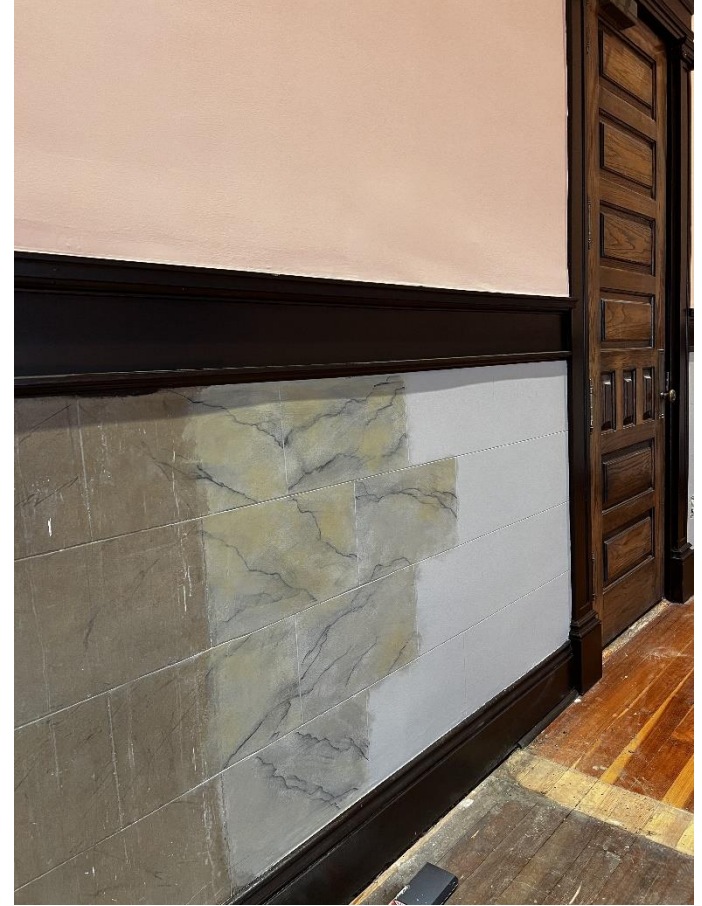
Discovery and recreation of marbleized wainscot

Based on drawings and photos, the wainscot in this room featured a stone-course pattern on the walls. This was missing but could be restored or replicated.

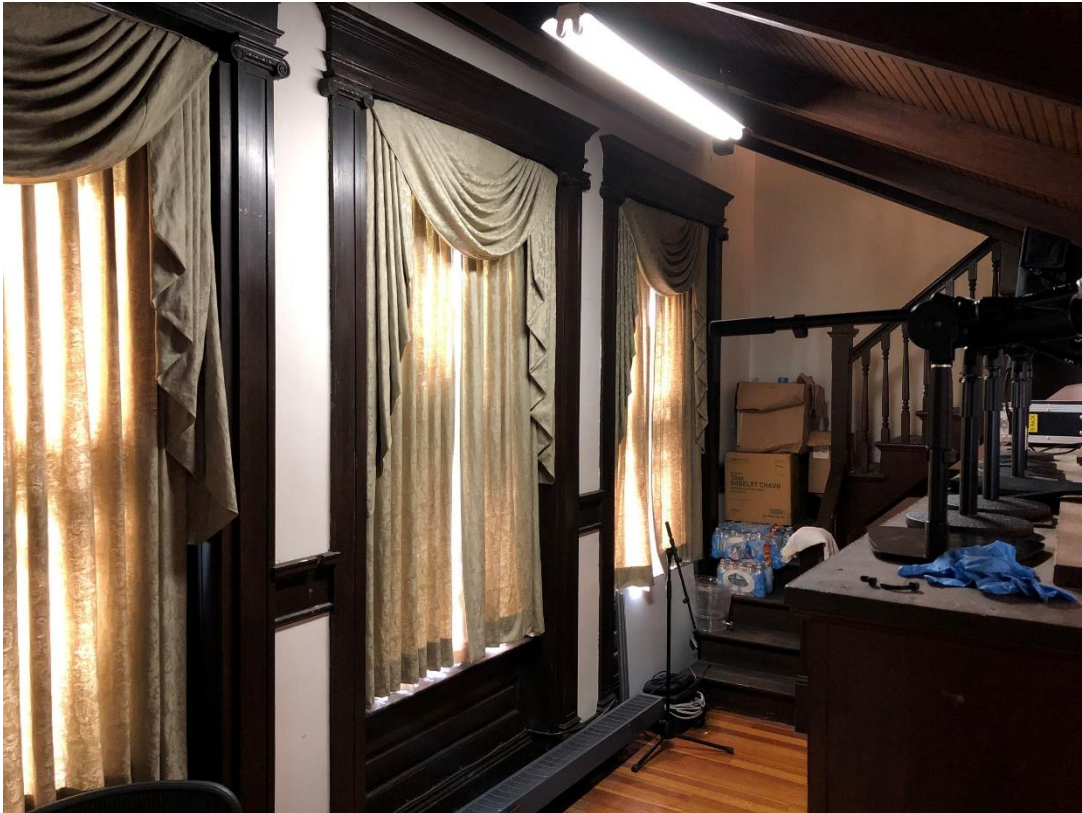
Before

The space under the balcony was changed into a small meeting room.
