Douglas County Courthouse
Commission Chamber

Courthouse Background

Built in 1903, the historic Douglas County Courthouse was designed by John G. Haskell and Frederick C. Gunn in the Richardsonian Romanesque style, and it is a late example of the style. The commission chamber, formerly the courtroom, occupies the southeastern corner of the second story.

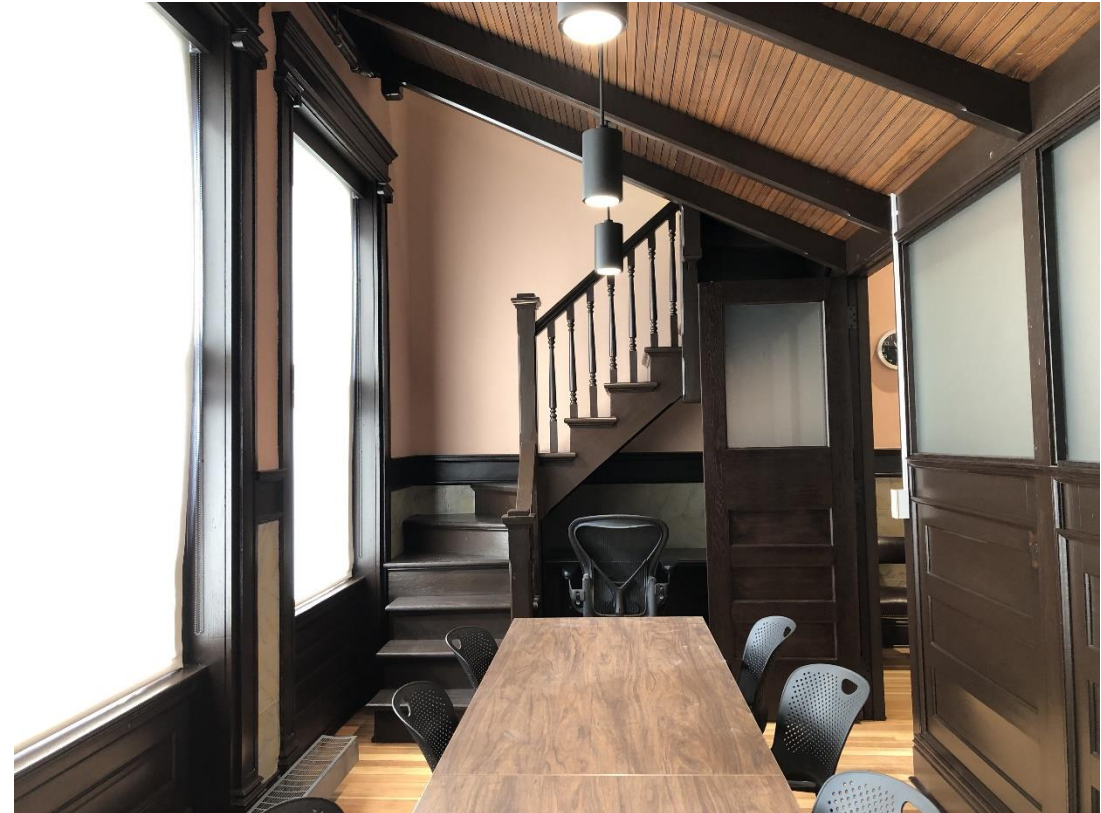
After

The space under the balcony was changed into a small meeting room.

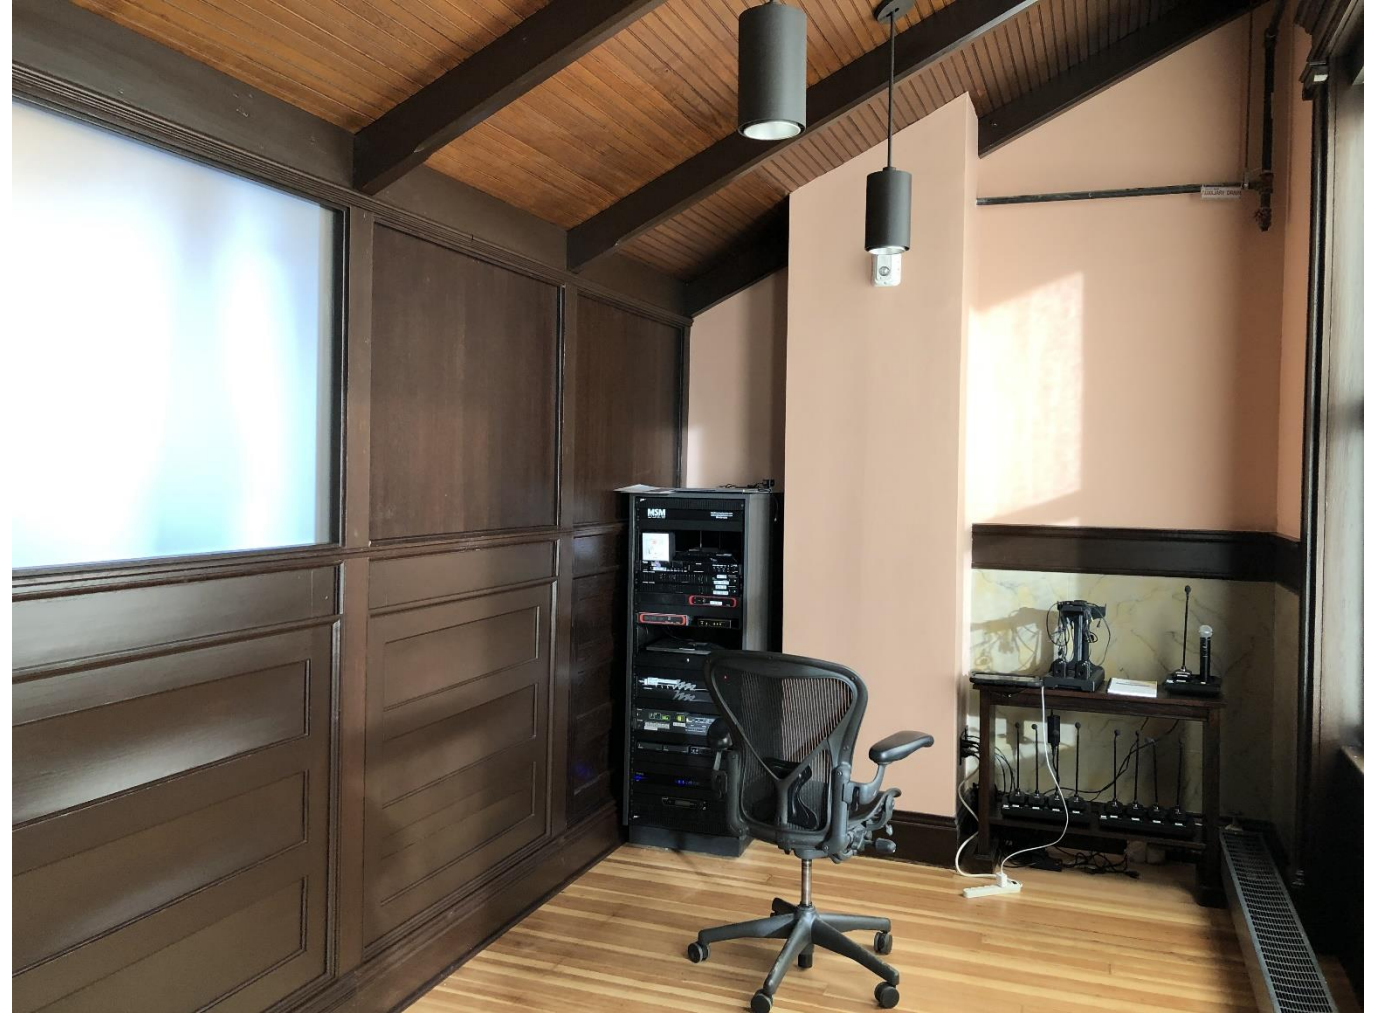
Audiovisual Findings

Audiovisual systems are critical to the operation of the commission, which are broadcast to the community and recorded for open records purposes.

The intent of this renovation was to integrate the existing functionality into the new room configuration and to extend the system where possible to provide additional functionality commonly found in council and commission chambers.

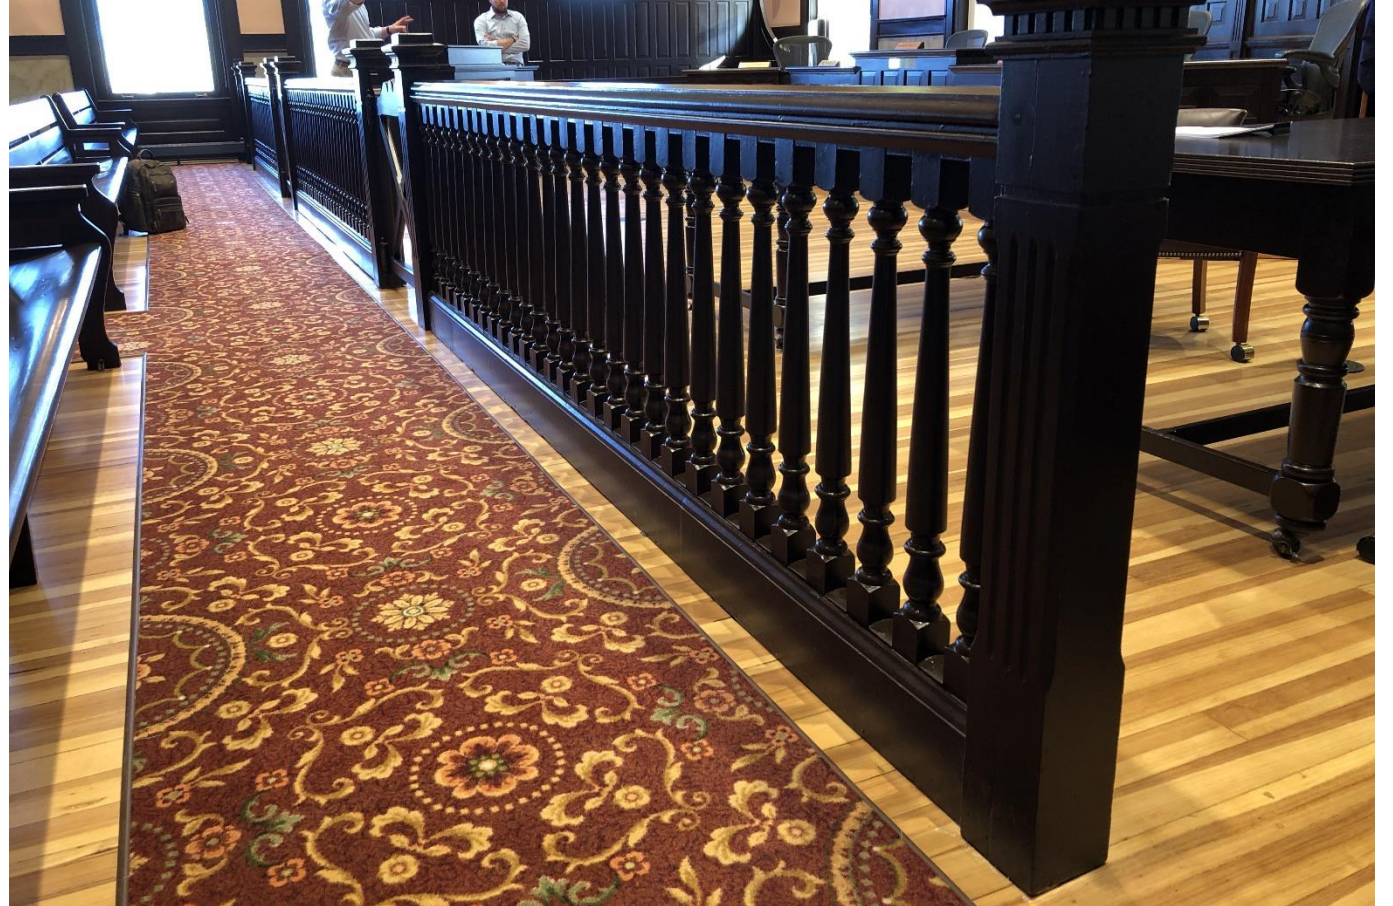
Gallery Treatment

To help the acoustic issues, the floor surface was included in the research. It was recommended that carpet runners remain in the gallery area walkways. In addition, the rows of wood benches could be provided with padding along the full extent of the seating area. Using a combination of all three options provided the solution.

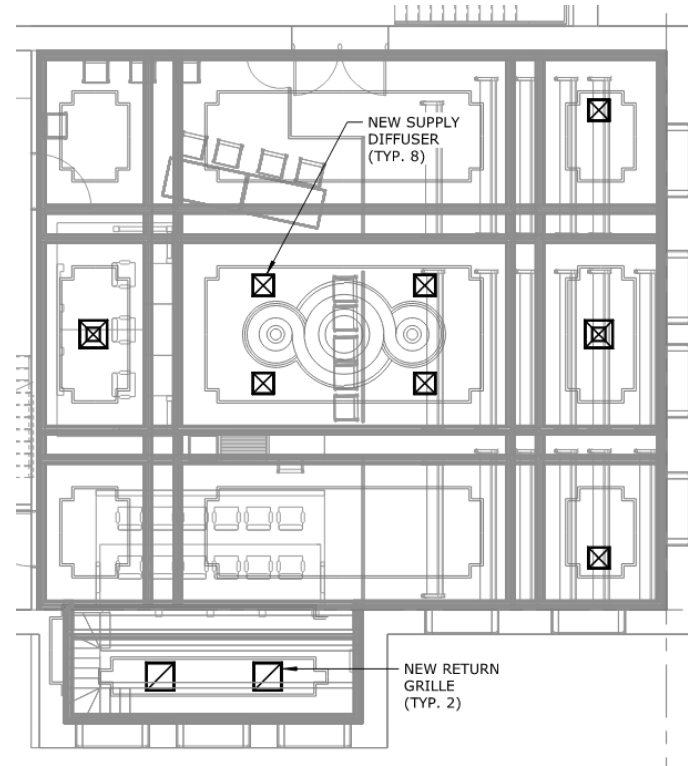
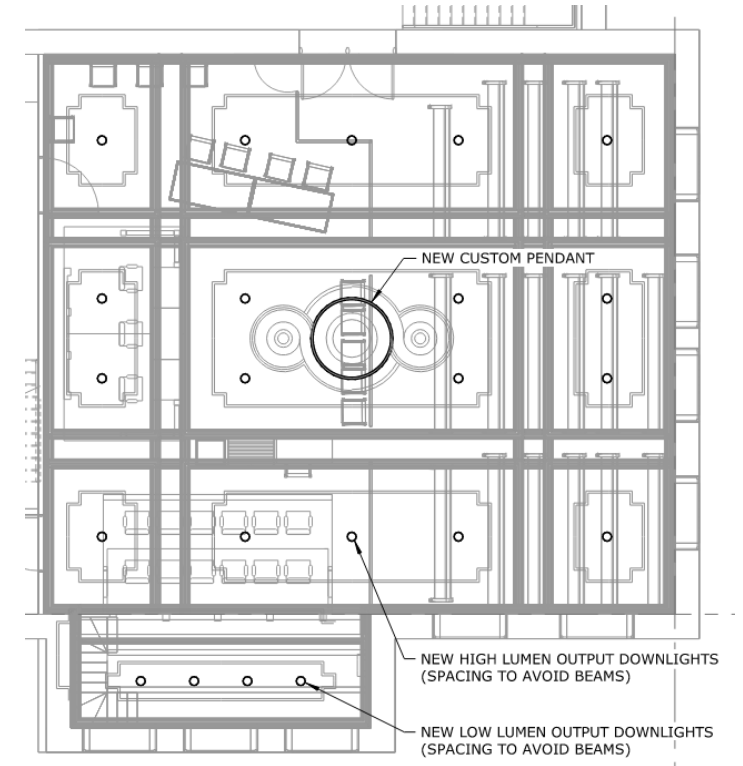
Lighting and HVAC

In addition to poor acoustics, the air distribution and lighting were not adequate. Mechanical ductwork was reconfigured in the attic above and connected to new devices. The electrical conduit was hidden, and the original lighting was replicated. The reintroduction of lost features such as light fixtures, ceiling ornamentation, and historic finishes enhanced the space, and the addition of improved lighting, systems, and acoustics brought the facility up to current standards.

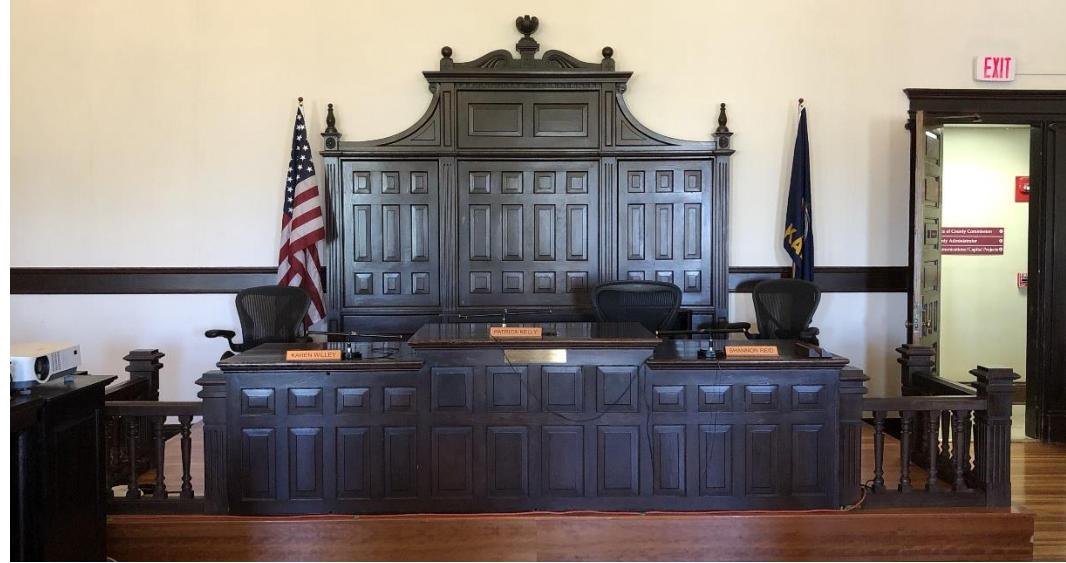
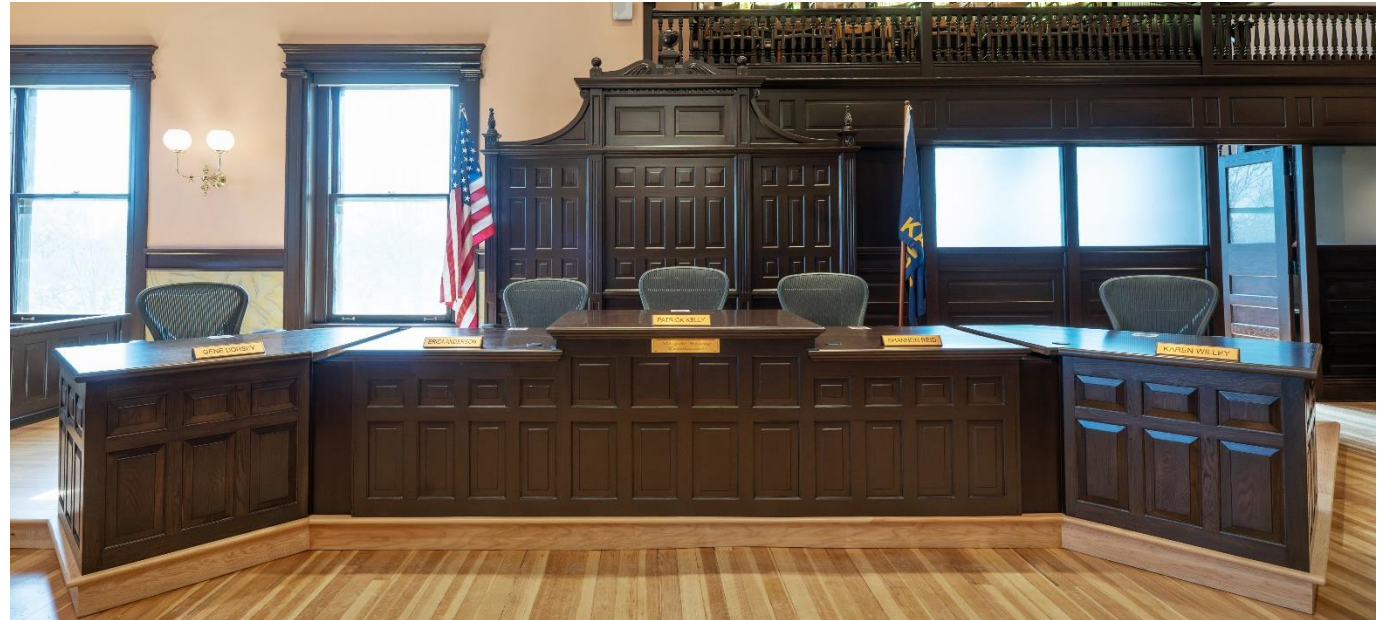
Dais Expansion

Douglas County voters chose to expand the Board of County Commissioners from three elected officials to five. This necessitated expanding the historic dais, which had once served as the judge's desk when the room was used by the court.

New angled wings were designed and added to the historic bench, and the non-historic platform was replaced. The new wings are designed to blend with the historic desk, sympathetically expanding it to serve the Commission for years to come.
